Full scale Stucco Model Testing  
Developed by Robert Koning – Director of  
Contractors Institute  
8301 Joliet Street  
Hudson, Florida 34667  
727-863-5147  
[robertk@koning.com](mailto:robertk@koning.com)  
All material Copyrighted 2015

# Full Scale Testing Model Constructed with a Sealed Stucco System

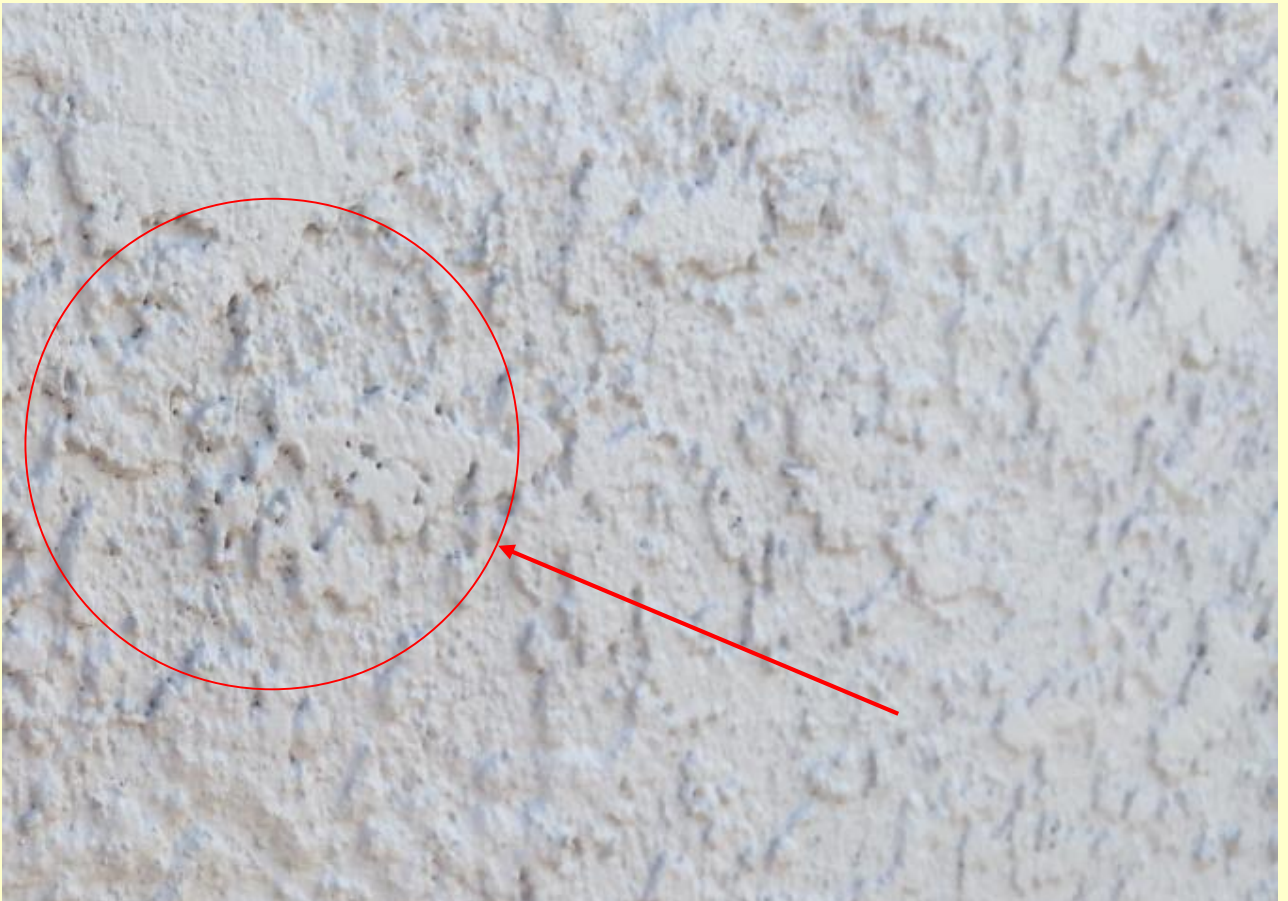
- Typical pinholes in the coating
- Observed on a high percentage of new construction homes
- Typically from use of an airless sprayer without sufficient back-rolling

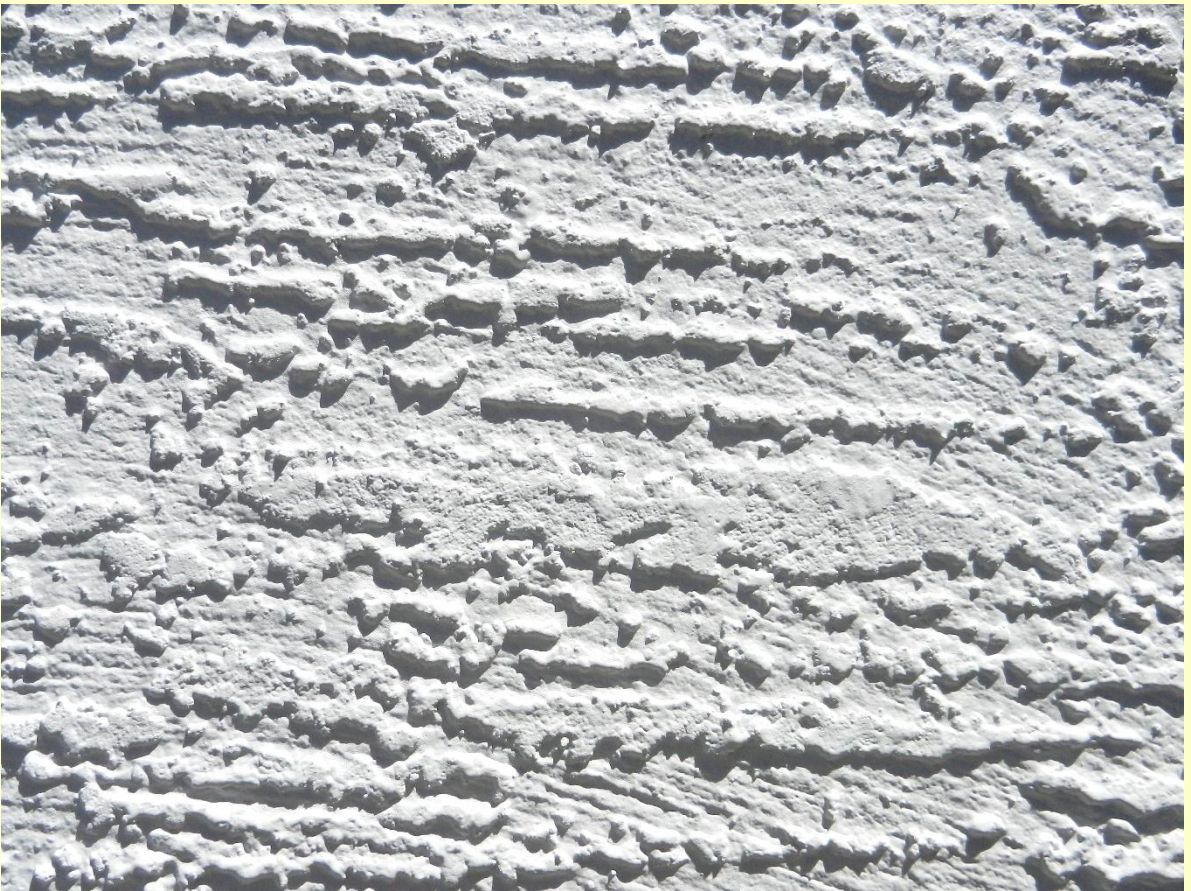
- Testing Model Painting
- Correct Mil thickness provides no visible pinholes in the coating
- Paint on the testing model was installed using traditional roller

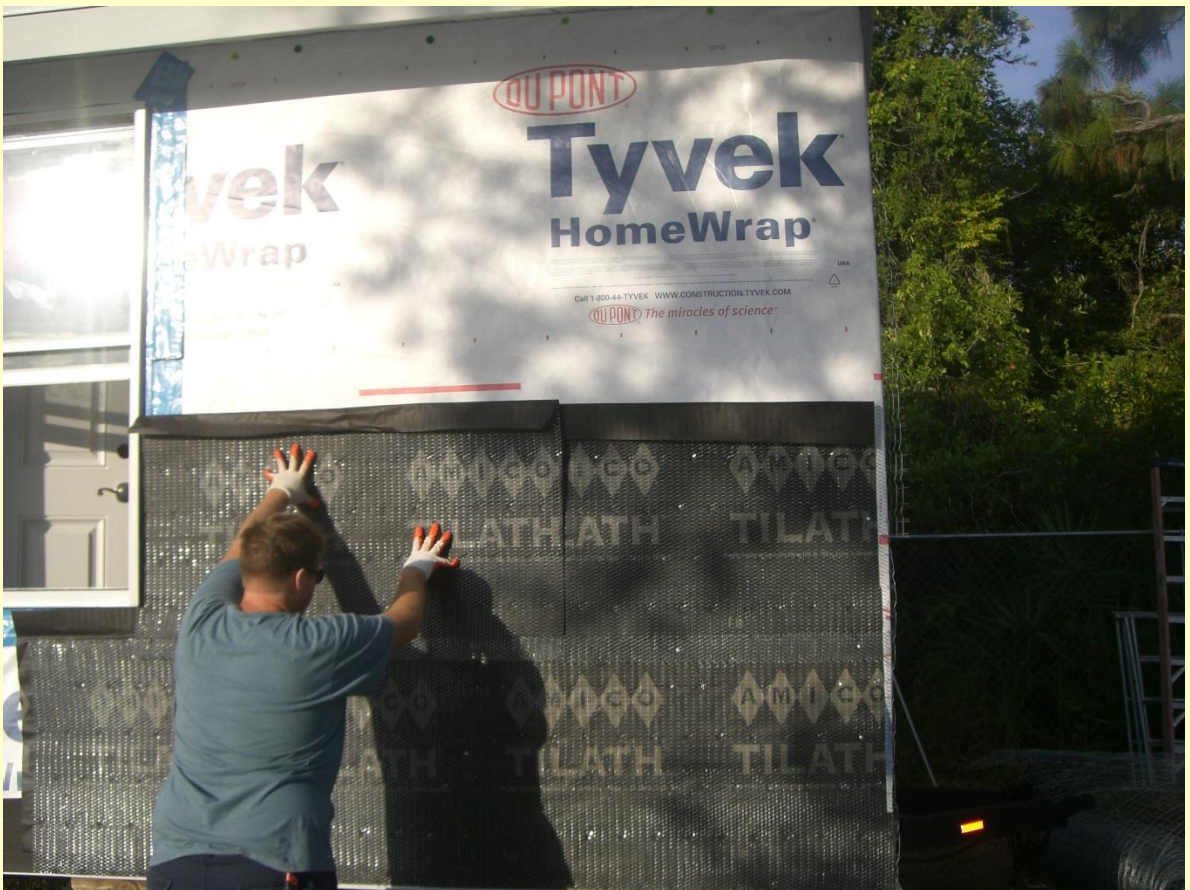
- North Wall lath installation
- Paper was not cut back on the vertical lap
- Installed July 10<sup>th</sup> 2015

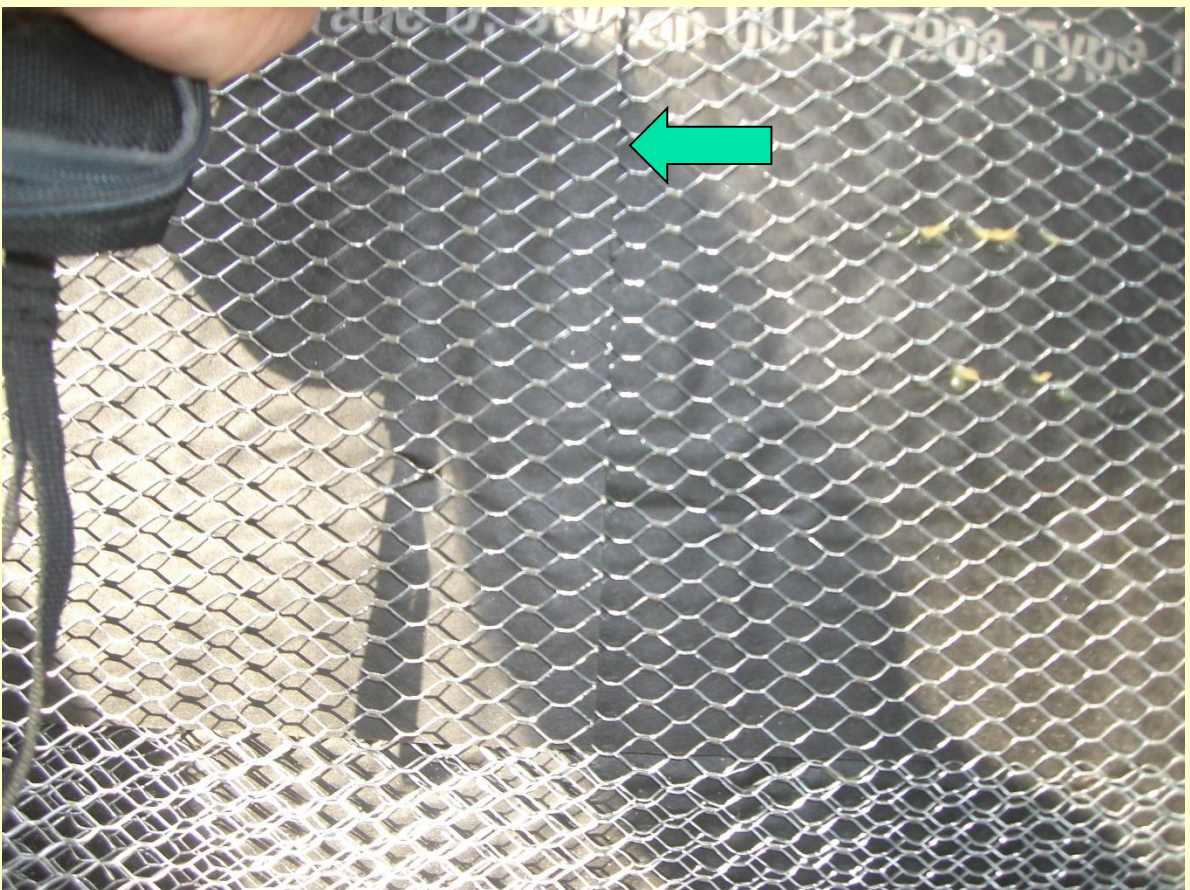
- North Wall lath installation
- Paper was not cut back on the vertical lap
- Installed July 10<sup>th</sup> 2015

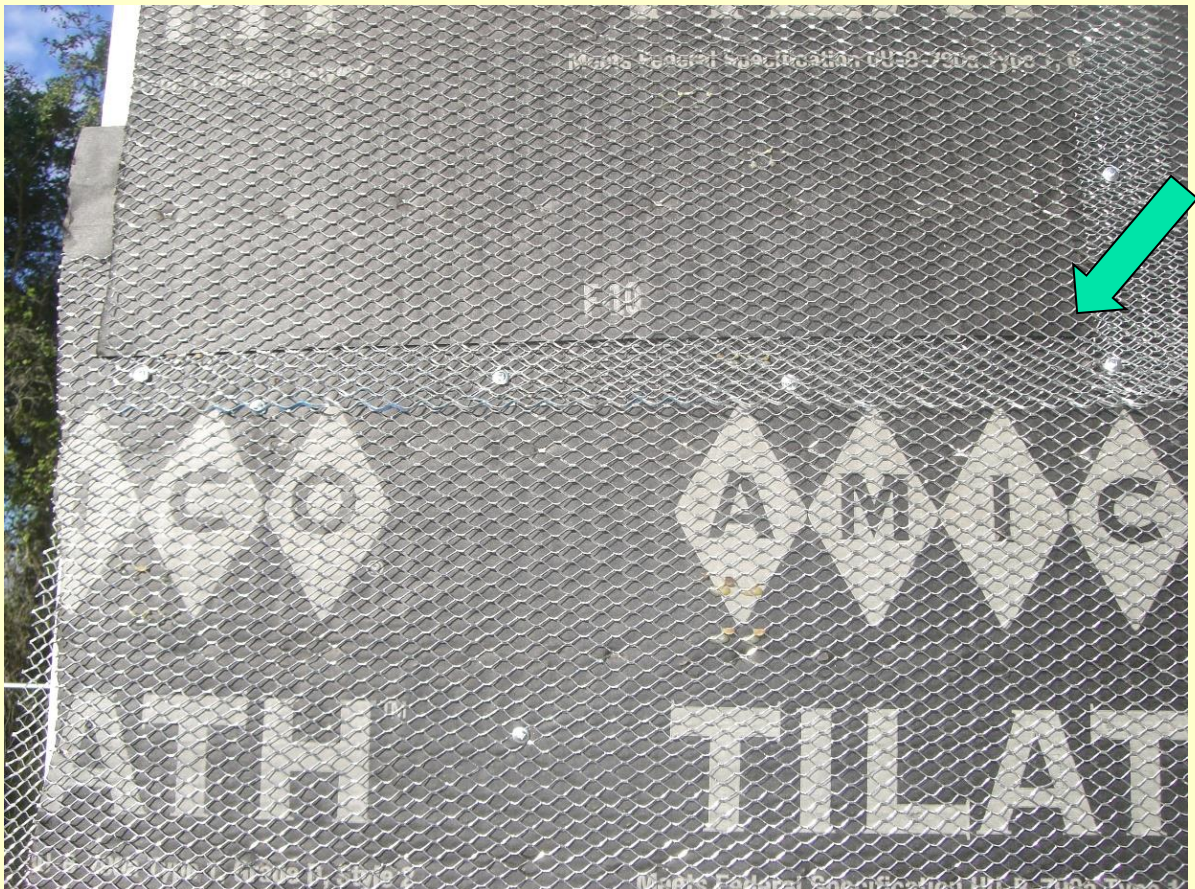
- North Wall lath installation
- Horizontal Lap in this area was installed with Paper over metal
- Installed July 10<sup>th</sup> 2015

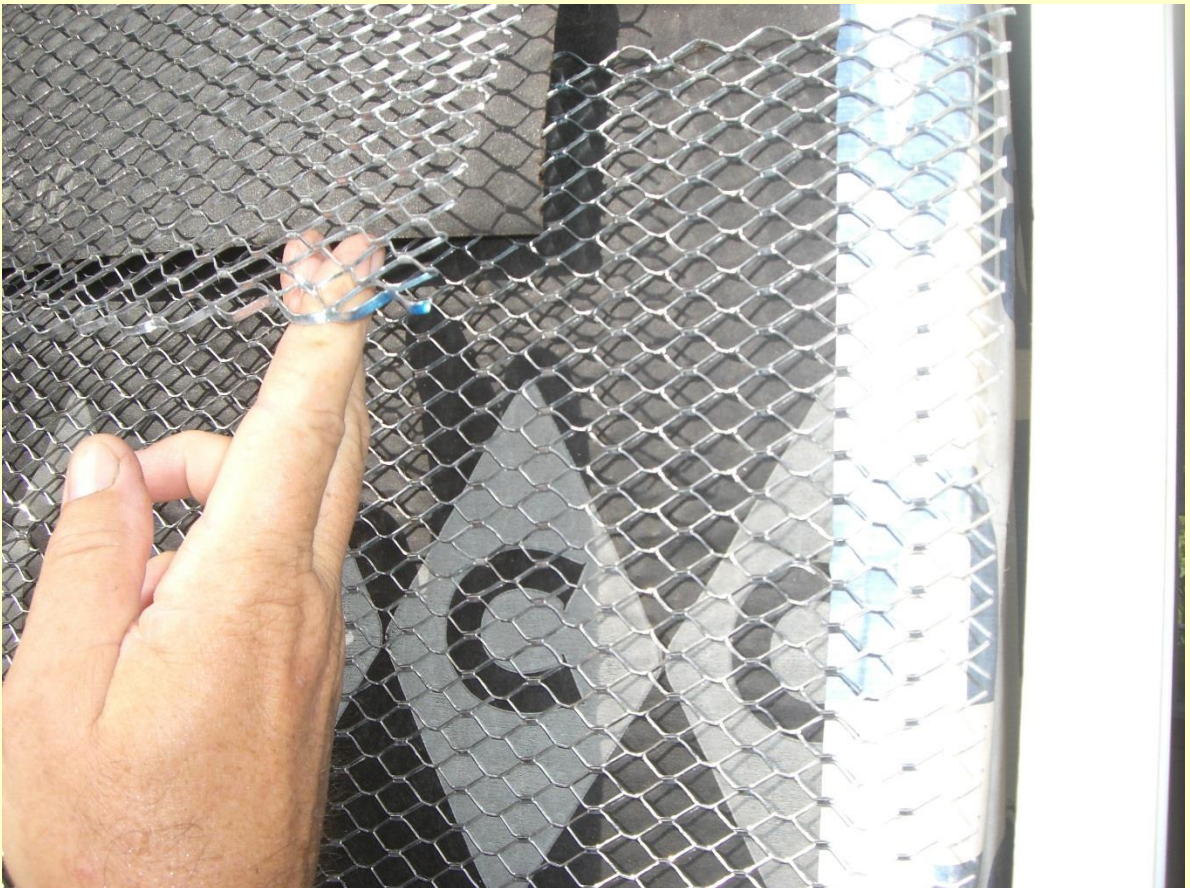
- North Wall lath installation
- Horizontal Lap in this area was installed with Paper over metal
- Installed July 10<sup>th</sup> 2015

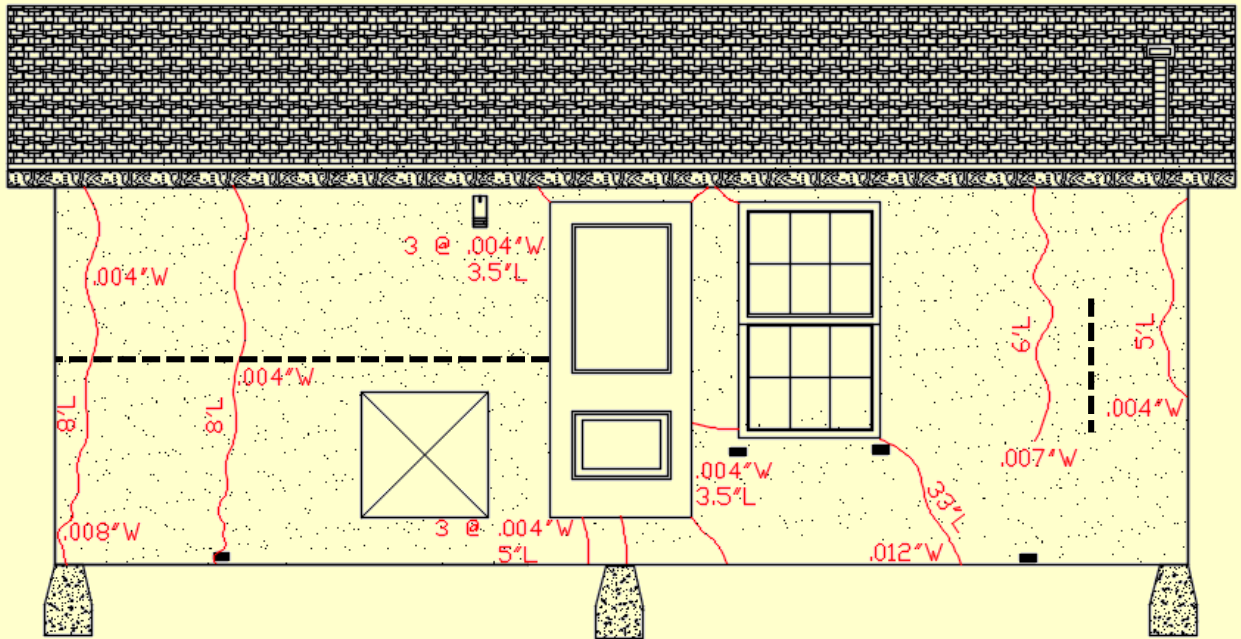
Front (North) Elevation

- The configuration on the front (North) elevation were as follows
- Traditional Amico Self Furring Paper back metal lath was installed over Tyvek Housewrap
- A 5/8" of stucco was installed over the lath and left to cure for 19 days.
- The above cracks were observed after the curing and settling process.
- The Horizontal dashed line represents a deliberate installation of a 2" lap of paper over metal
- The vertical dashed line represents a vertical lap where the paper extended to the edge of the metal and was not cut back

Area in SF	LF Cracks	LF Cracks PSF
192	31.583	.16

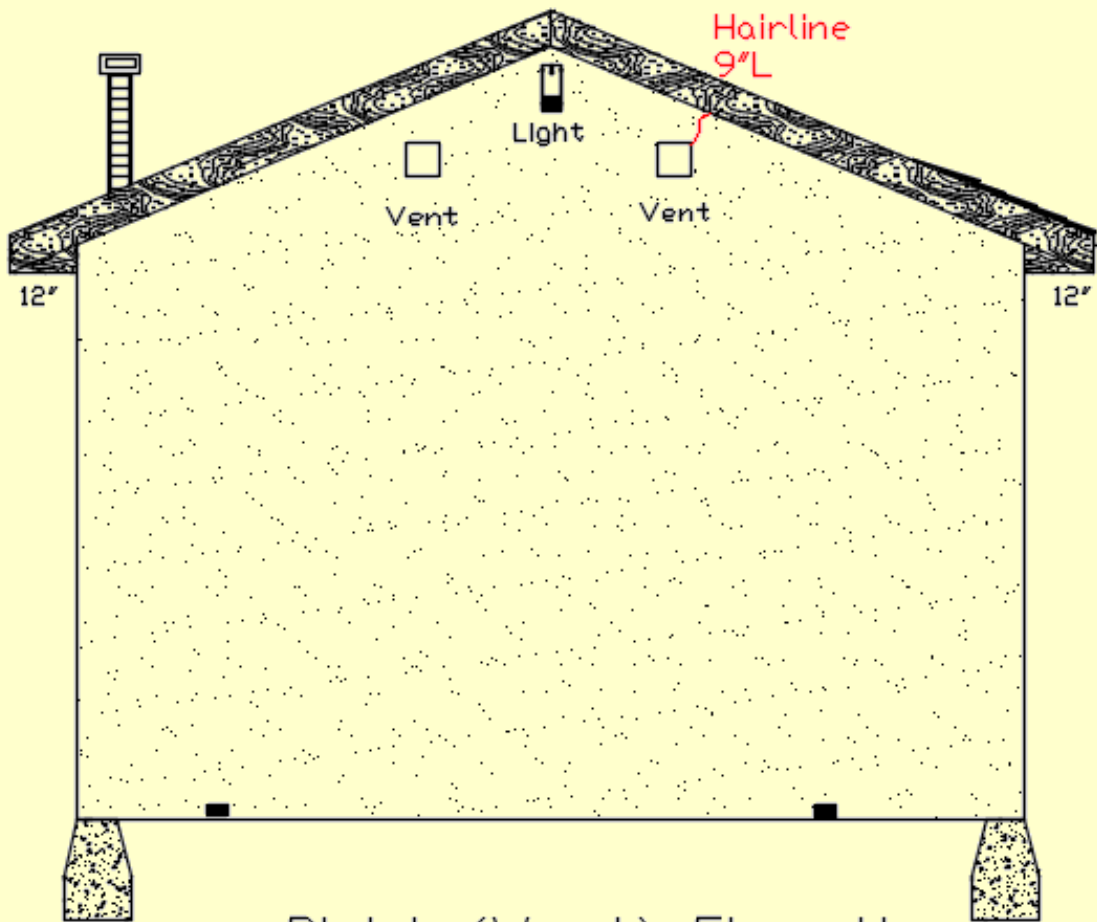
Right (West) Elevation

- The configuration on the Right(West) elevation were as follows:
- StructaWire StructaLath installed directly over Tyvek Housewrap
- A 5/8" stucco assembly was installed over the lath and left to cure for 19 days.
- One visible diagonal crack was observed at a penetration (Vent) approximately 9" in length at the top of the wall.
- The above crack was observed after the curing and settling process.

Area in SF	LF Cracks	LF Cracks PSF
140	.75	.01

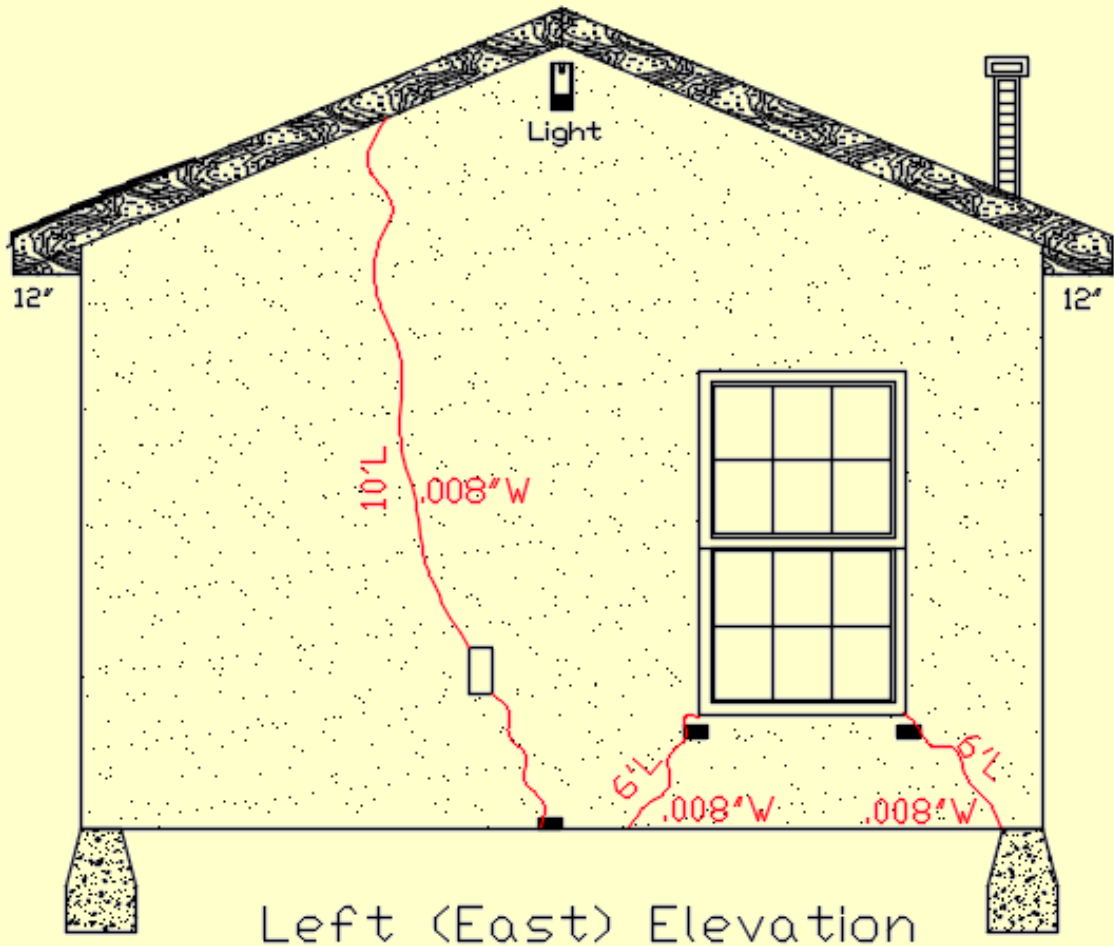
## East (Right) Elevation

- The configuration on the front (North) elevation were as follows
- Traditional Amico Self Furring metal lath was installed directly over Tyvek Housewrap
- A 5/8" of stucco was installed over the lath and left to cure for 19 days.
- The above cracks were observed after the curing and settling process.

Area in SF	LF Cracks	LF Cracks PSF
140	22	.16

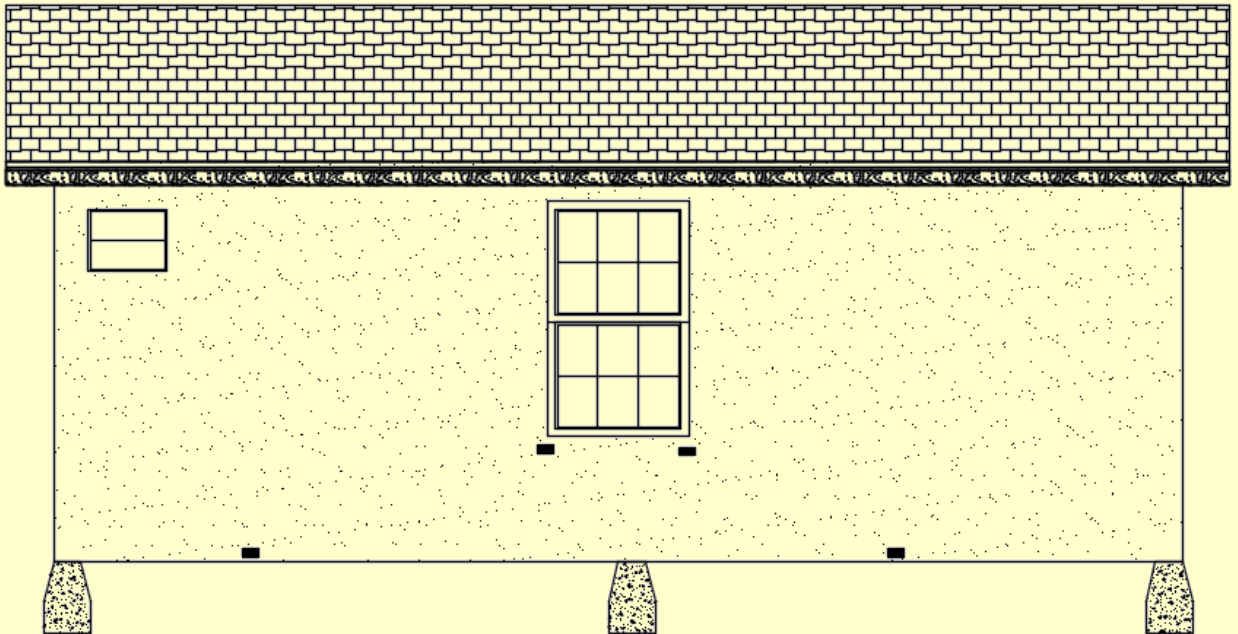
Rear (South) Elevation

No Visible Cracks

- The configuration on the Rear (South) elevation were as follows:
- StructaWire StructaLath Installed directly over Tyvek Housewrap
- A 5/8" of stucco was installed over the lath and left to cure for 19 days.
- No visible cracks were observed on this wall

Area in SF	LF Cracks	LF Cracks PSF
192	0	0

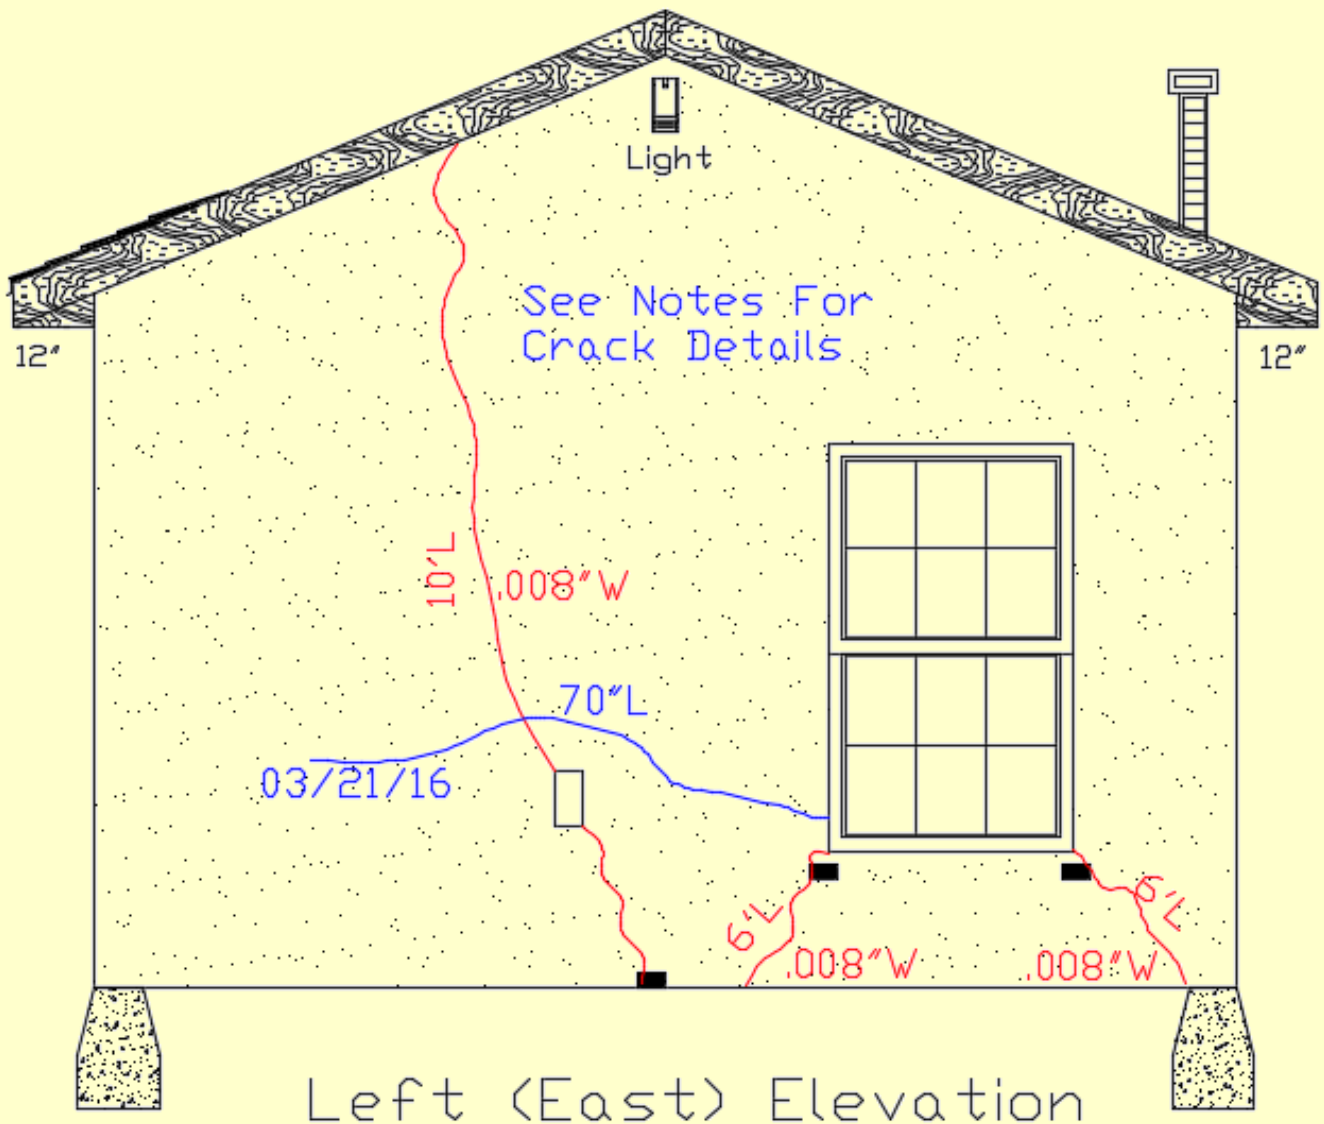
# Post Painting Fractures Developed March 21, 2016

- The fracture appeared on March 21, 2016, after a cold front had passed through the area, dropping the temperatures to the low 50s. It is important to note that this fracture had not appeared during our initial crack identification before painting. It is also important to note that the cracking only occurred in the areas that were covered by the expanded metal lath. The areas that were covered with StructaLath still maintained zero cracks.

- Our hypothesis to why this has happened: The StructaLath has less mass and is a more rigid product than the expanded metal lath. The StructaLath provides more reinforcement with less mass than the other products. Therefore temperature induced changes in the metal mass and expanded the "diamond lath" at a greater rate than the cementitious stucco attached to it. That induced stresses that are causing cracking, further tests are warranted. However, the fracture has closed up during warmer temperatures and therefore will be monitored for future changes.

- As far as waterproofing, the initial fracture is too fine to allow water penetration to any measureable amount causing damage, and when closed in warmer temperatures like the summer months the fracture will be closed up therefore preventing any water intrusion.

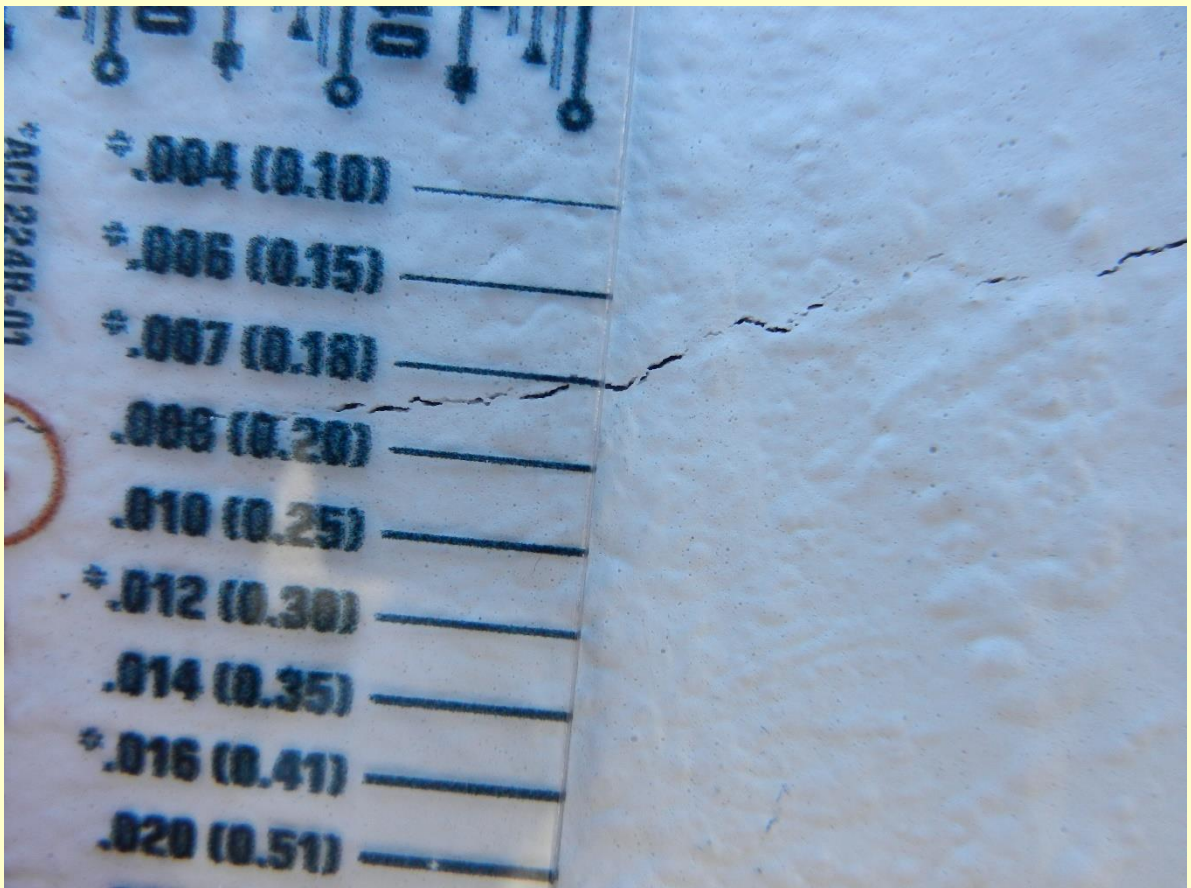
- 3/21/2016
- Fracture appears after cold front. .007" in width
- East Wall

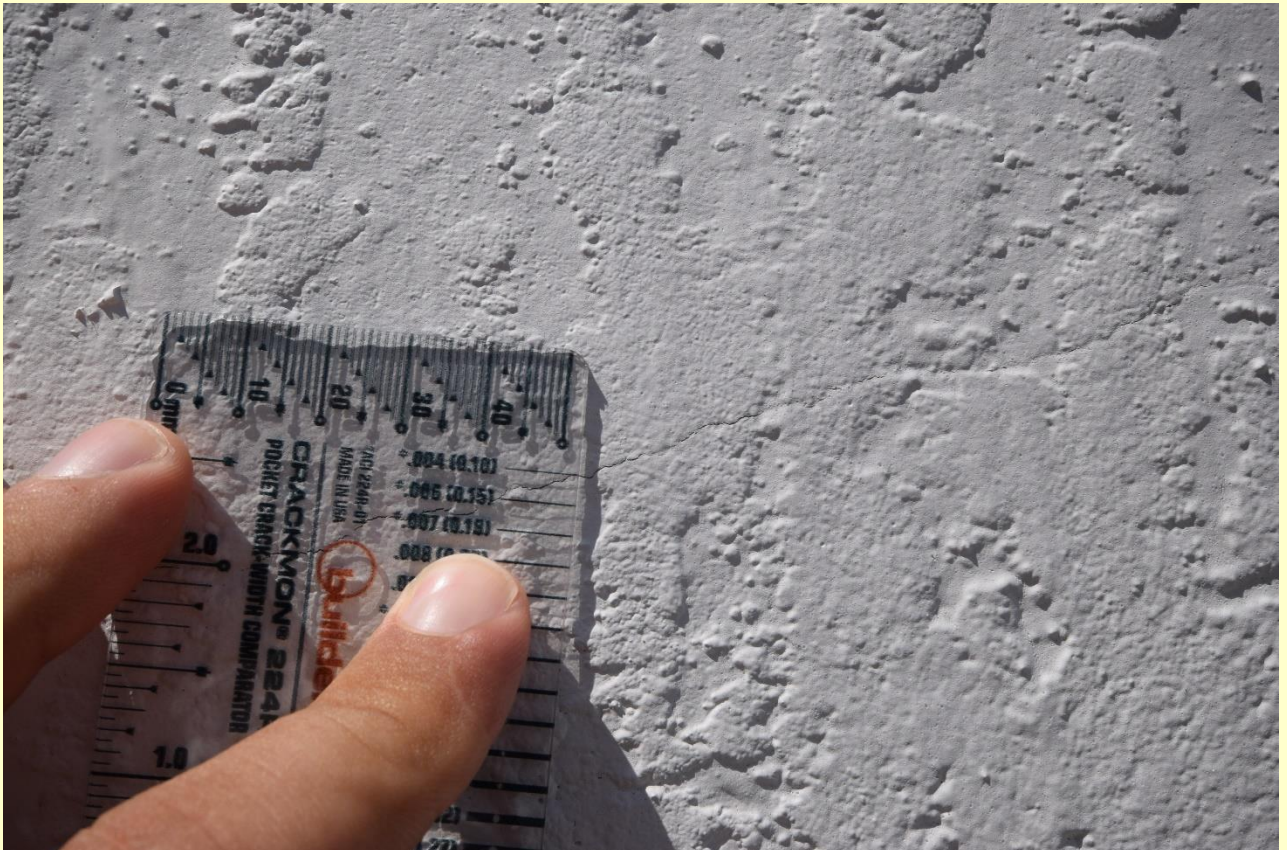
- 3/23/2016
- Fracture shrunk from .007" to .004", closed in certain areas
- East Wall

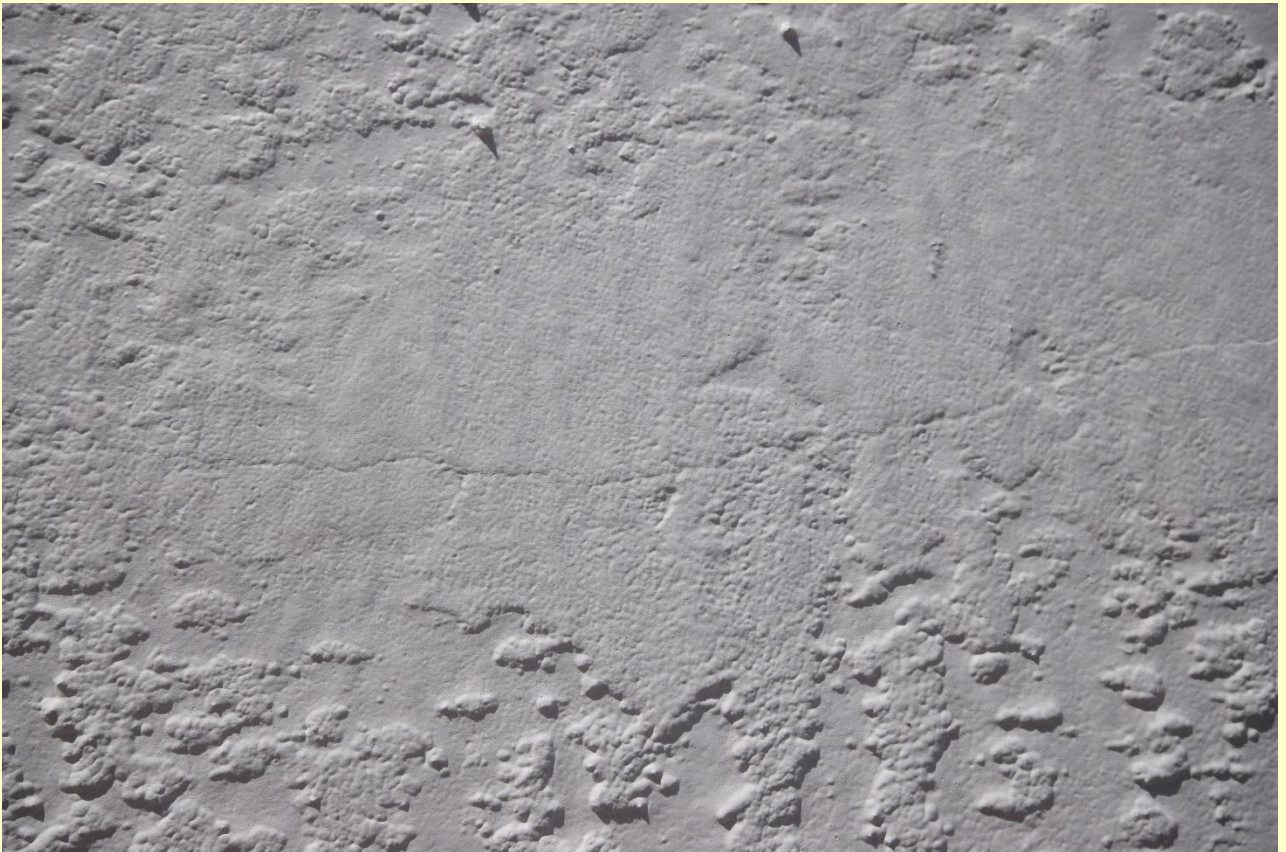
- 3/23/2016
- Fracture closed in most areas
- East Wall

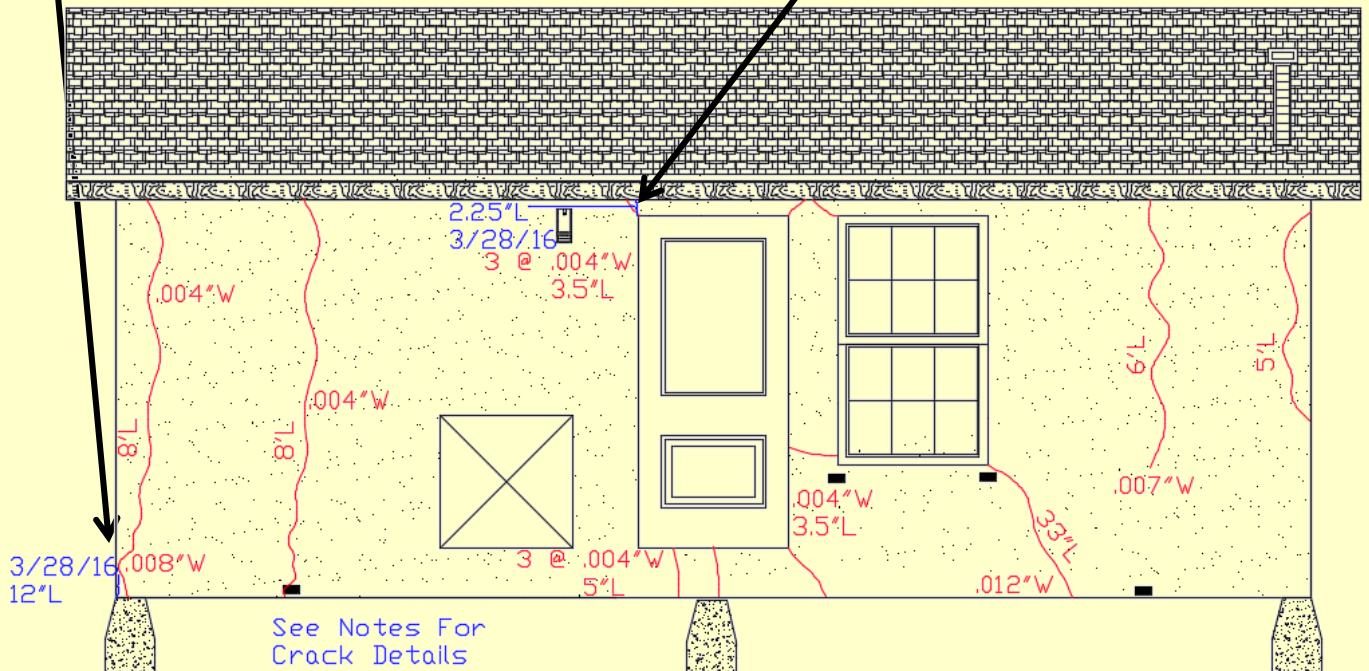
Front (North) Elevation

# Post Painting Fractures Developed March 28, 2016

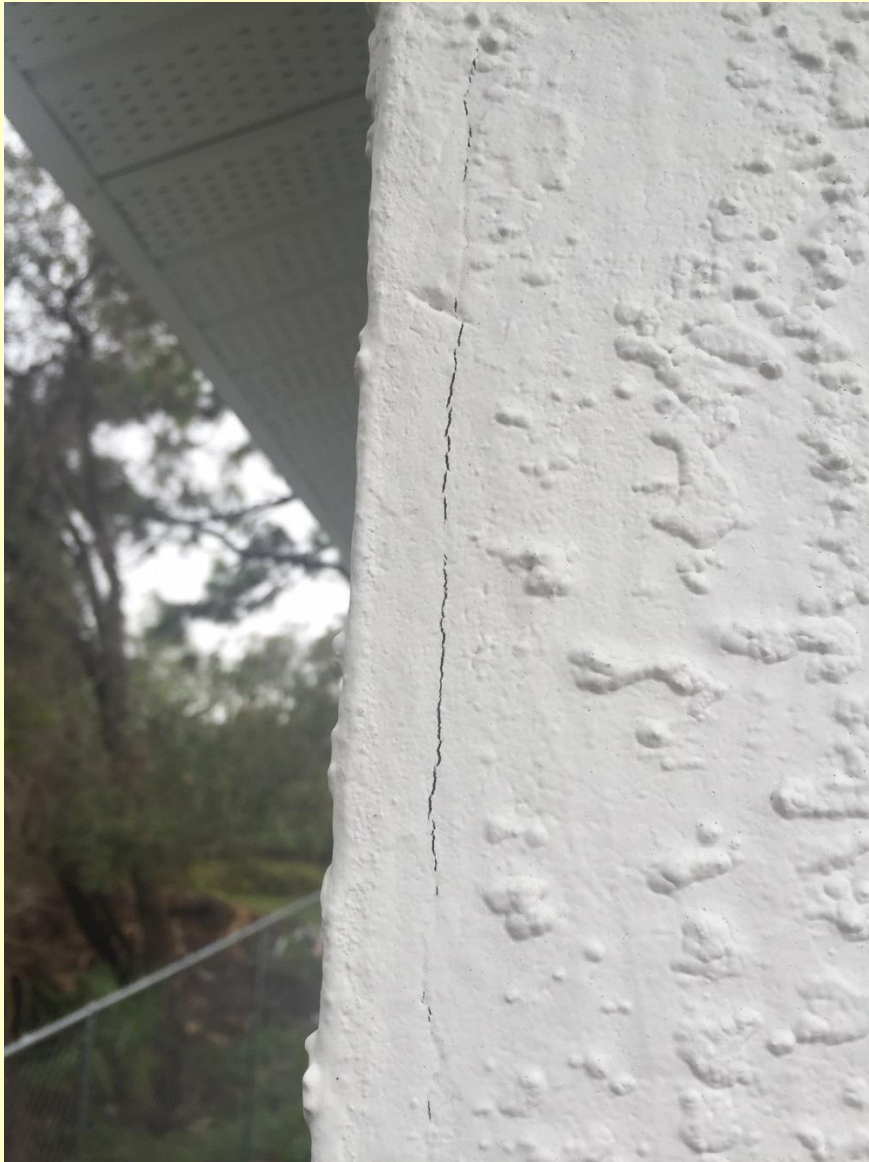
- 3/28/2016
- New Crack Developed
- East Wall

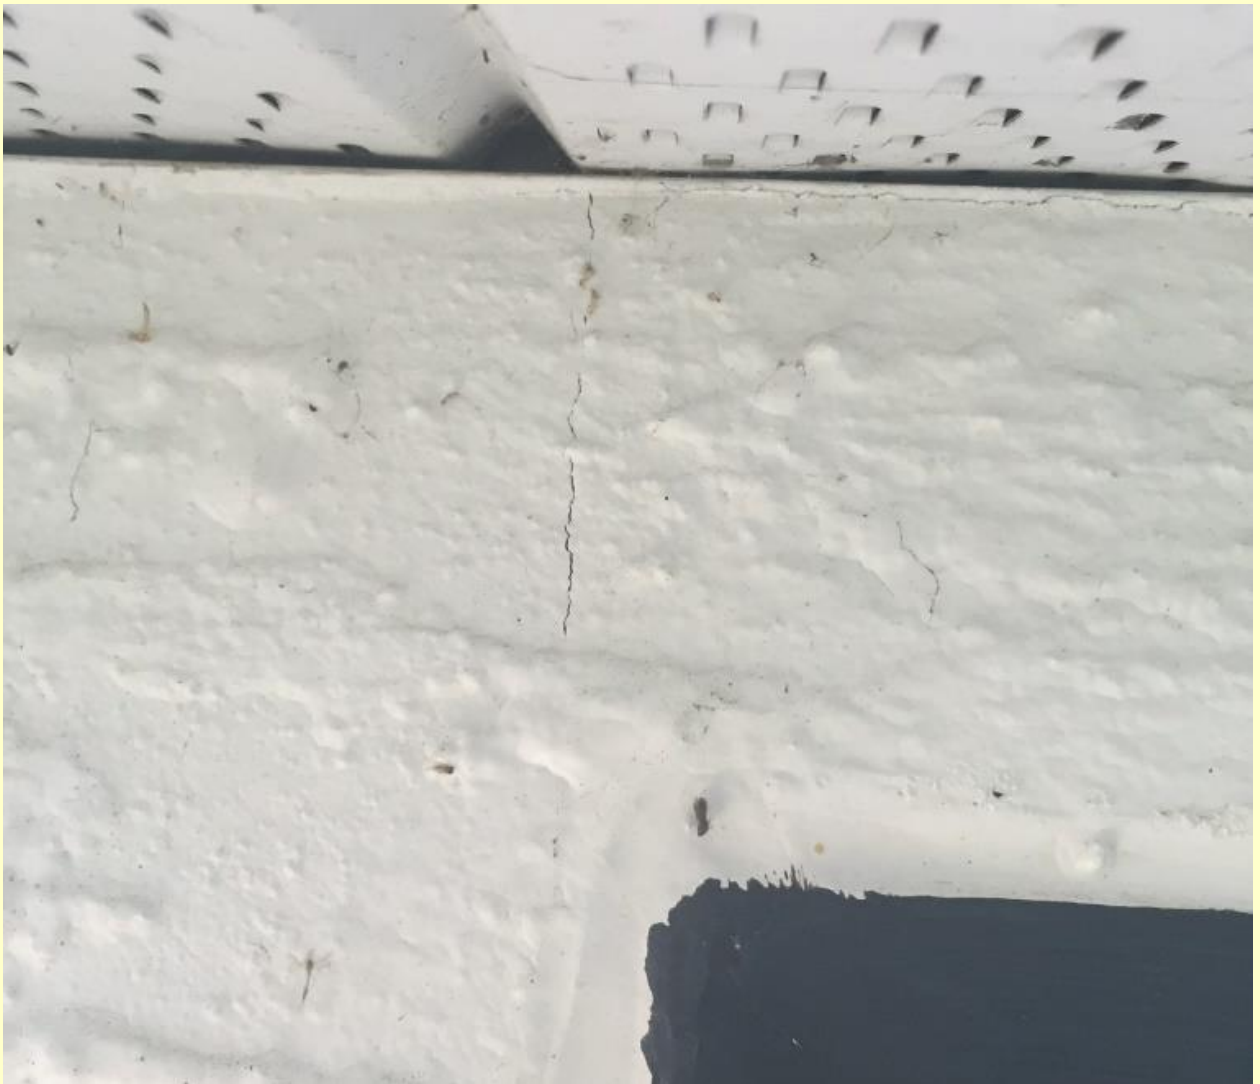
- 3/28/2016
- New Crack Developed
- North Wall

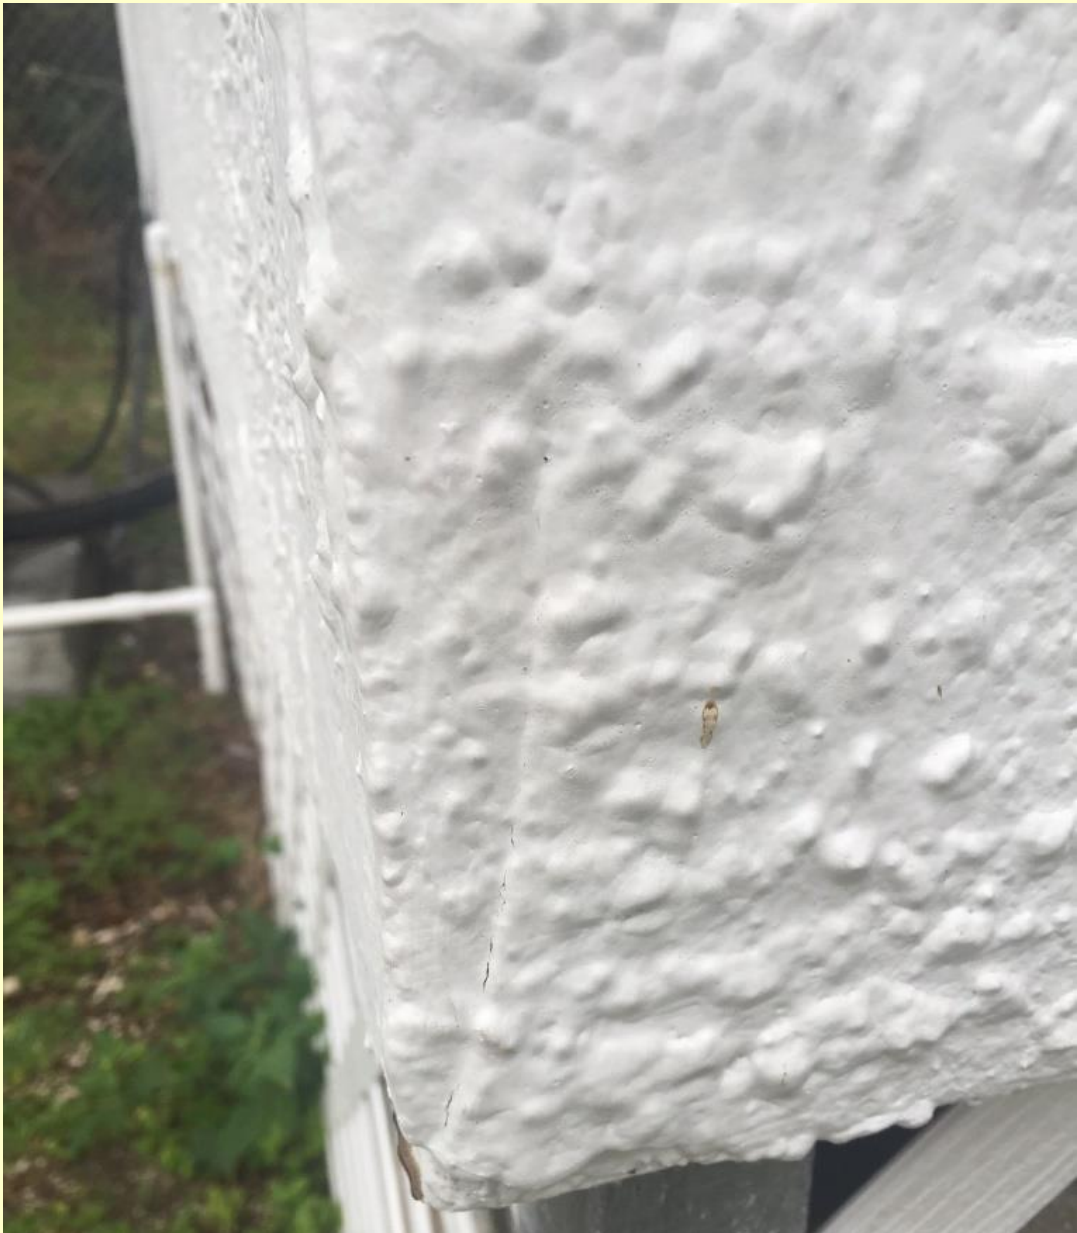
- 3/28/2016
- New Crack Developed
- North Wall

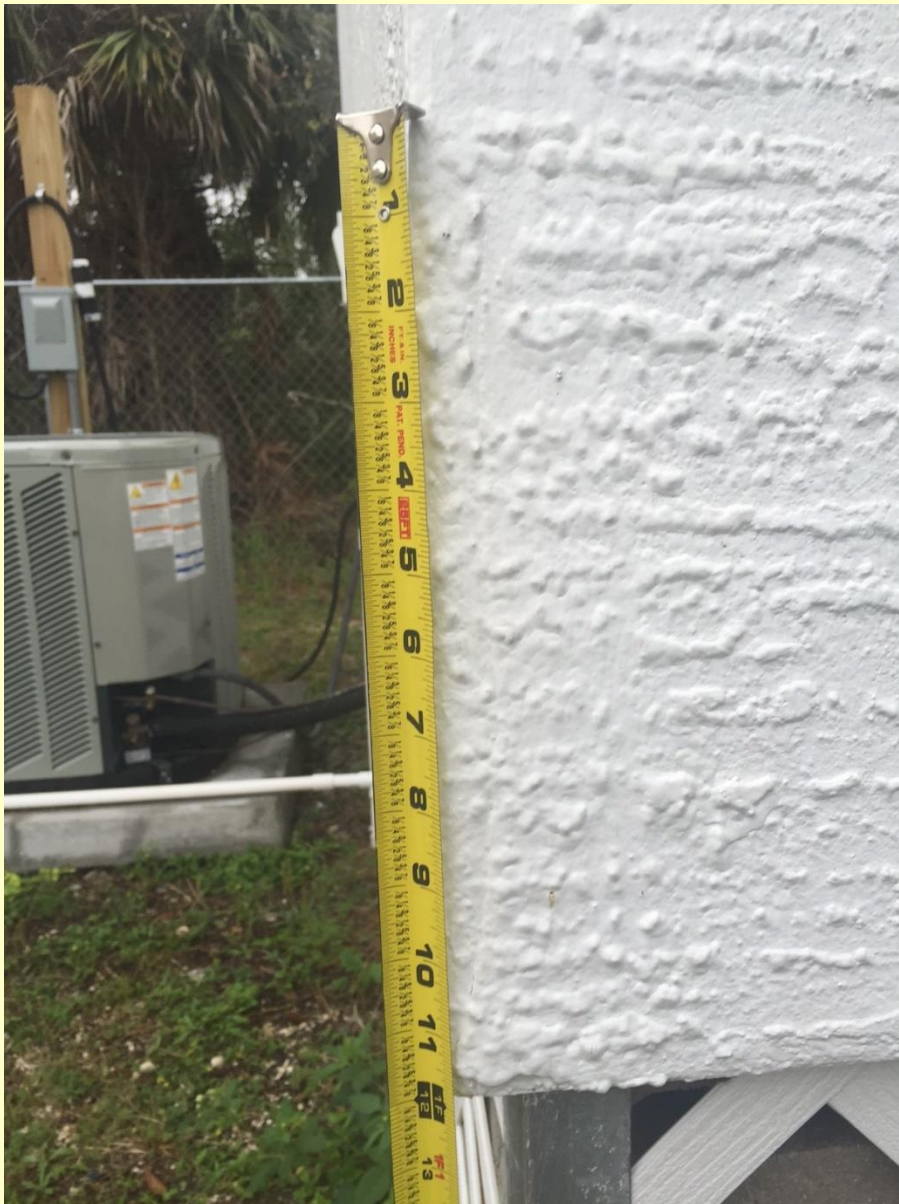
- 3/28/2016
- New Crack Developed
- North Wall

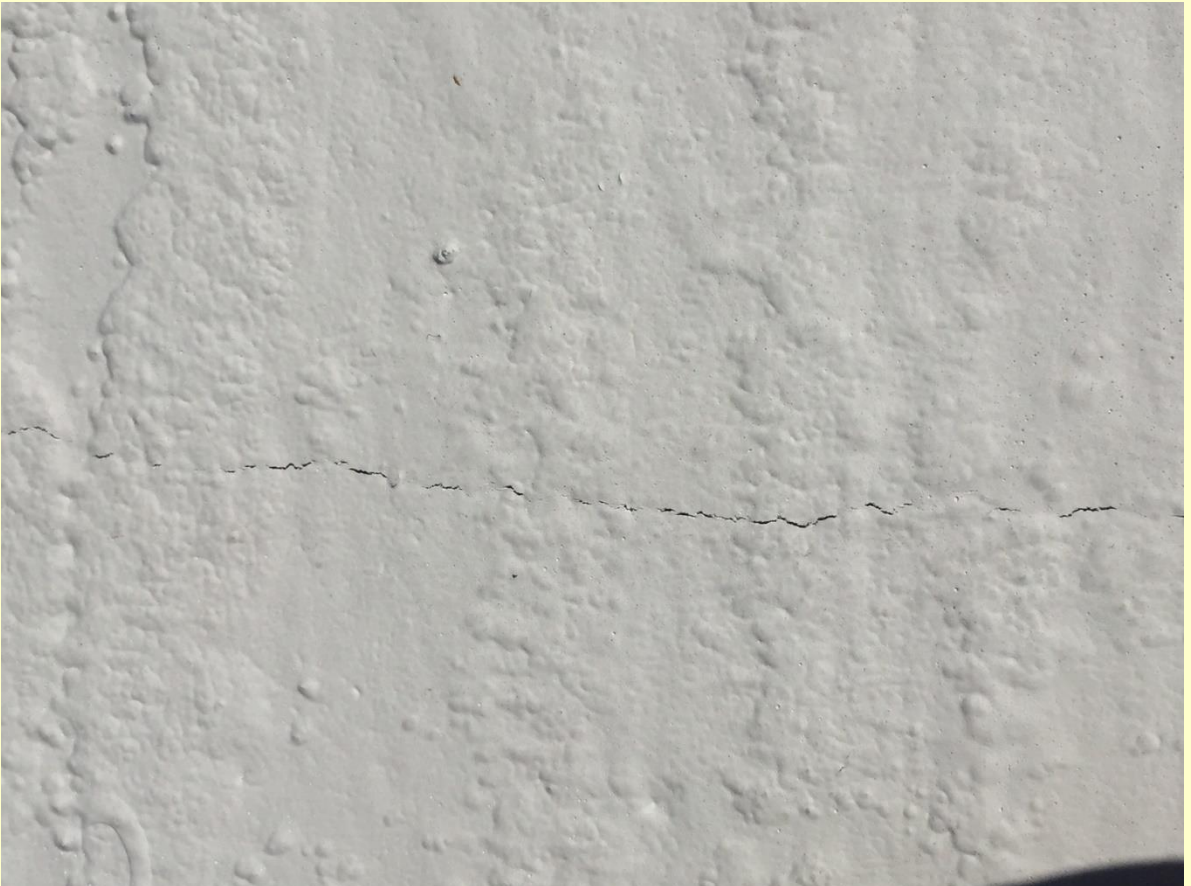
- First Developed Crack Update
- After another cold front crack expanded to the original .007"

Although minor, none of these cracks  
appeared on the walls with Structa  
Wire
