Florida Stucco Application and Repair Newsletter

35 Year old Stucco Walls Performing
Flawlessly!
2nd Story Wood Sheathed Wall Over Block
1st Story.

Newsletter 19-01-1&2

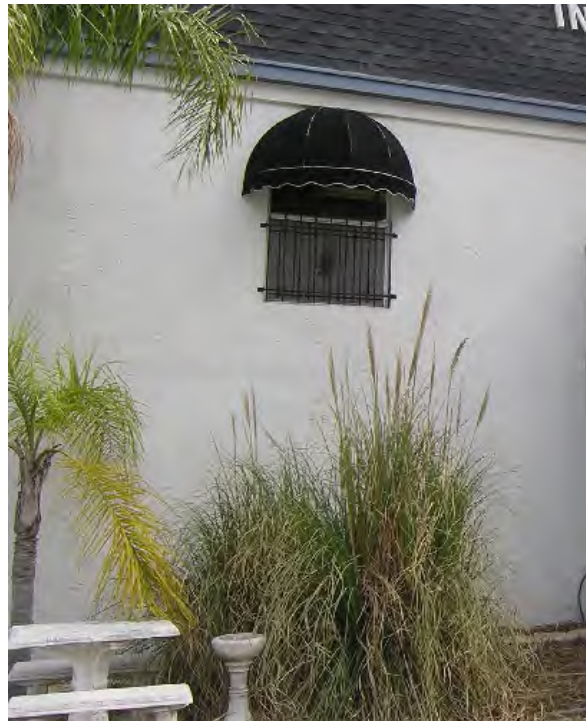
Look mom, No cracks, No leaks, No flaws, No faults!
Perfect Performance!

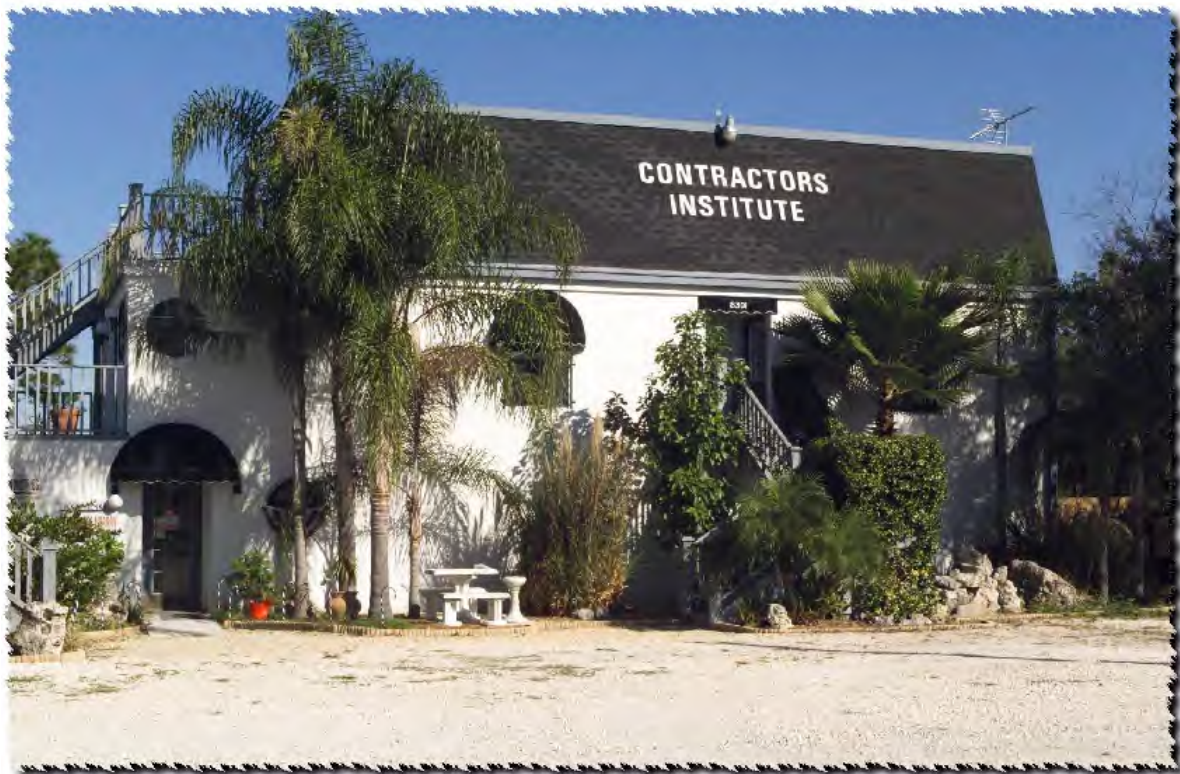
Stucco Cladding exterior fascia removal. Short flange casing used to terminate the top, Expanded flange at bottom. No weep screed, No leaks, No cracks, No flaws, No faults

Note lower portion has a stuccoed return without any weeping mechanism. Some consultants say this violates the code and will never work. (It does not violate the code and always works in these installations. If its doesn't, there are other causes outside of the stucco installation.) Plywood used on fascia was surplus and had been previously painted for another job. All other plywood was not.

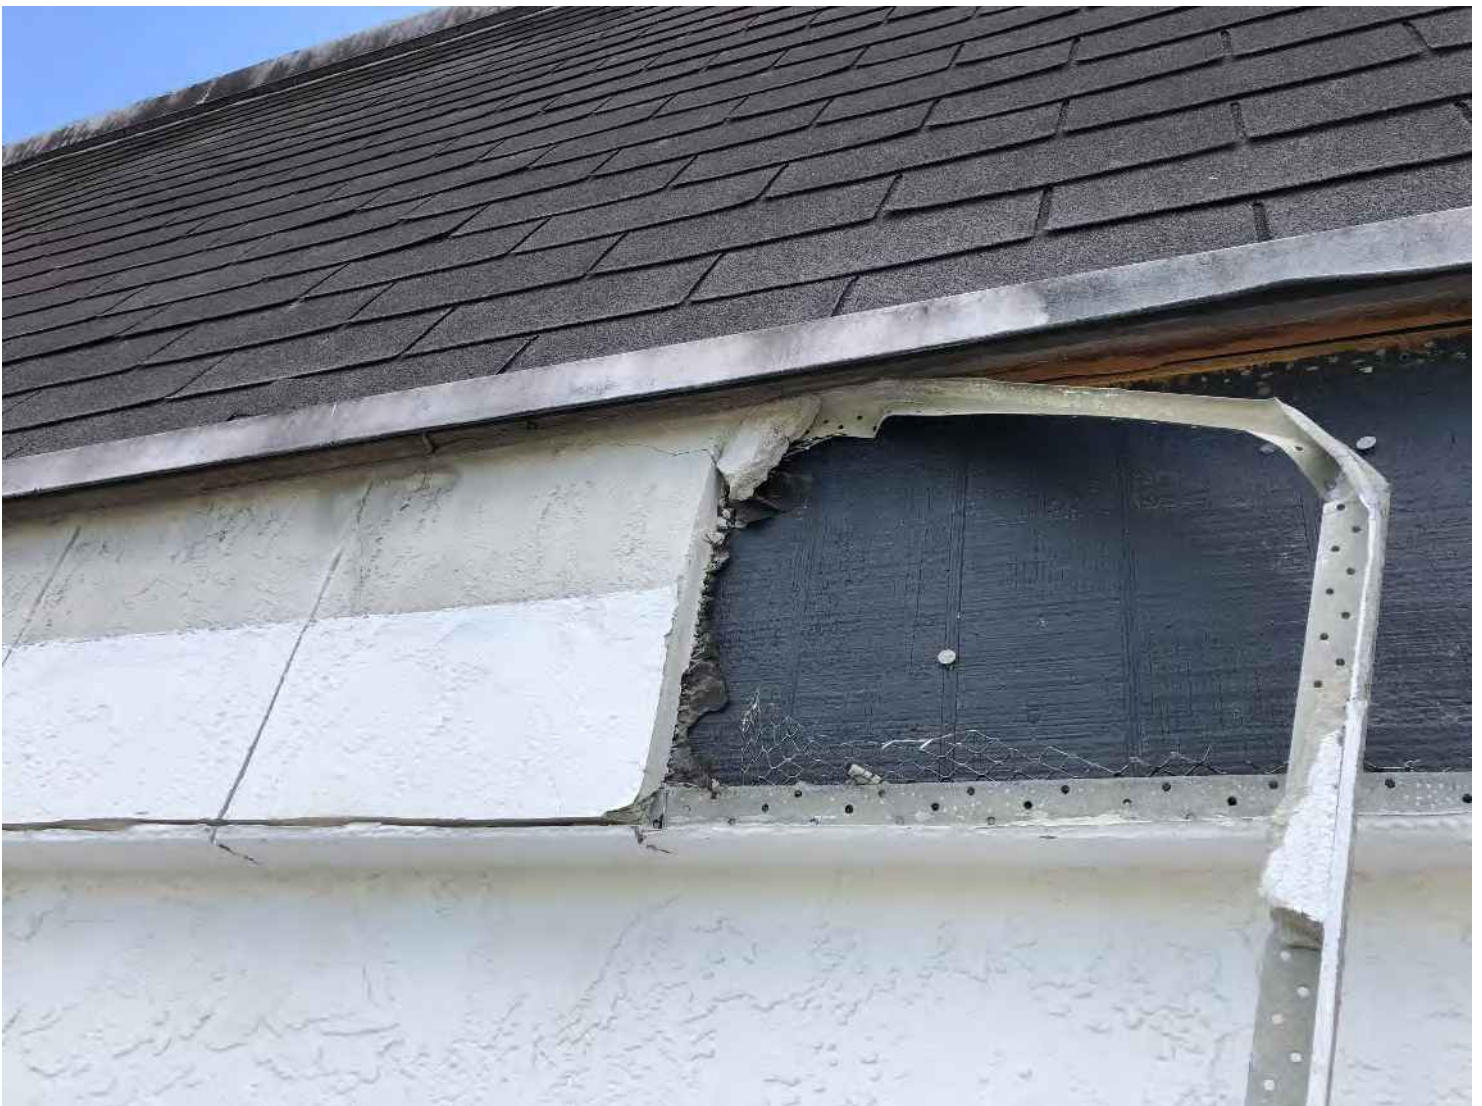
Upper section of rear wall with Stucco Fascia removed ready for back wall scoring.

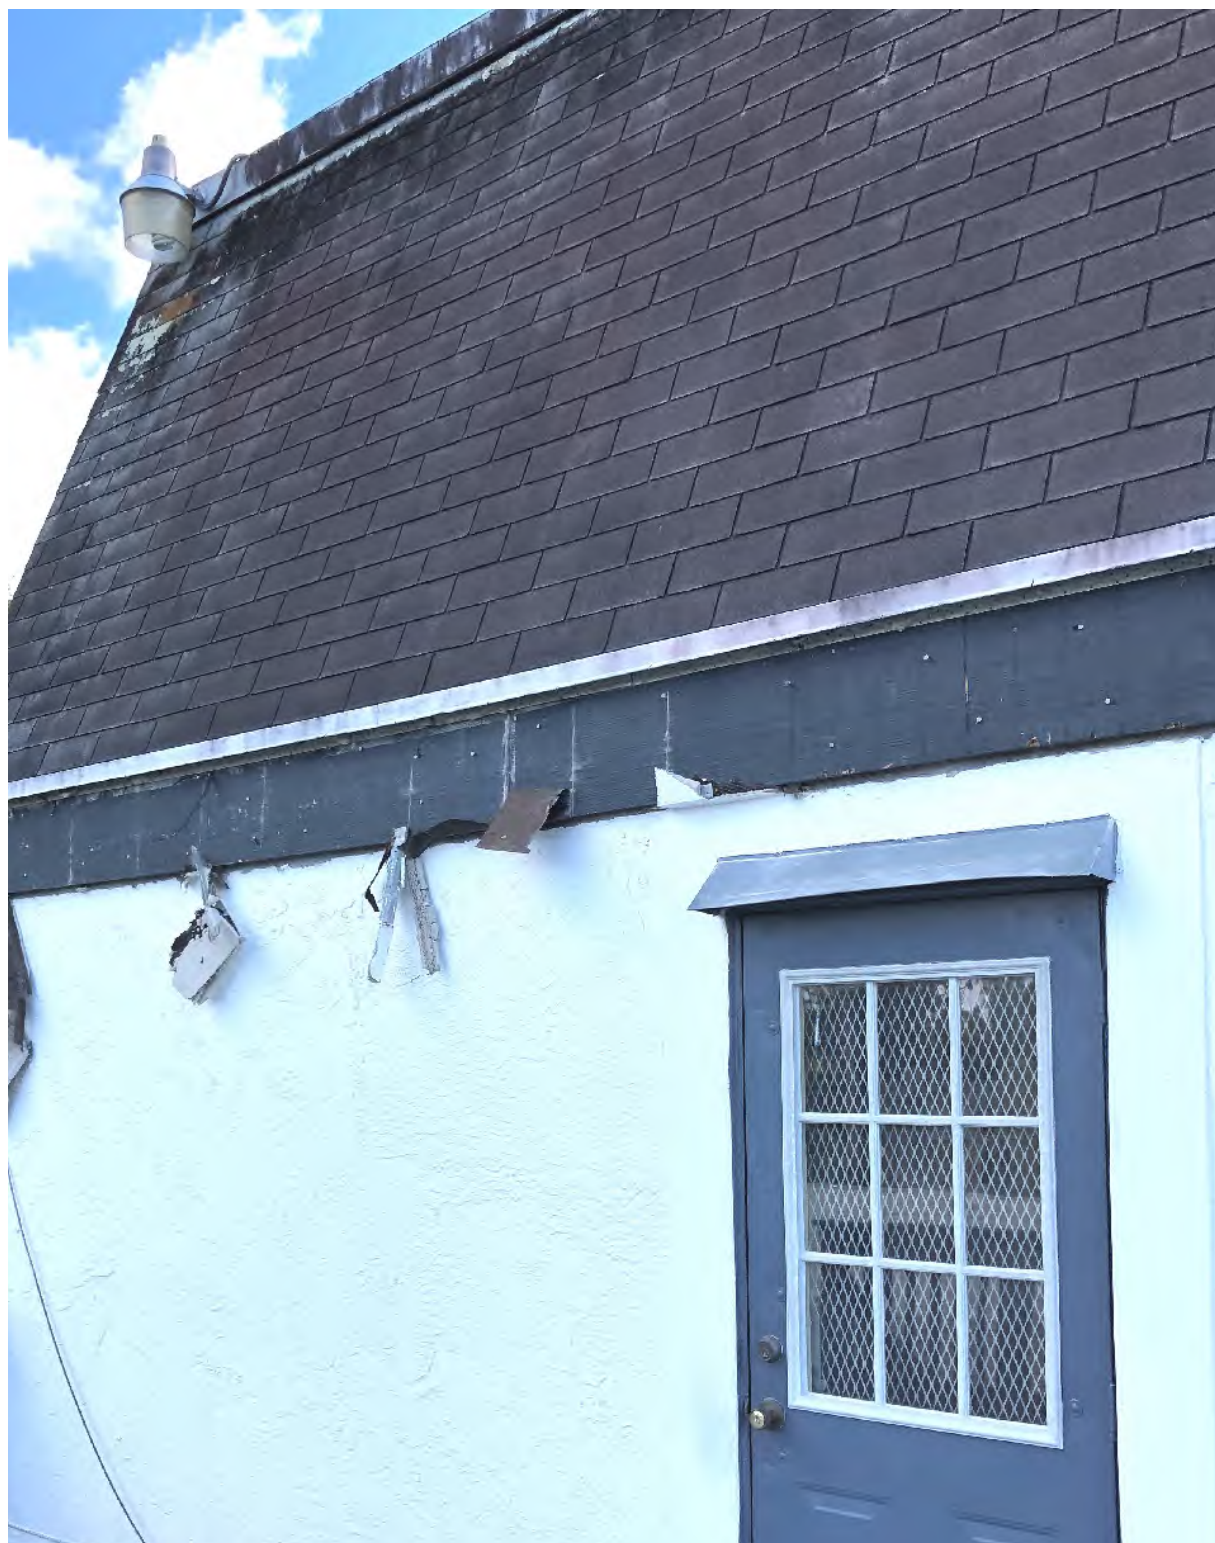
Rear Wall with scoring to remove stucco assembly. Stucco Cladding had zero cracks, zero leaks, zero faults. We will later look at the back side of the lath.

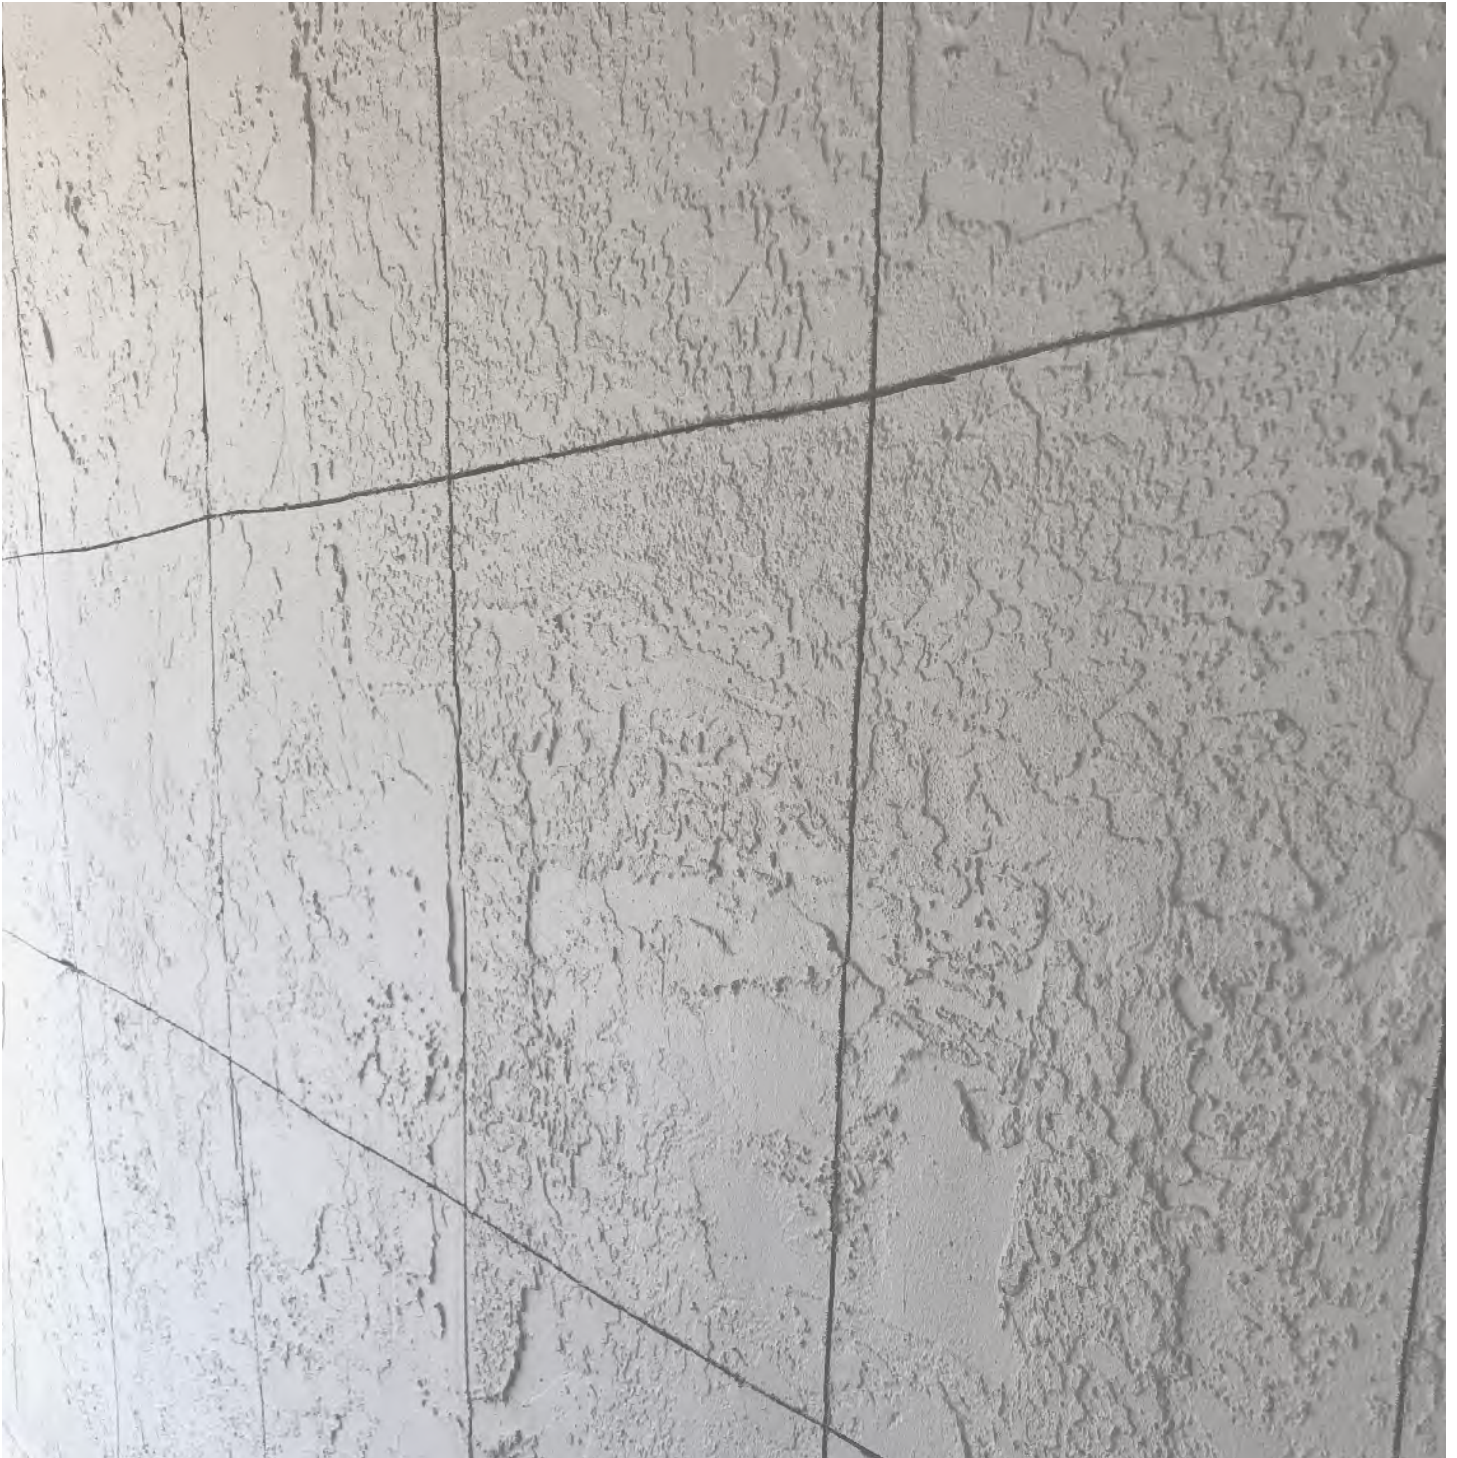
Exterior wall plywood pristine after 35 years covered with stucco cladding.

Note: Stucco scored deep to aid in plywood removal for examination only.

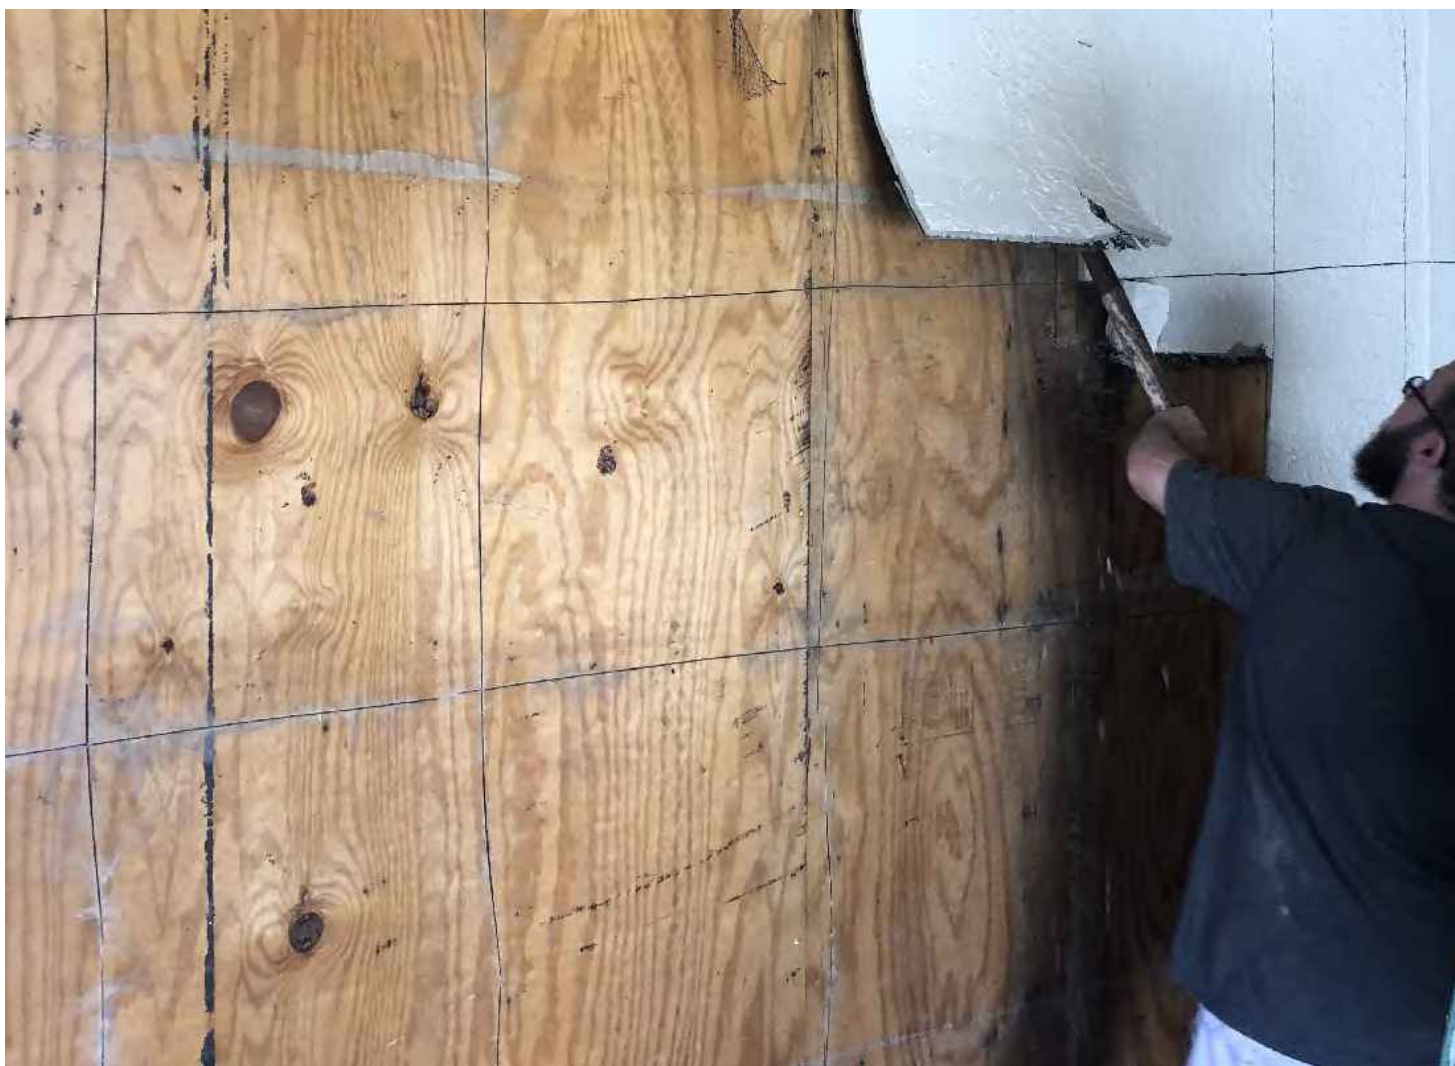
Exterior wall plywood pristine after 35 years covered with stucco cladding.

Note: Stucco scored deep to aid in plywood removal for examination only.

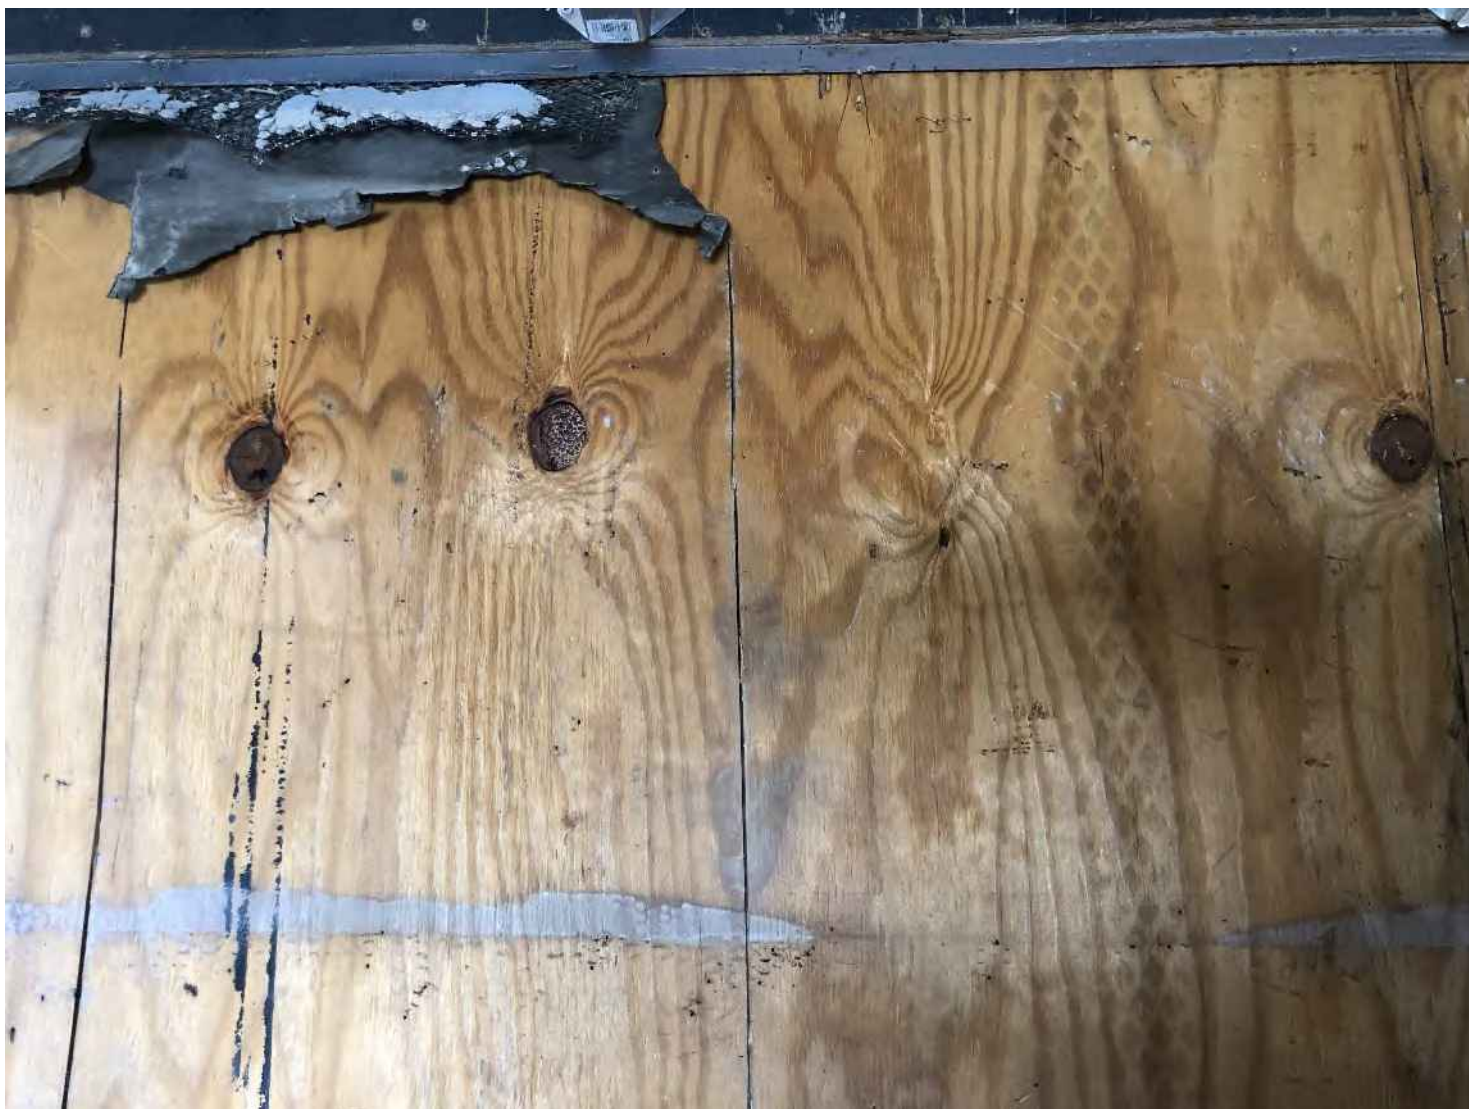
Exterior wall plywood pristine after 35 years covered with stucco cladding.

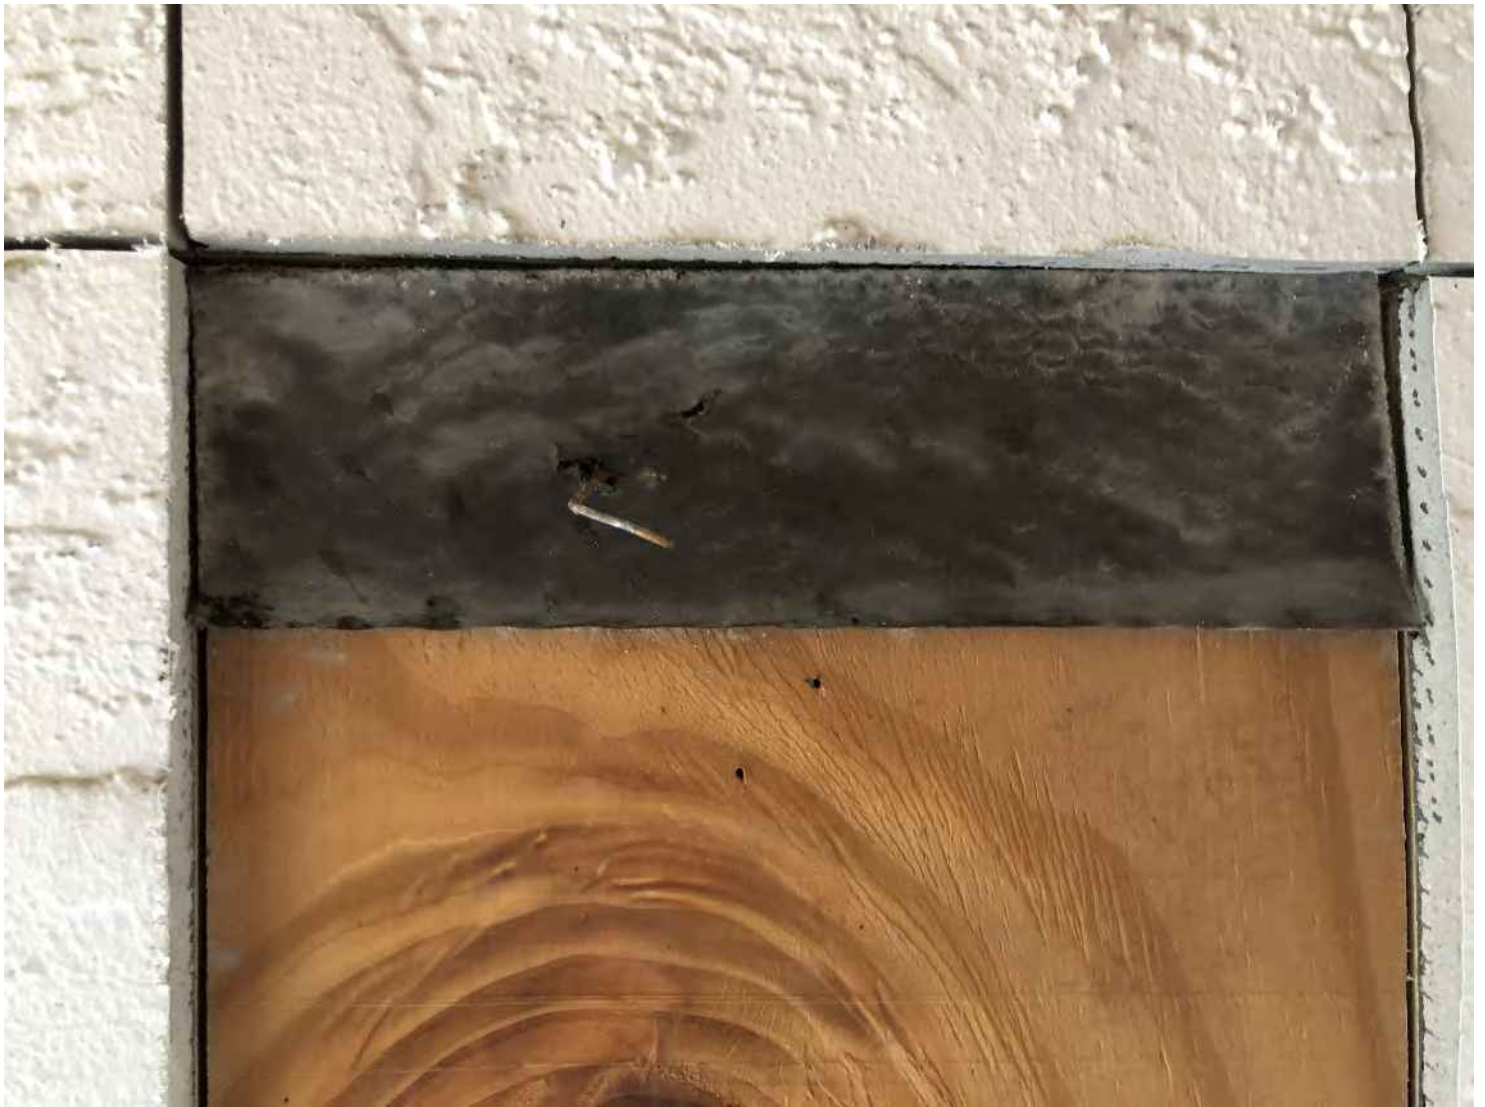
Exterior wall plywood pristine after 35 years covered with stucco cladding.

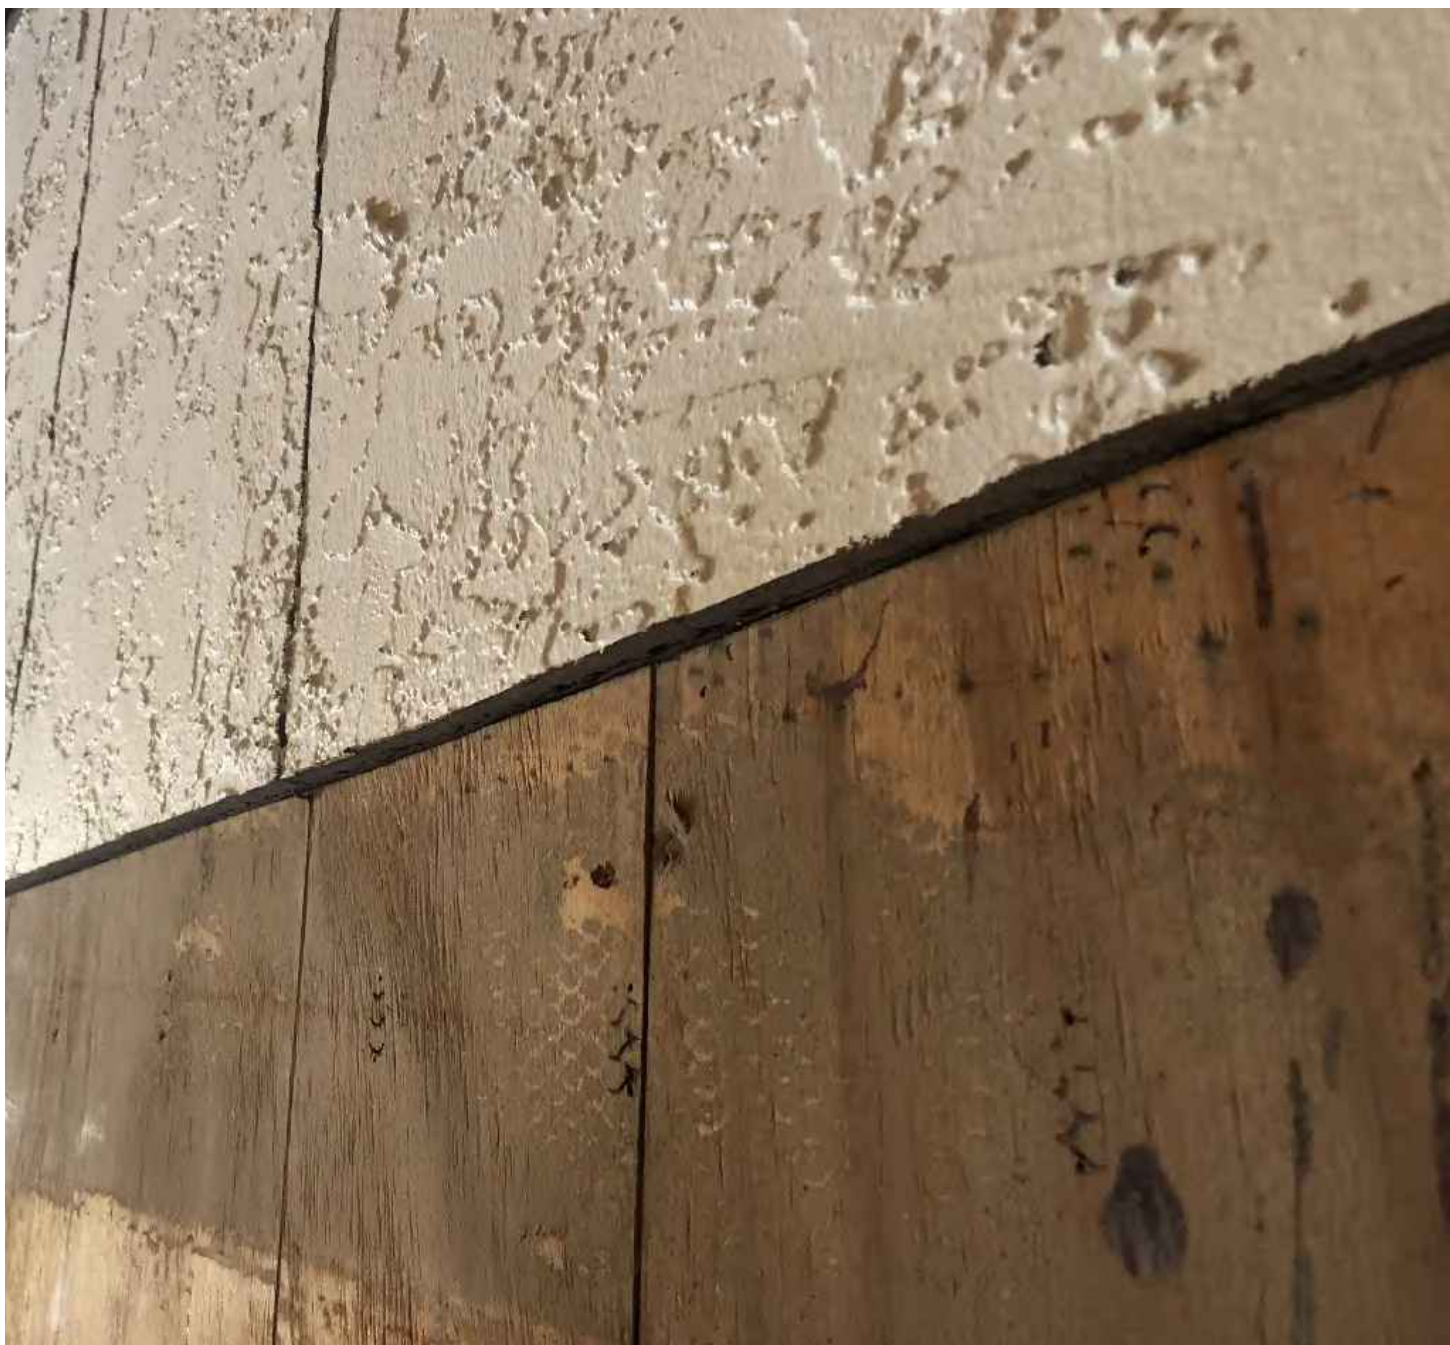
Un-Galvanized metal lath, no rust, no degradation, no water stains, no moisture deterioration. Just like the day it was put on 35 years ago.

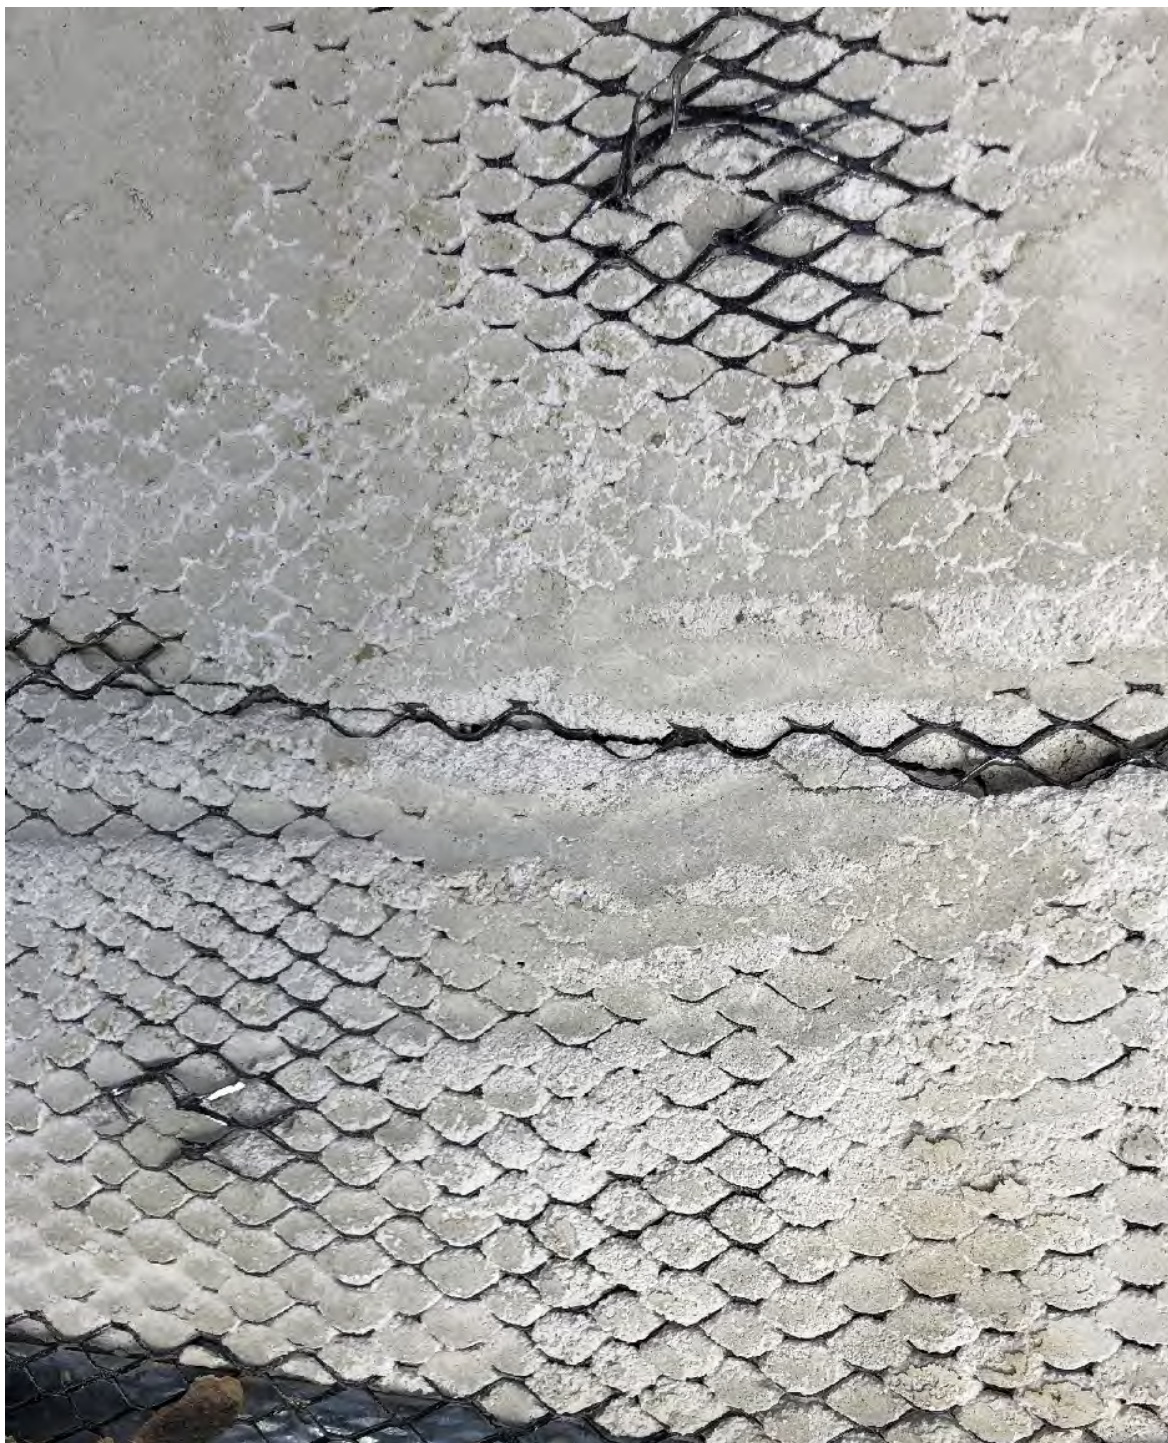
Un-Galvanized metal lath, no rust, no degradation, no water stains, no moisture deterioration. Just like the day it was put on 35 years ago. Lath shiny where cut through.

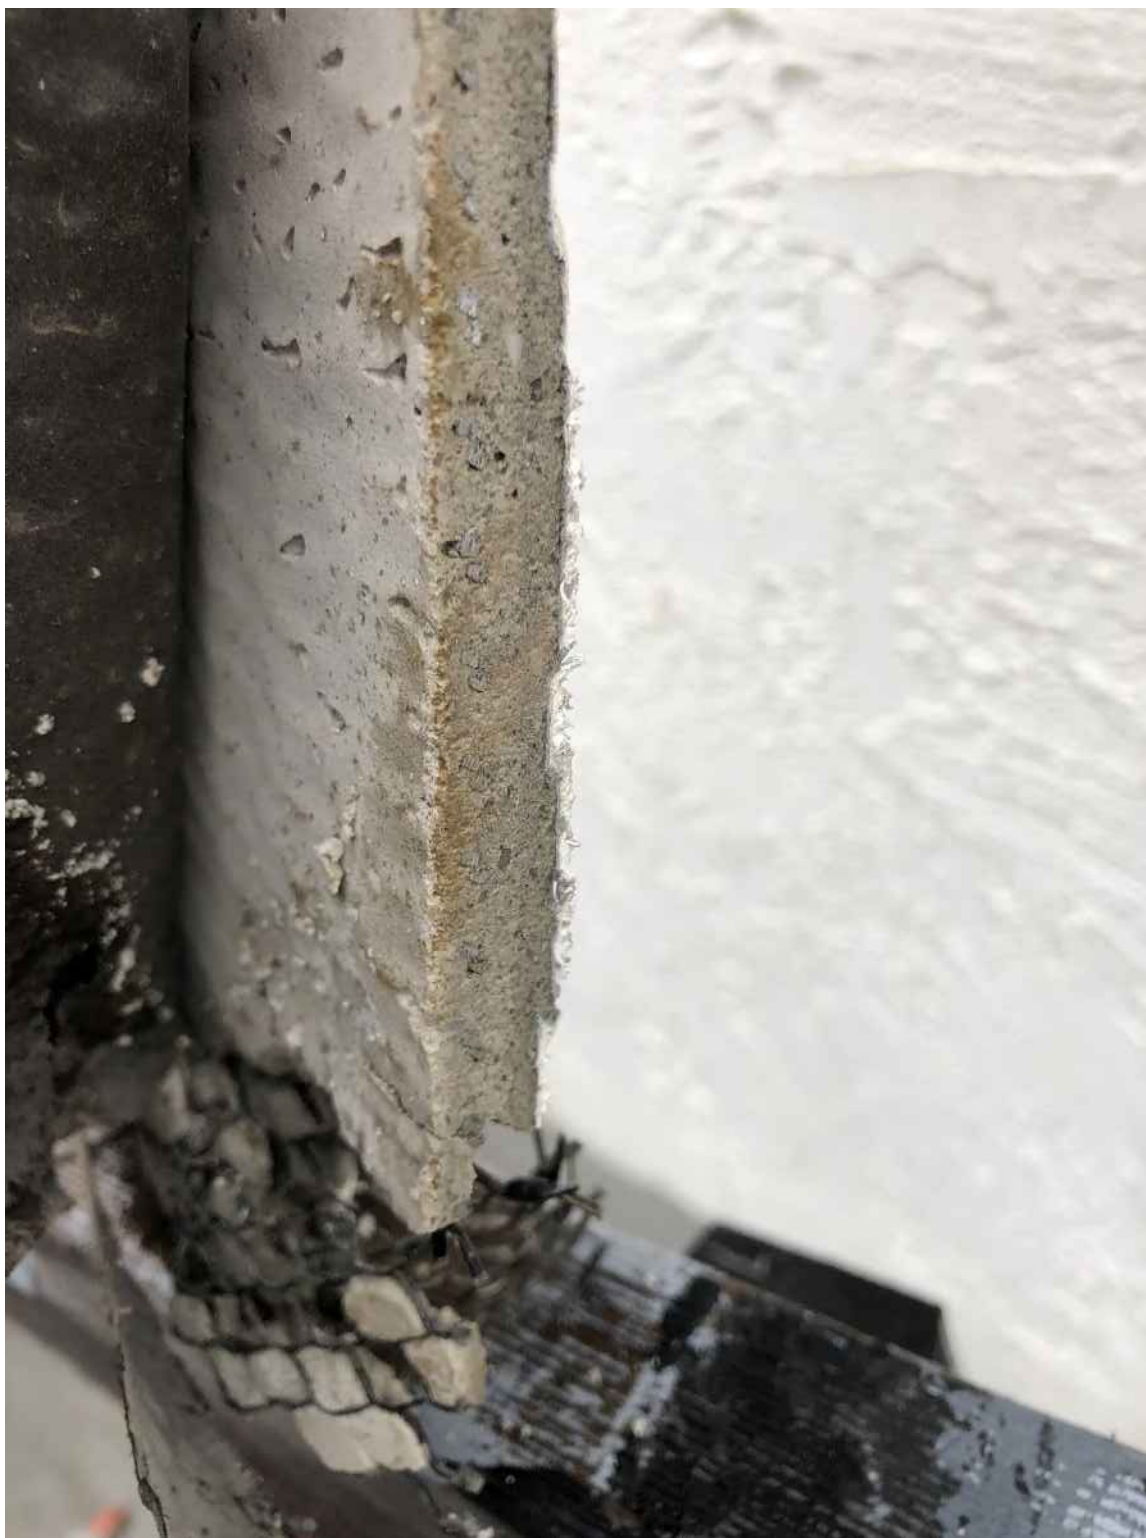
Stucco Cladding 1/2" Thick - applied using South Florida Building Code requirement or using the ASTM "unless otherwise specified" provision. No cracks anywhere. Metal shiny where cut through sample.

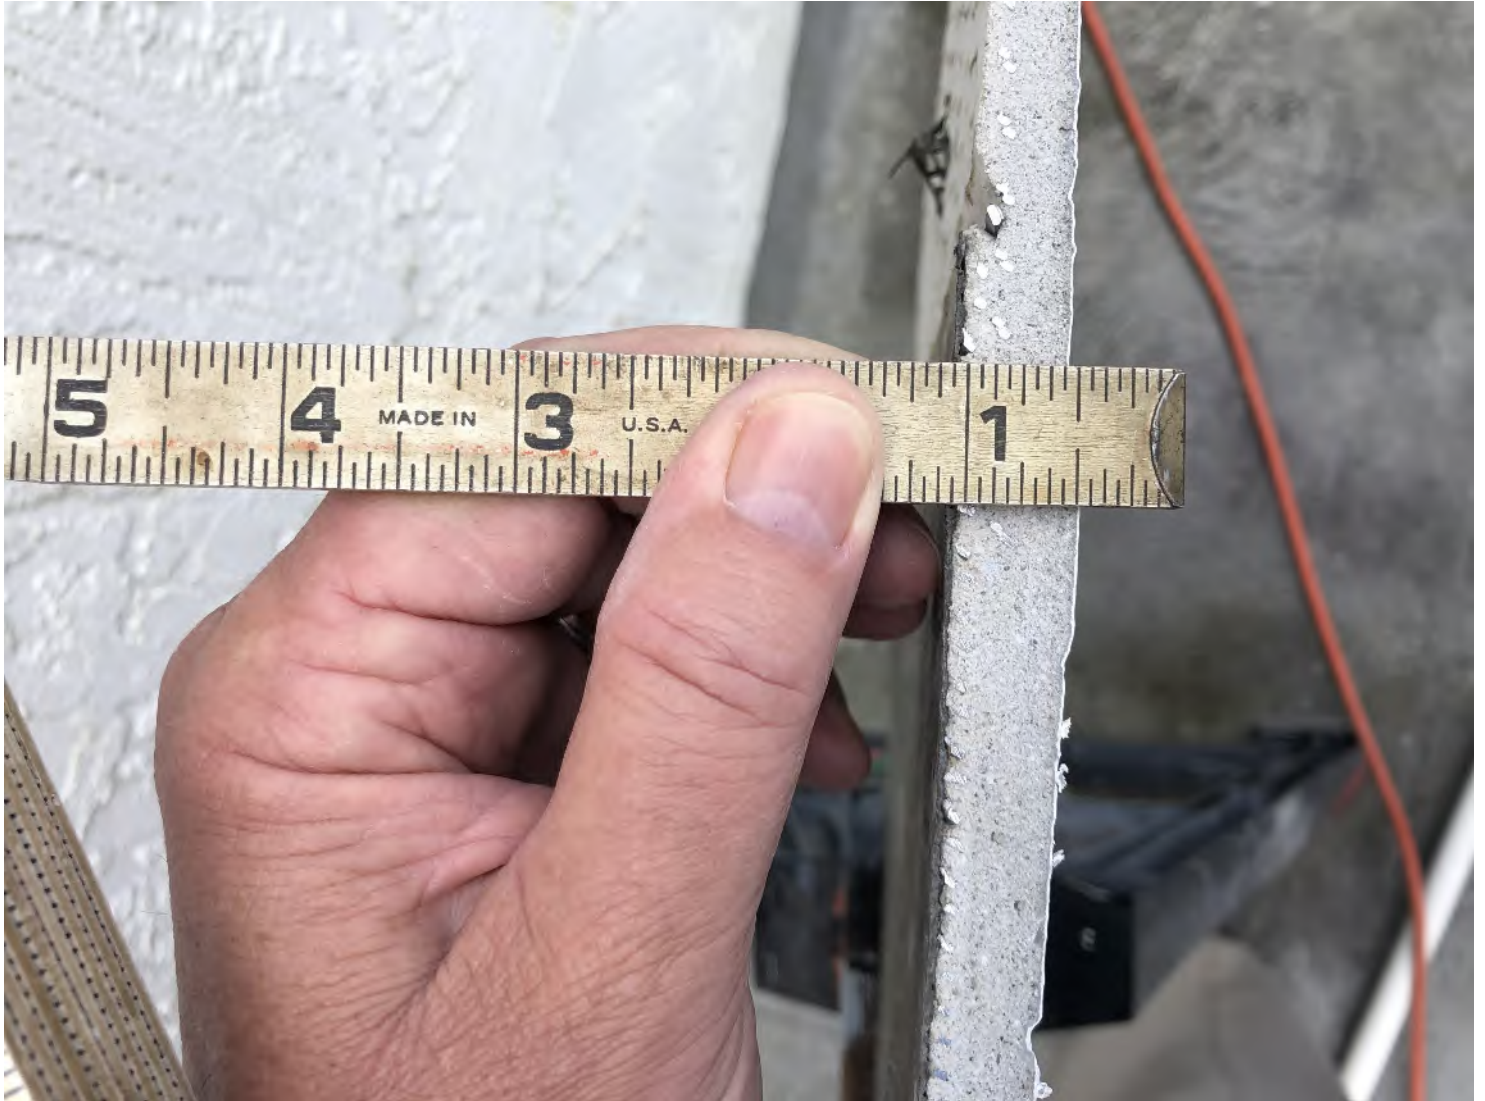
2 Inch lath lap - No cracks. Metal pristine. Metal shiny like new where cut through sample.

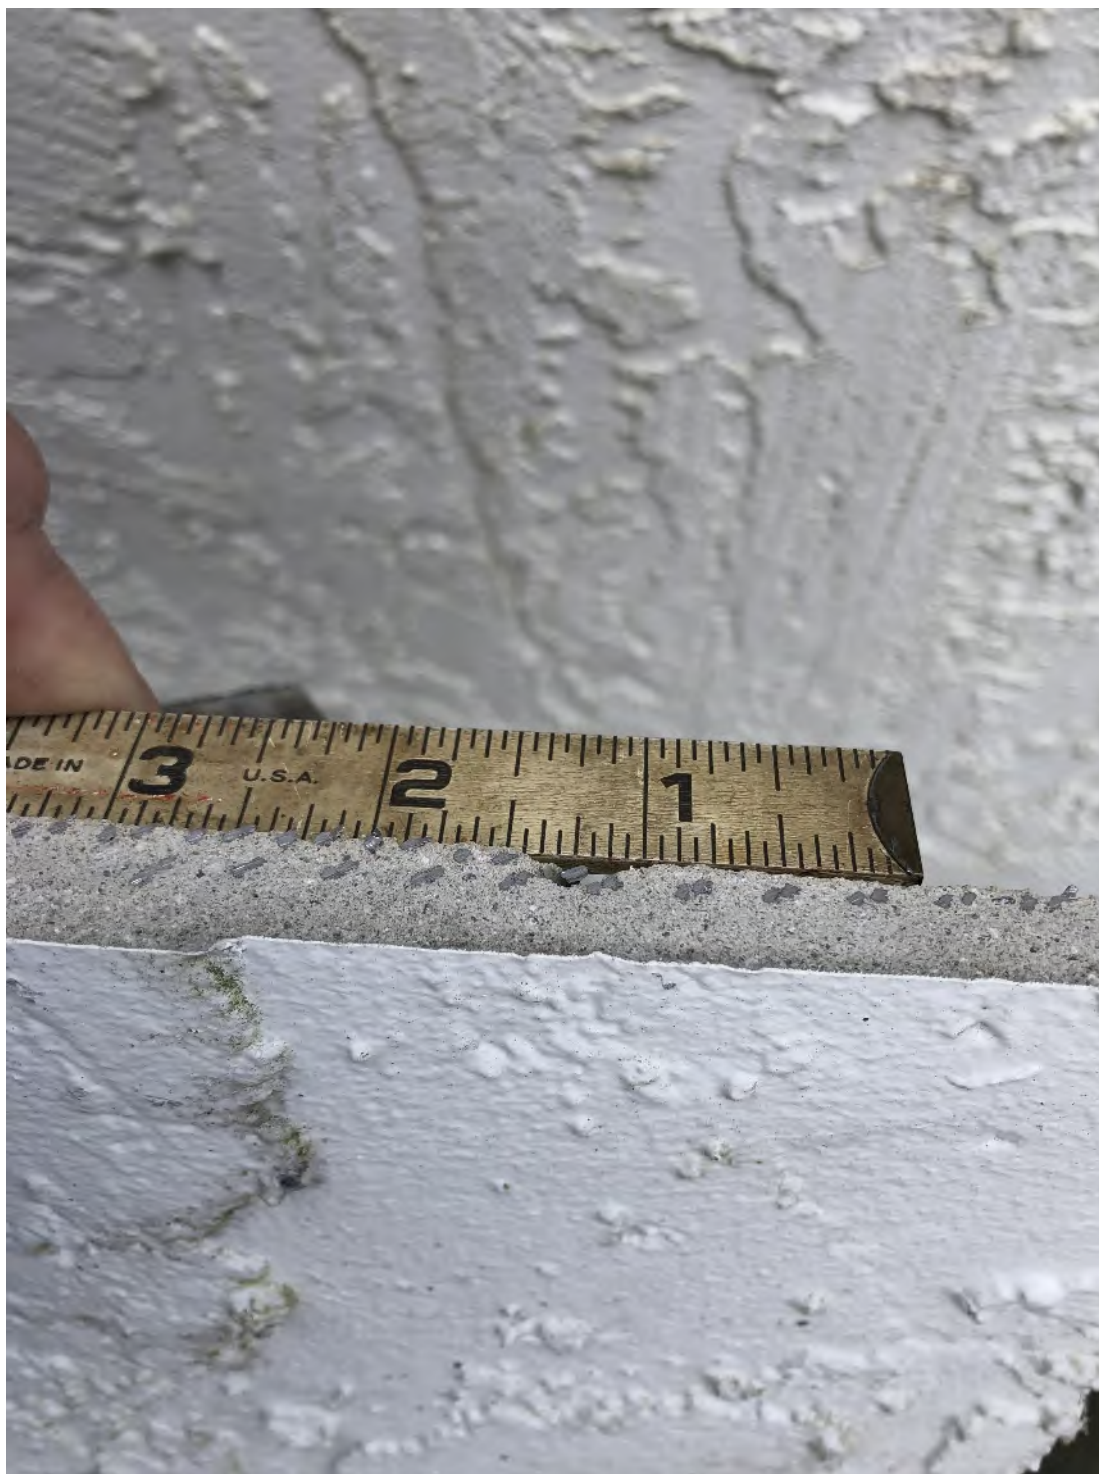
Stucco Cladding 3/8" thick in one area - Still no cracks, No rust, No faults.

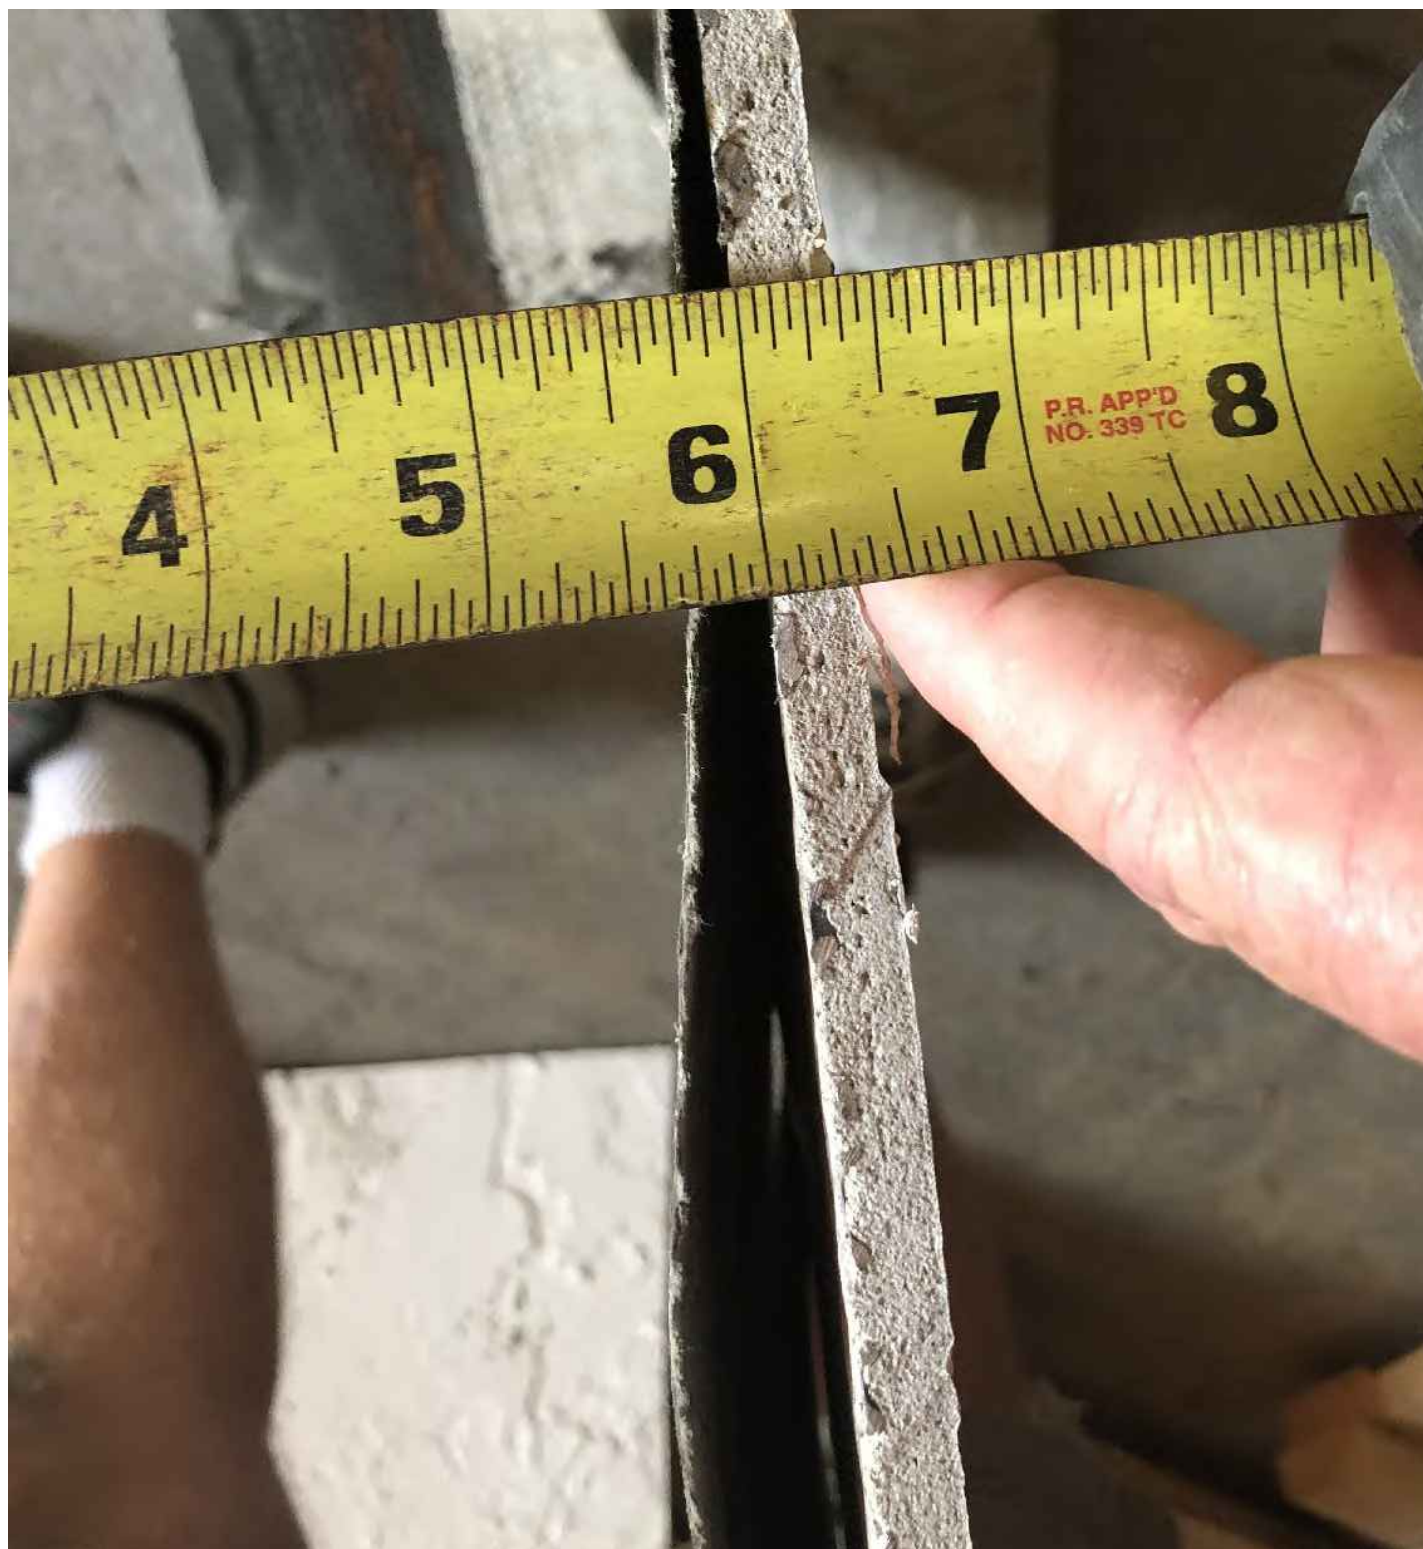
Un-Galvanized metal lath, no rust, no degradation, no water stains, no moisture deterioration. Just like the day it was put on 35 years ago.
