Florida Stucco Application and Repair Newsletter

35 Year old Stucco Walls Performing
Flawlessly!
2nd Story Wood Sheathed Wall Over Block
1st Story.

Newsletter 19-01-1&2

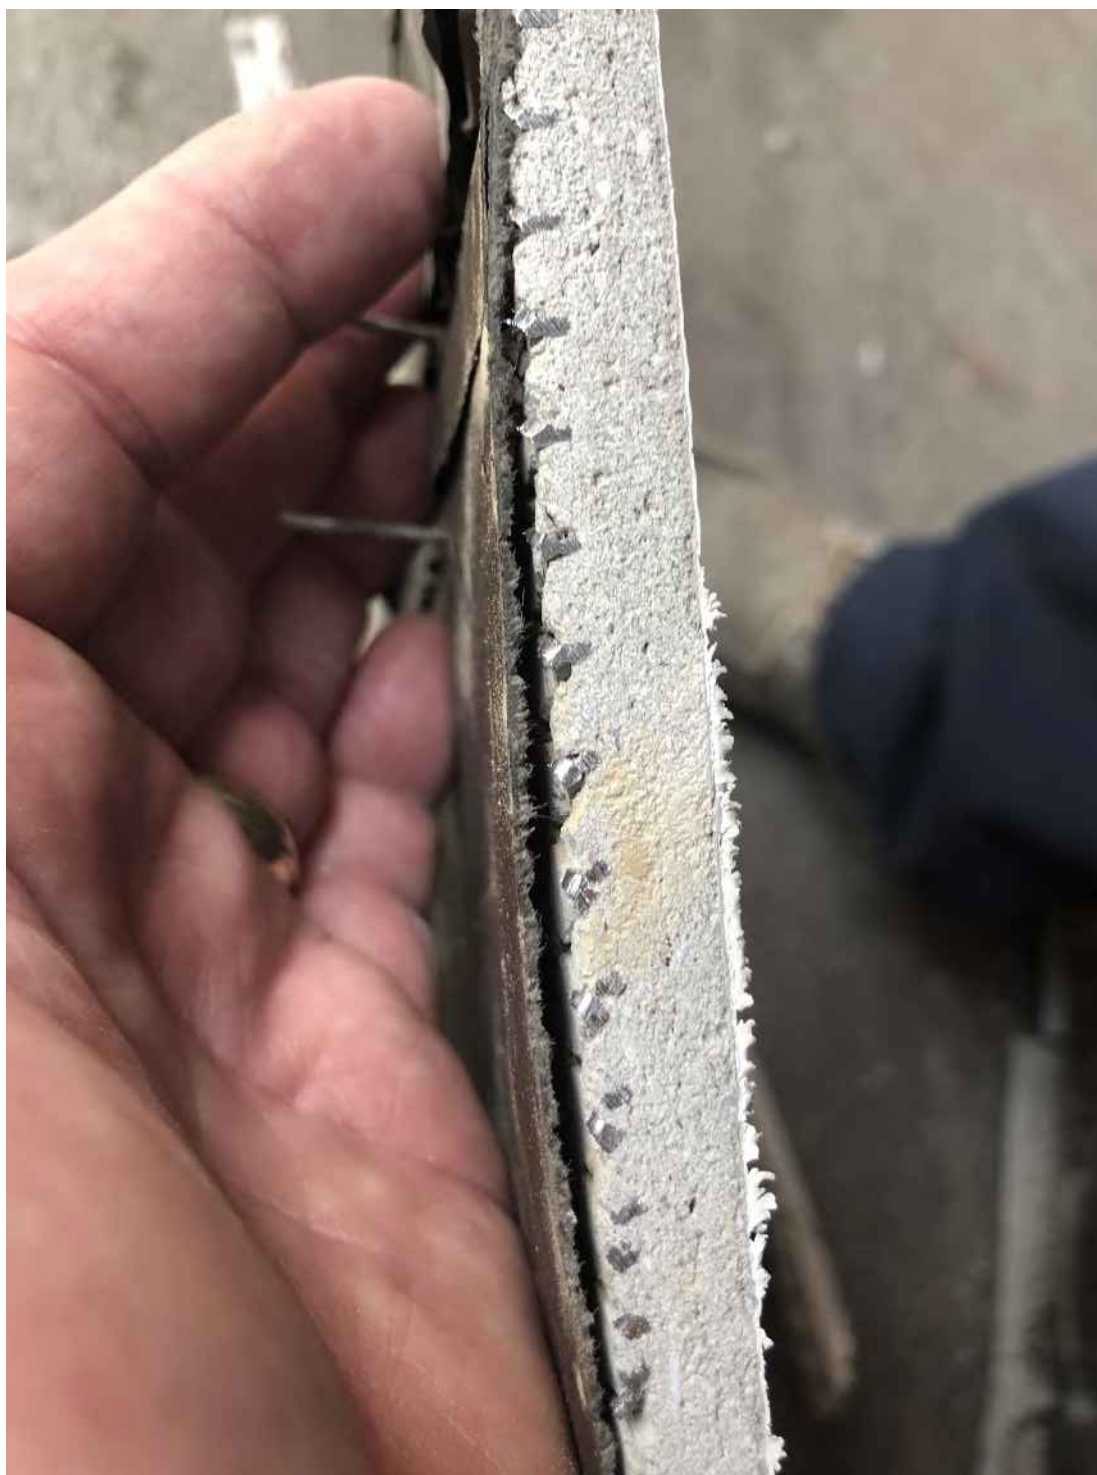
Un-Galvanized metal lath, no rust, no degradation, no water stains, no moisture deterioration. Just like the day it was put on 35 years ago. Constant weather exposure in Florida's environment.

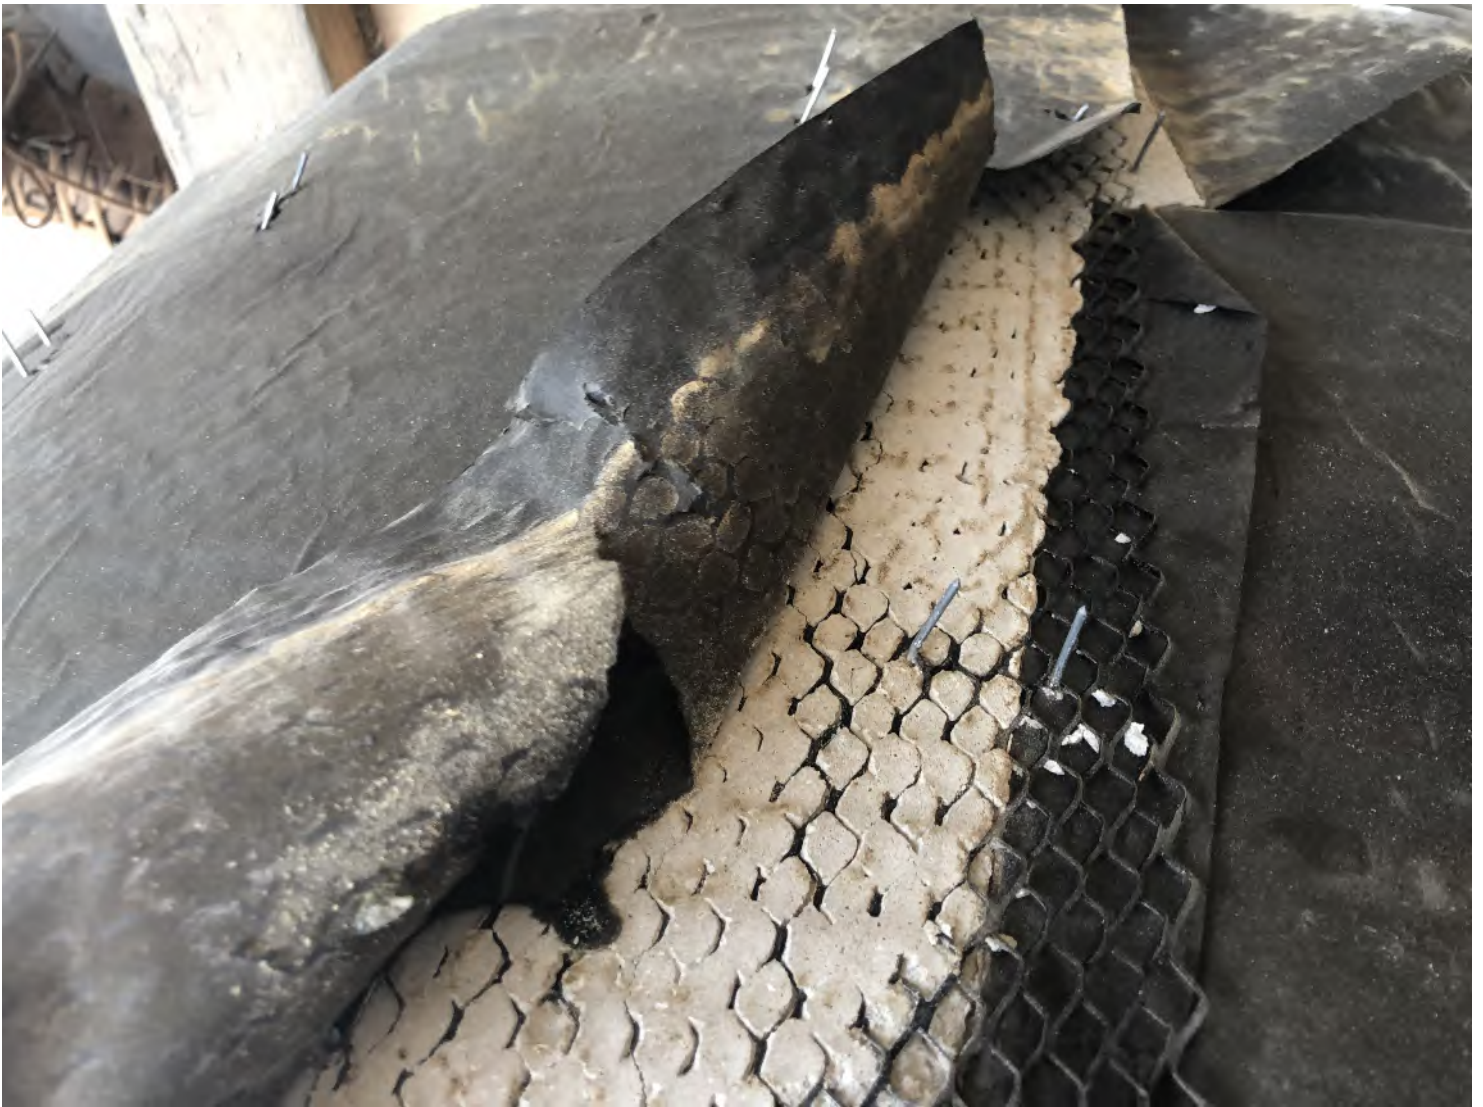
Back side of 1/2" exterior expanded flange casing stop used at bottom of stucco fascia. No weep, nor drainage, 35 years exposed to the weather, looks like the day it was installed. No leaks, No faults, No flaws, No cracks, No rust.

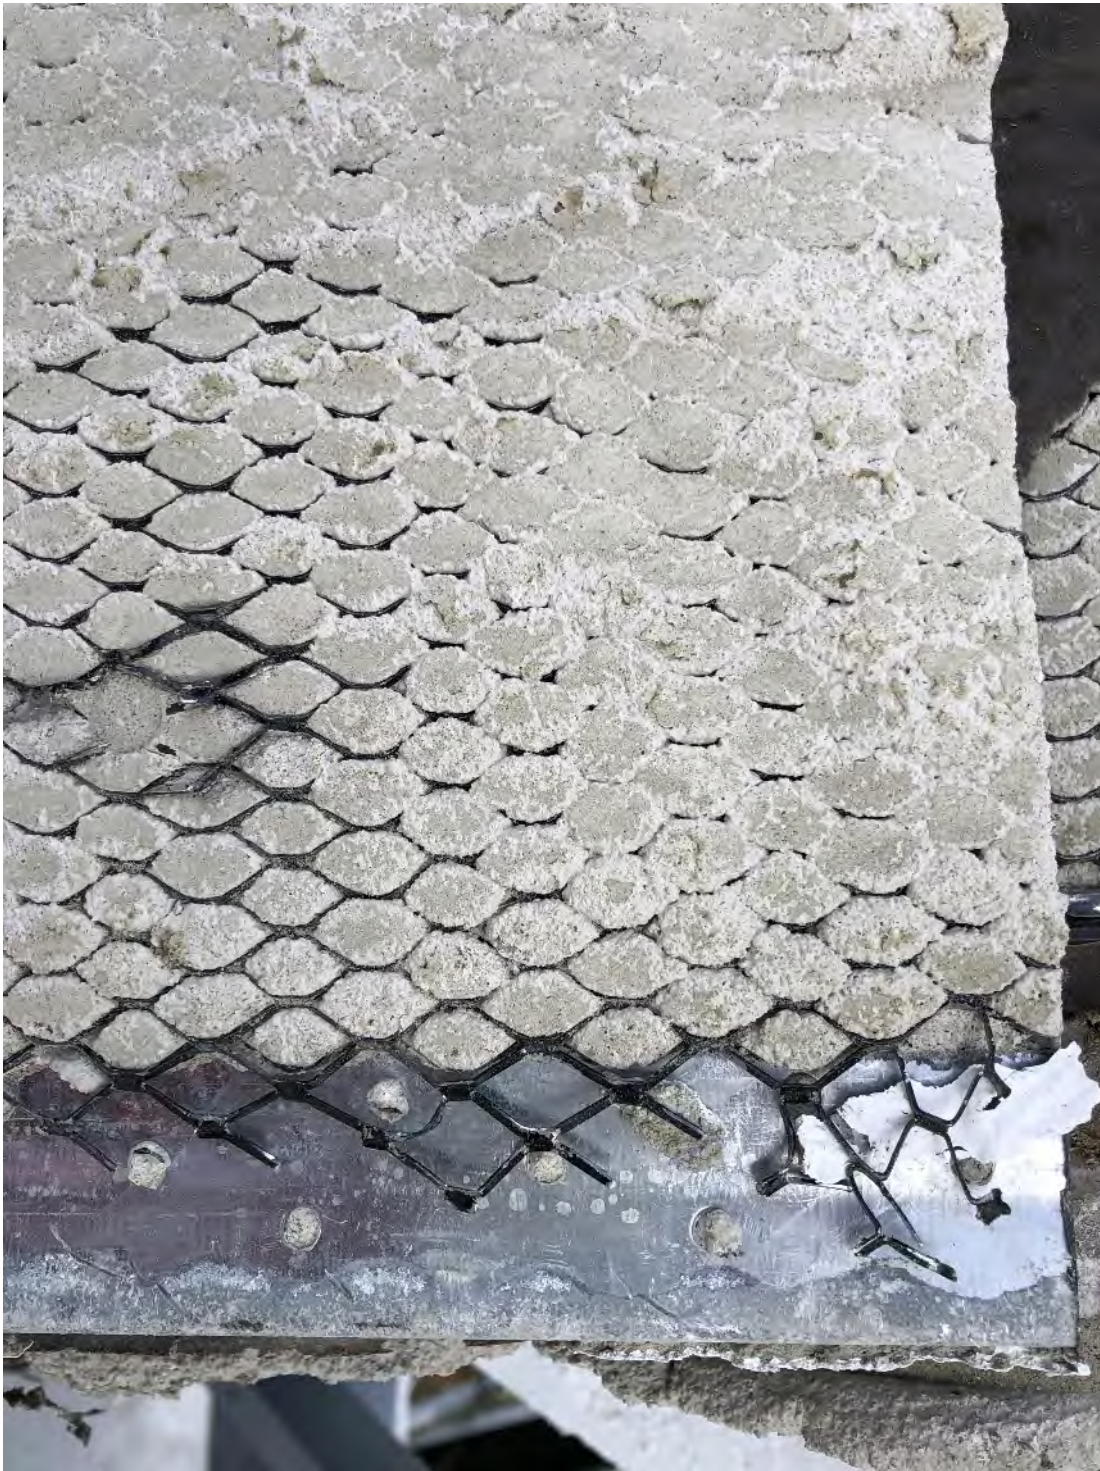
Back side of 1/2" exterior expanded flange casing stop used at bottom of stucco fascia. No weep, nor drainage, 35 years exposed to the weather, looks like the day it was installed. No leaks, No faults, No flaws, No cracks, No rust.

Note how wet plaster was pushed through flanges and exudes out of the nail holes in the casing's solid flange. Exposed lath is where it was pried off its attachment.

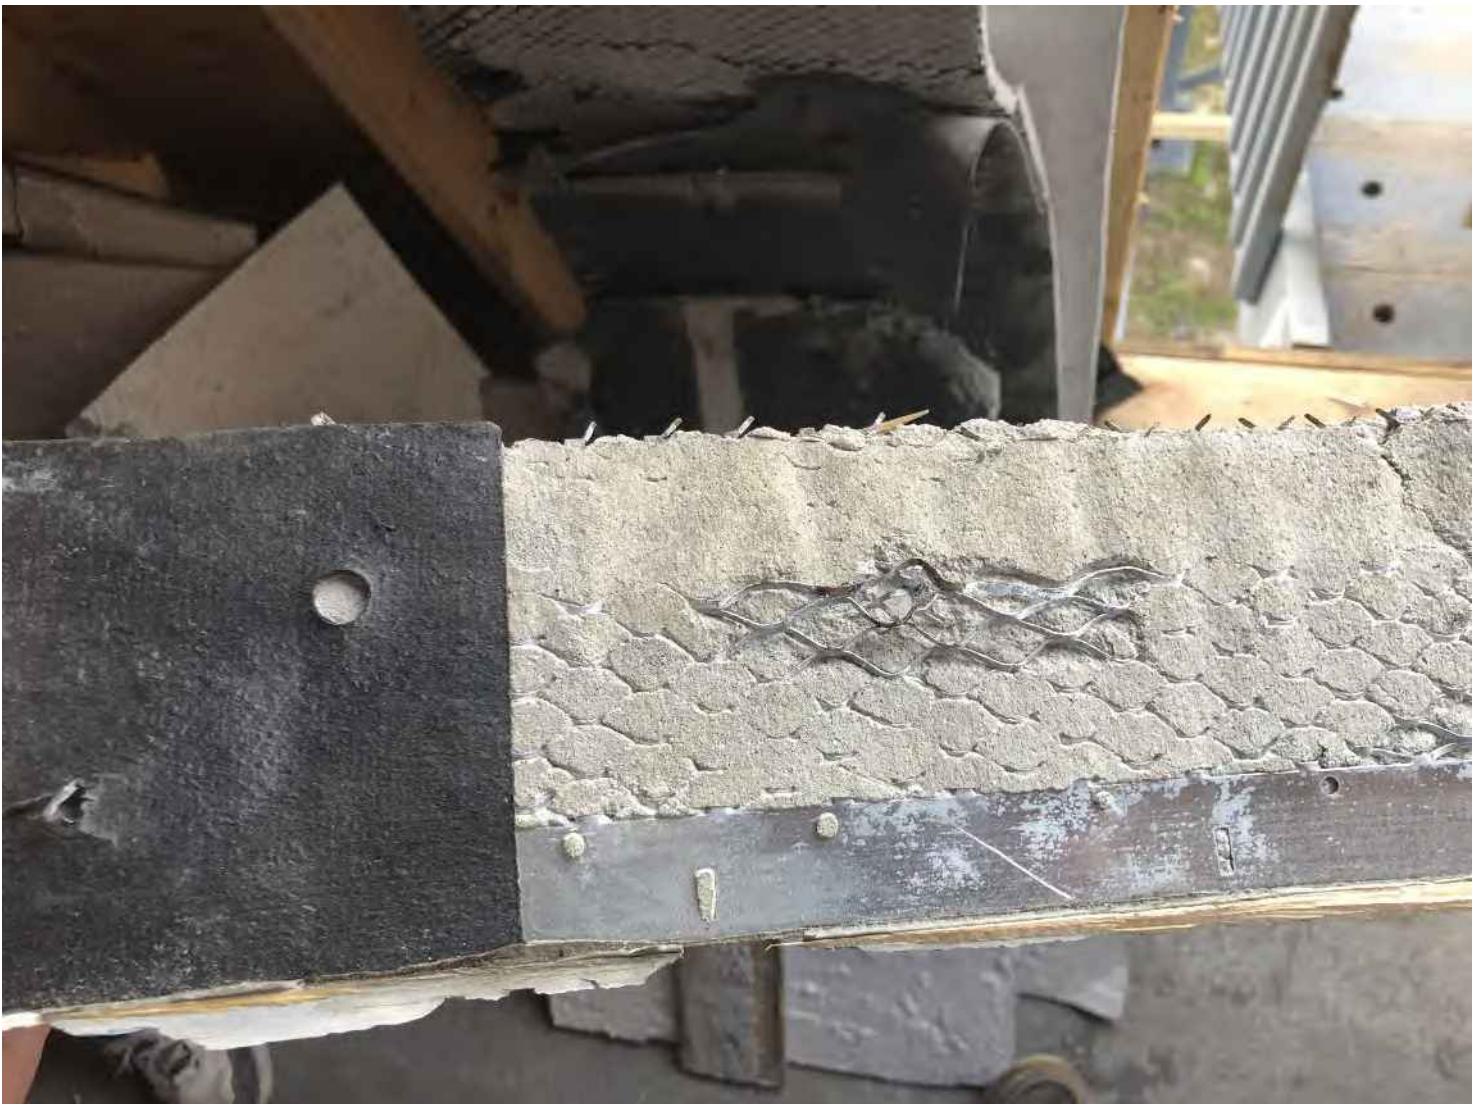
Stucco Cladding painted twice in 35 years, original paint and white re-paint. Both followed standard painting instructions and was applied with rollers to the standard mill thickness required for exterior cement plaster installation.

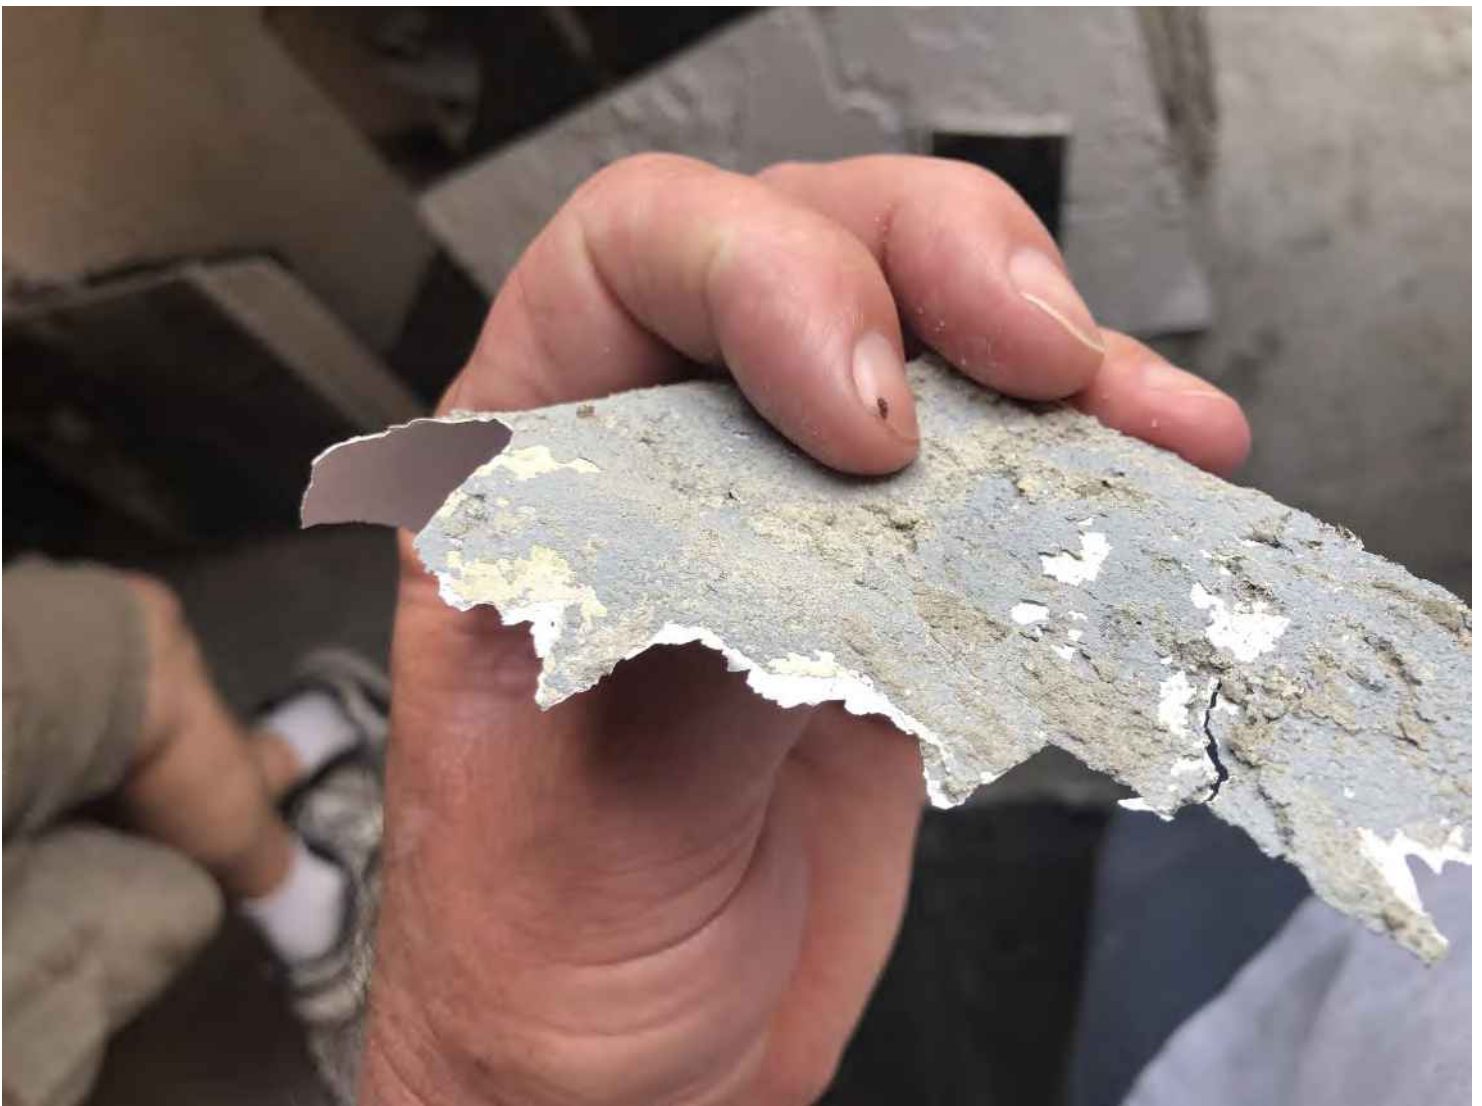
Stucco Cladding painted twice in 35 years, original paint and white re-paint. Both followed standard painting instructions and was applied with rollers to the standard mill thickness required by the manufacturer.

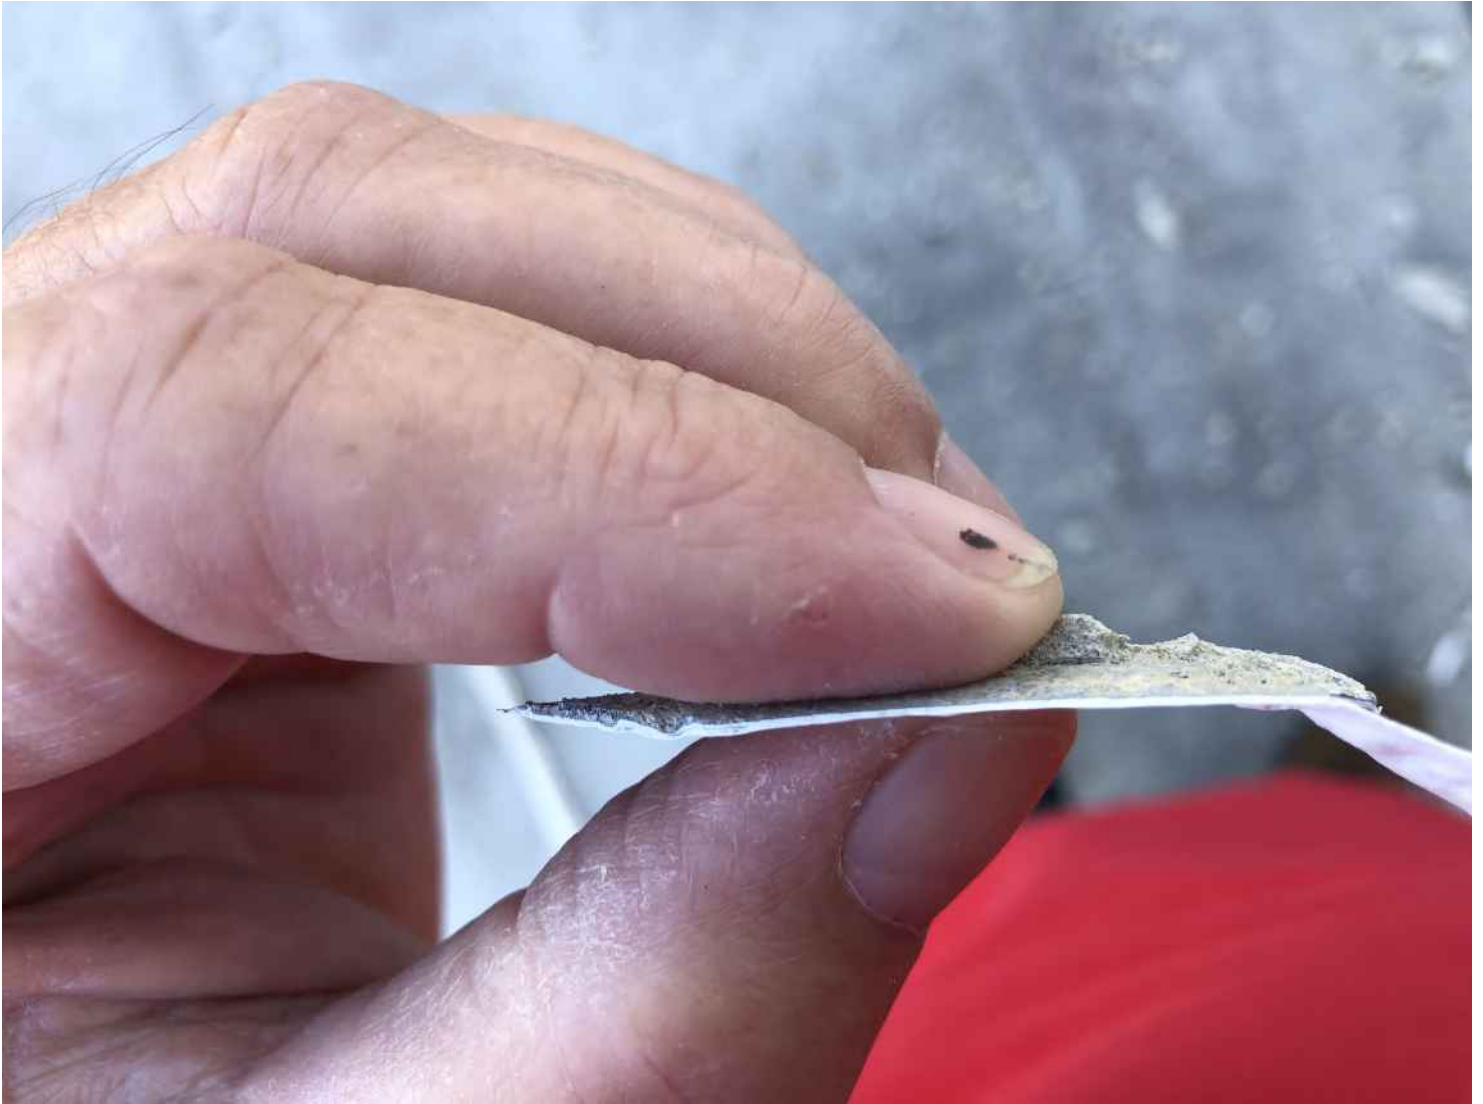
Back side of metal lath on the wall - Un-Galvanized metal lath, no rust, no degradation, no water stains, no moisture deterioration. Just like the day it was put on 35 years ago. Constant weather exposure in Florida's environment. Lap paper over metal. Still no Cracks, No faults, No flaws. Note staple attachment.

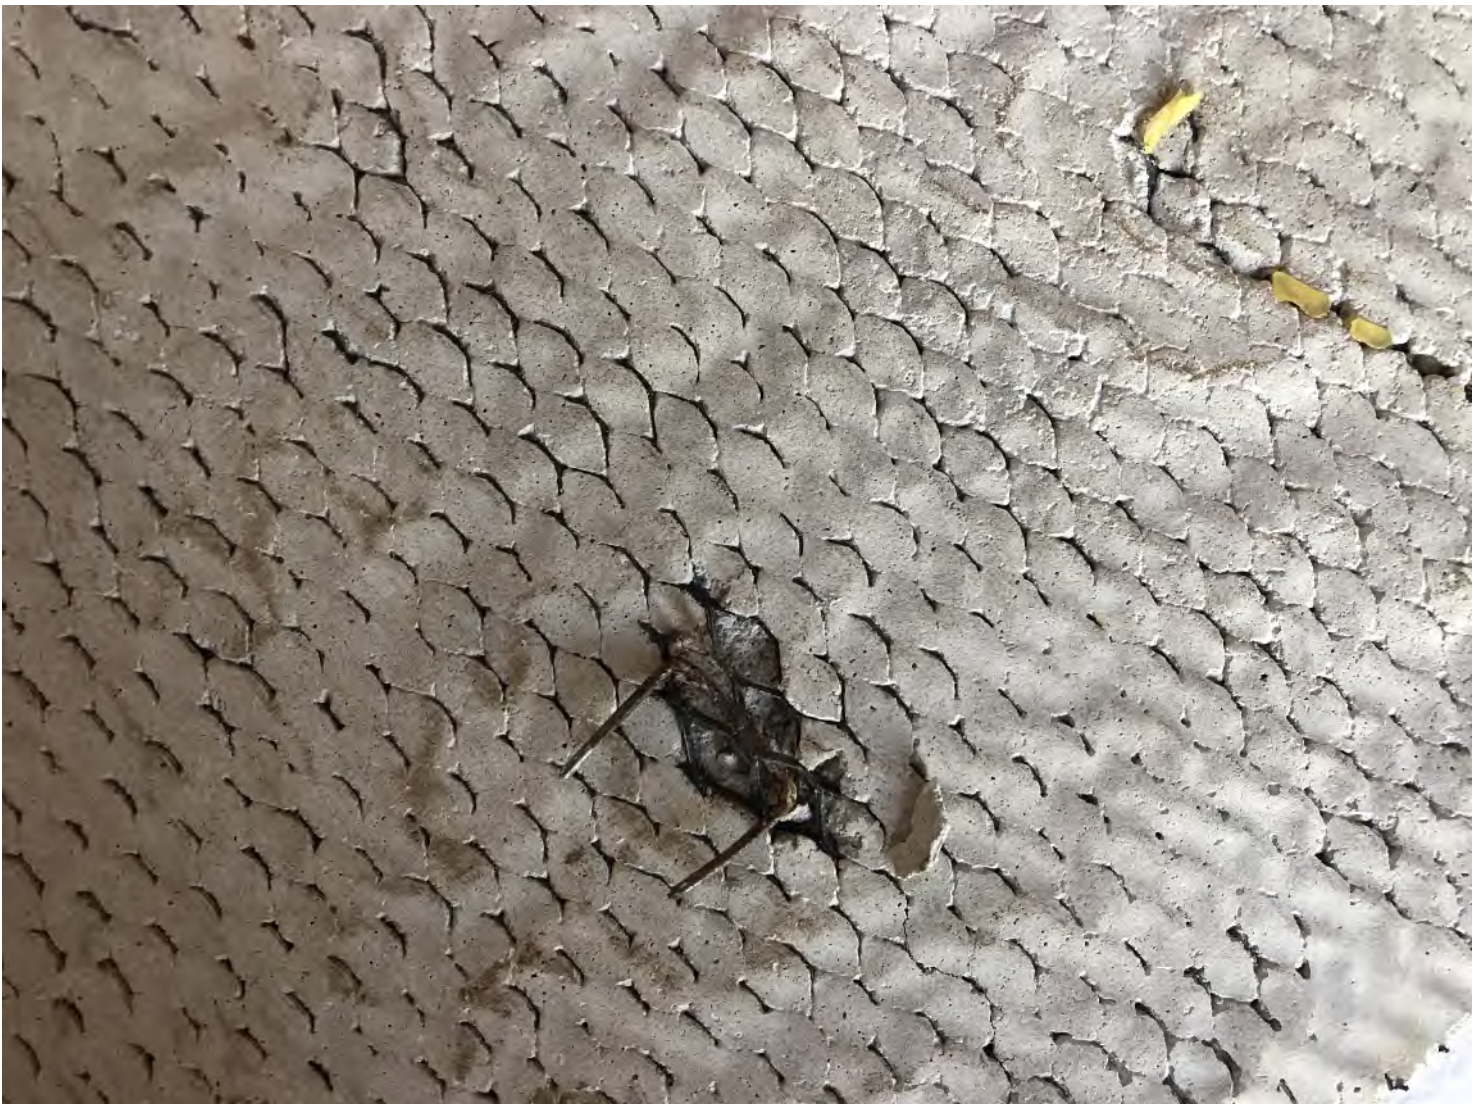
Paper over lath & back lap - No cracks, No leaks and No faults.

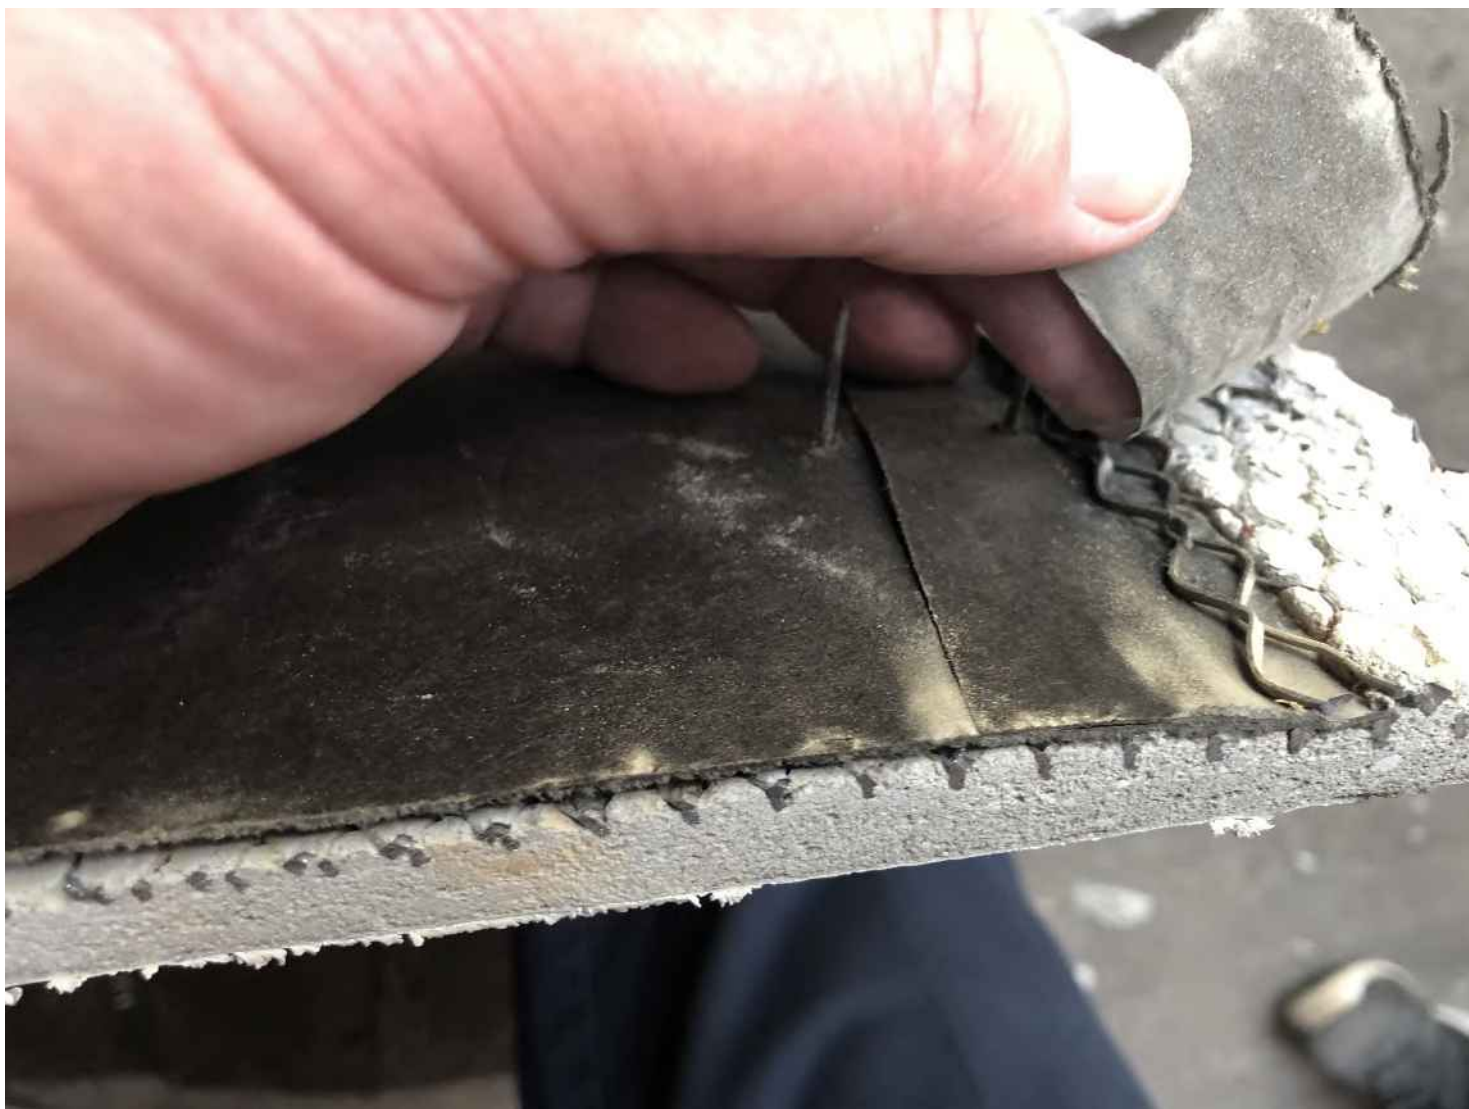
Un-Galvanized metal lath, no rust, no degradation, no water stains, no moisture deterioration. Just like the day it was put on 35 years ago. Constant weather exposure in Florida's environment. Lap is paper over metal. Still no Cracks, No faults, No flaws. Note: Crack seen in section sample underneath in rubbish pile was broken during removal.

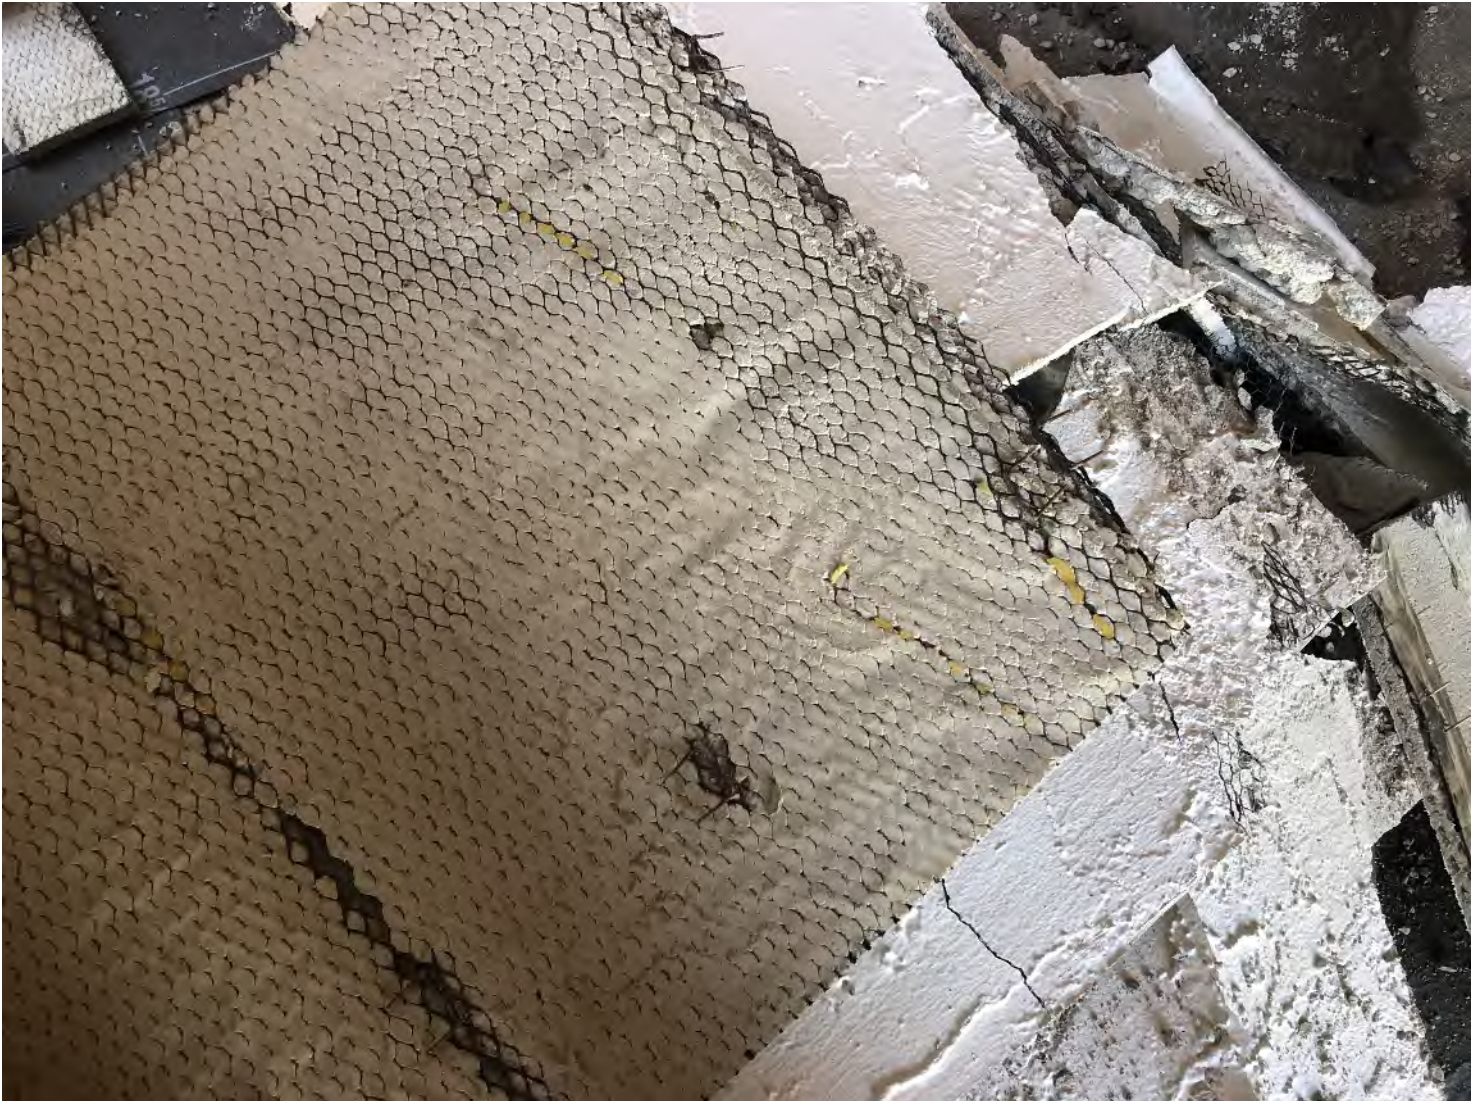
Un-Galvanized metal lath, no rust, no degradation, no water stains, no moisture deterioration. Just like the day it was put on 35 years ago. Constant weather exposure in Florida's environment. Lap paper over metal. Still no Cracks, No faults, No flaws. Photo from back side of removed panel.

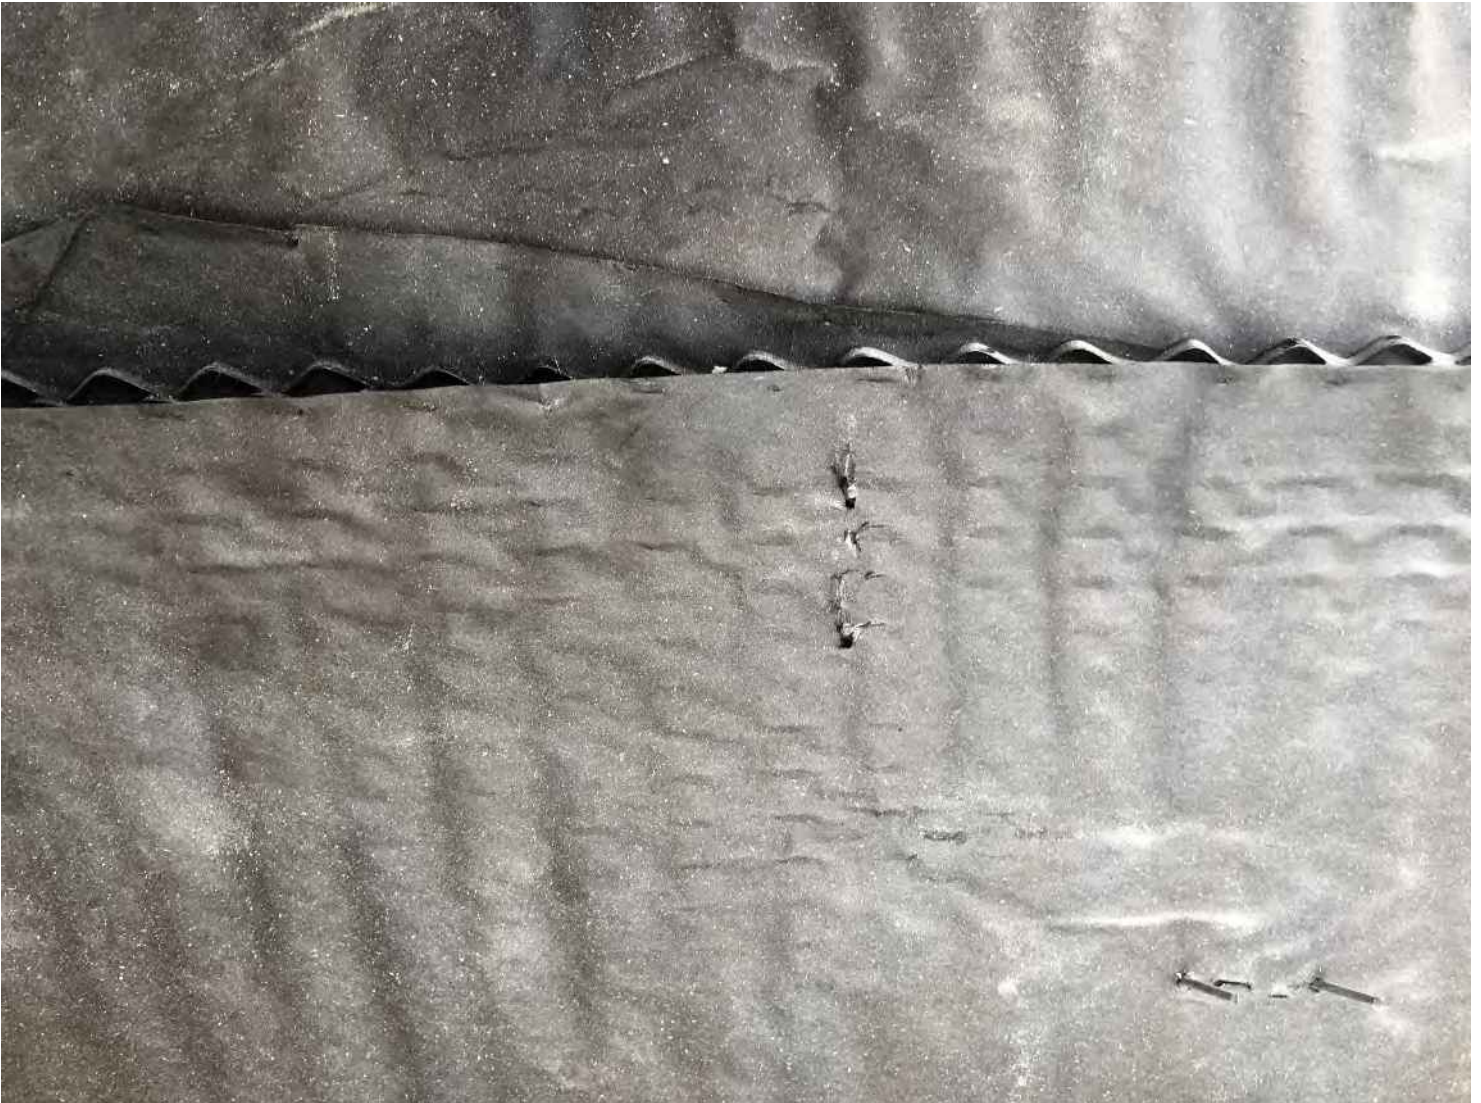
Un-Galvanized metal lath, no rust, no degradation, no water stains, no moisture deterioration. Just like the day it was put on 35 years ago. Constant weather exposure in Florida's environment. Note paper over lath - No cracks, No faults, No flaws.

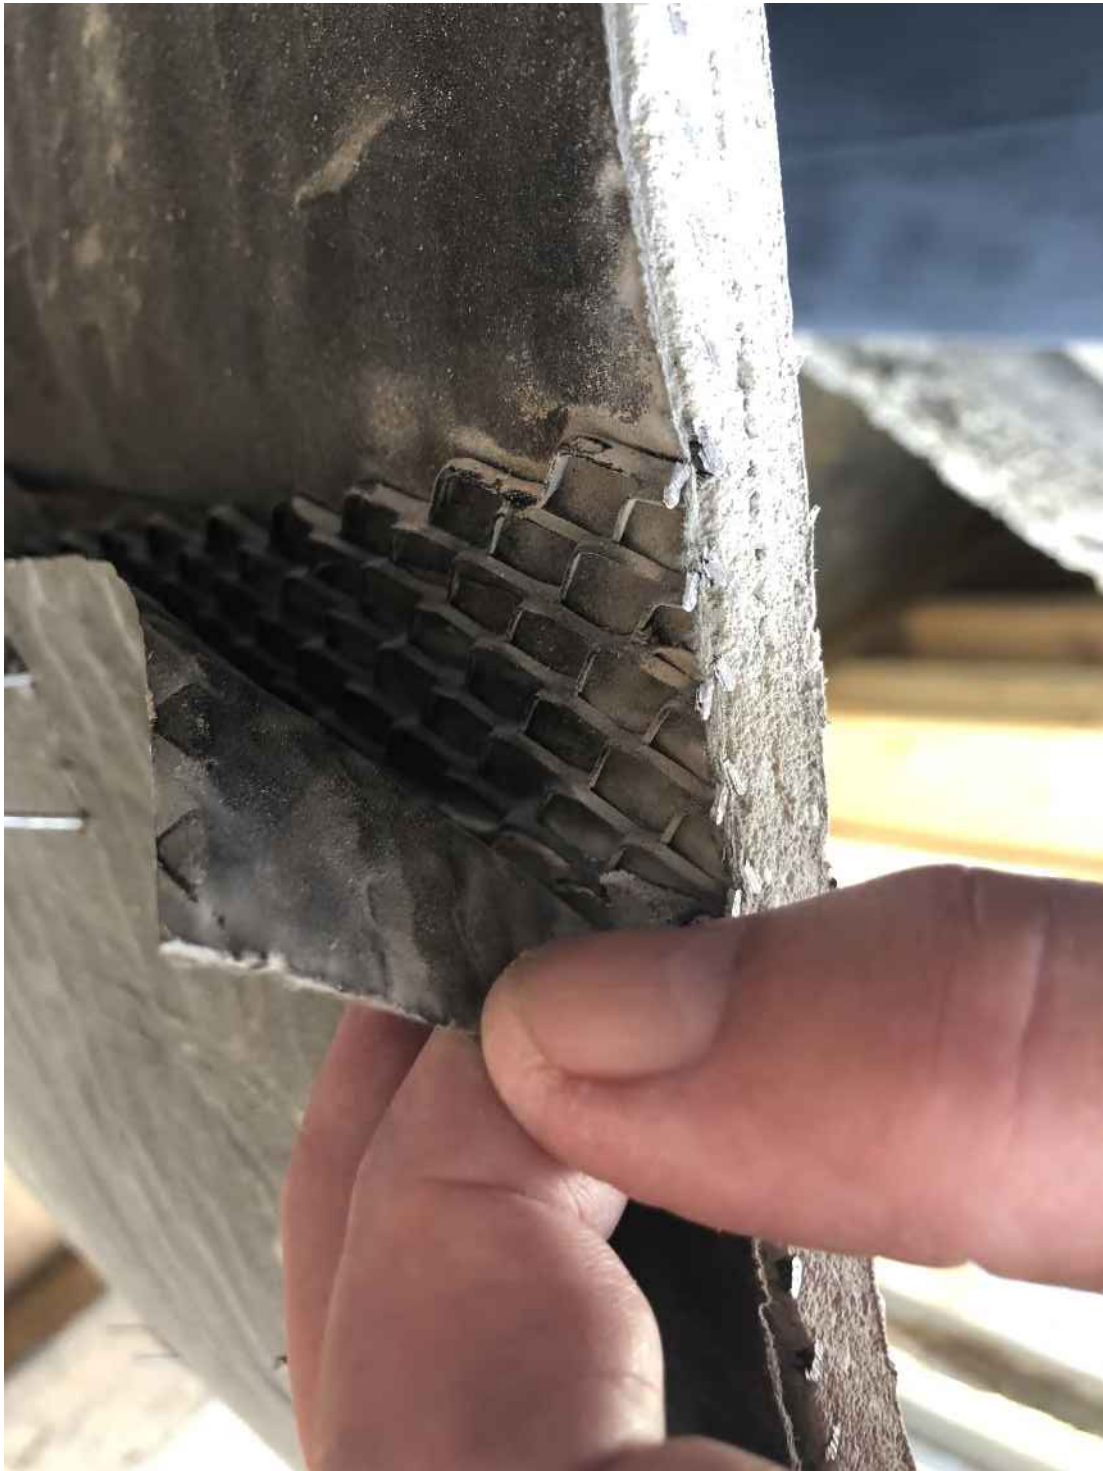
No Weep Screed—Lath brought over block and stub-nailed. Un-Galvanized metal lath, no rust, no degradation, no water stains, no moisture deterioration. Just like the day it was put on 35 years ago. Constant weather exposure in Florida's environment. No wood degradation whatsoever.

Note: Visible crack below lath was induced from prybar when dislodging the lath from the stub nail for documentation.

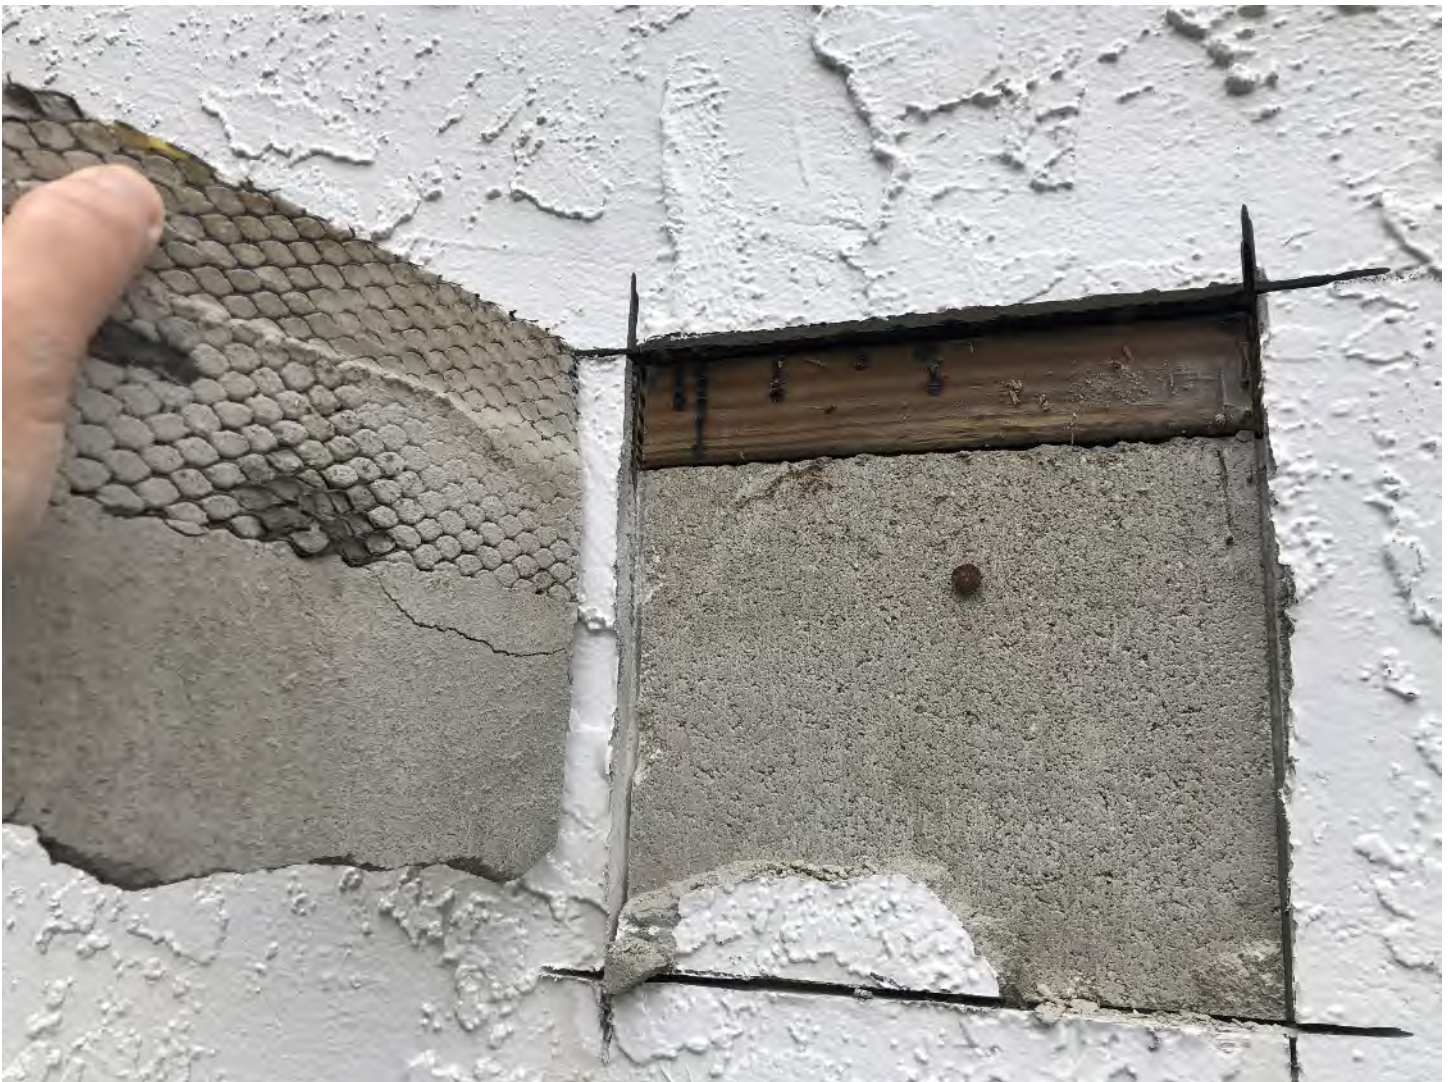
35 year old frame to block wall transition. Un-Galvanized metal lath, no rust, no degradation, no water stains, no moisture deterioration. Just like the day it was put on 35 years ago. Constant weather exposure in Florida's environment. Lap paper over metal. Still no Cracks, No faults, No flaws, and No weed screed.

Note: Visible crack below lath was induced from prybar when dislodging the lath from the stub nail for documentation.

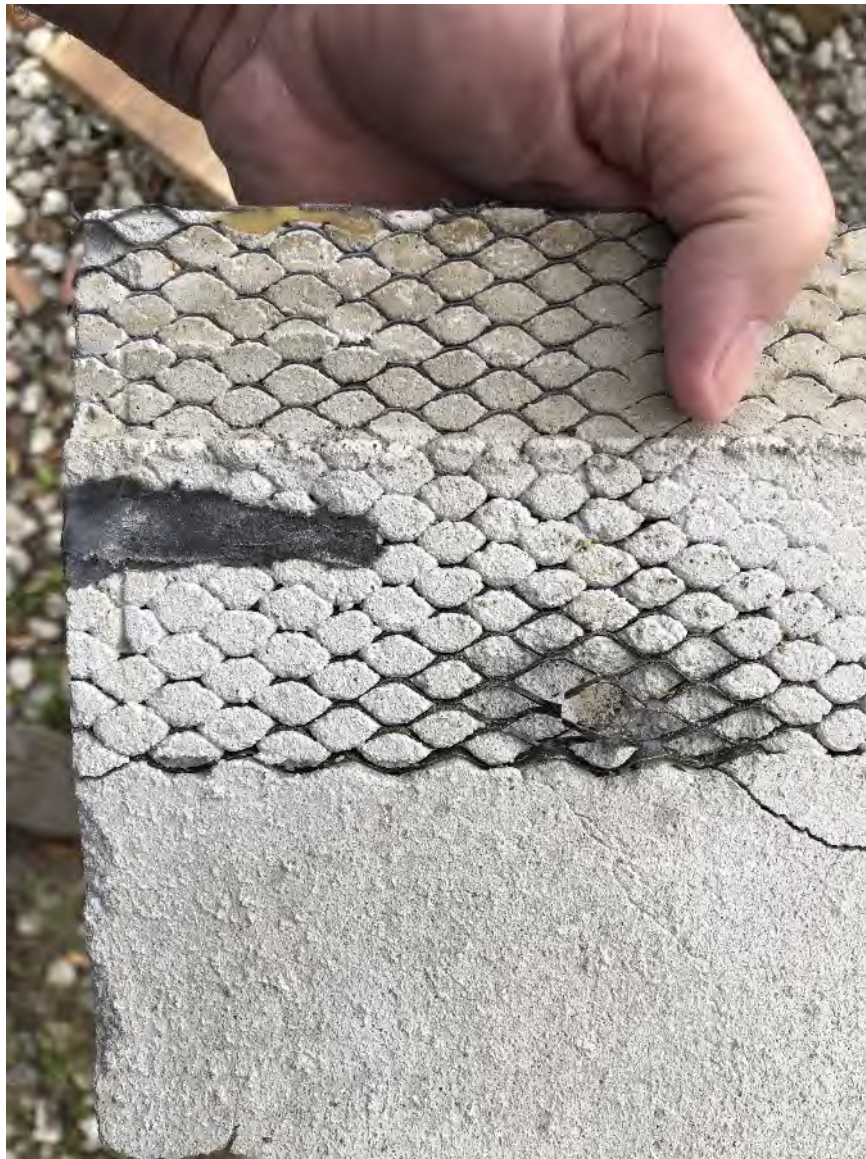
No Weep Screed—Lath brought over block and stub-nailed. Un-Galvanized metal lath, no rust, no degradation, no water stains, no moisture deterioration. Just like the day it was put on 35 years ago. Constant weather exposure in Florida's environment. No wood degradation whatsoever on sheathing.

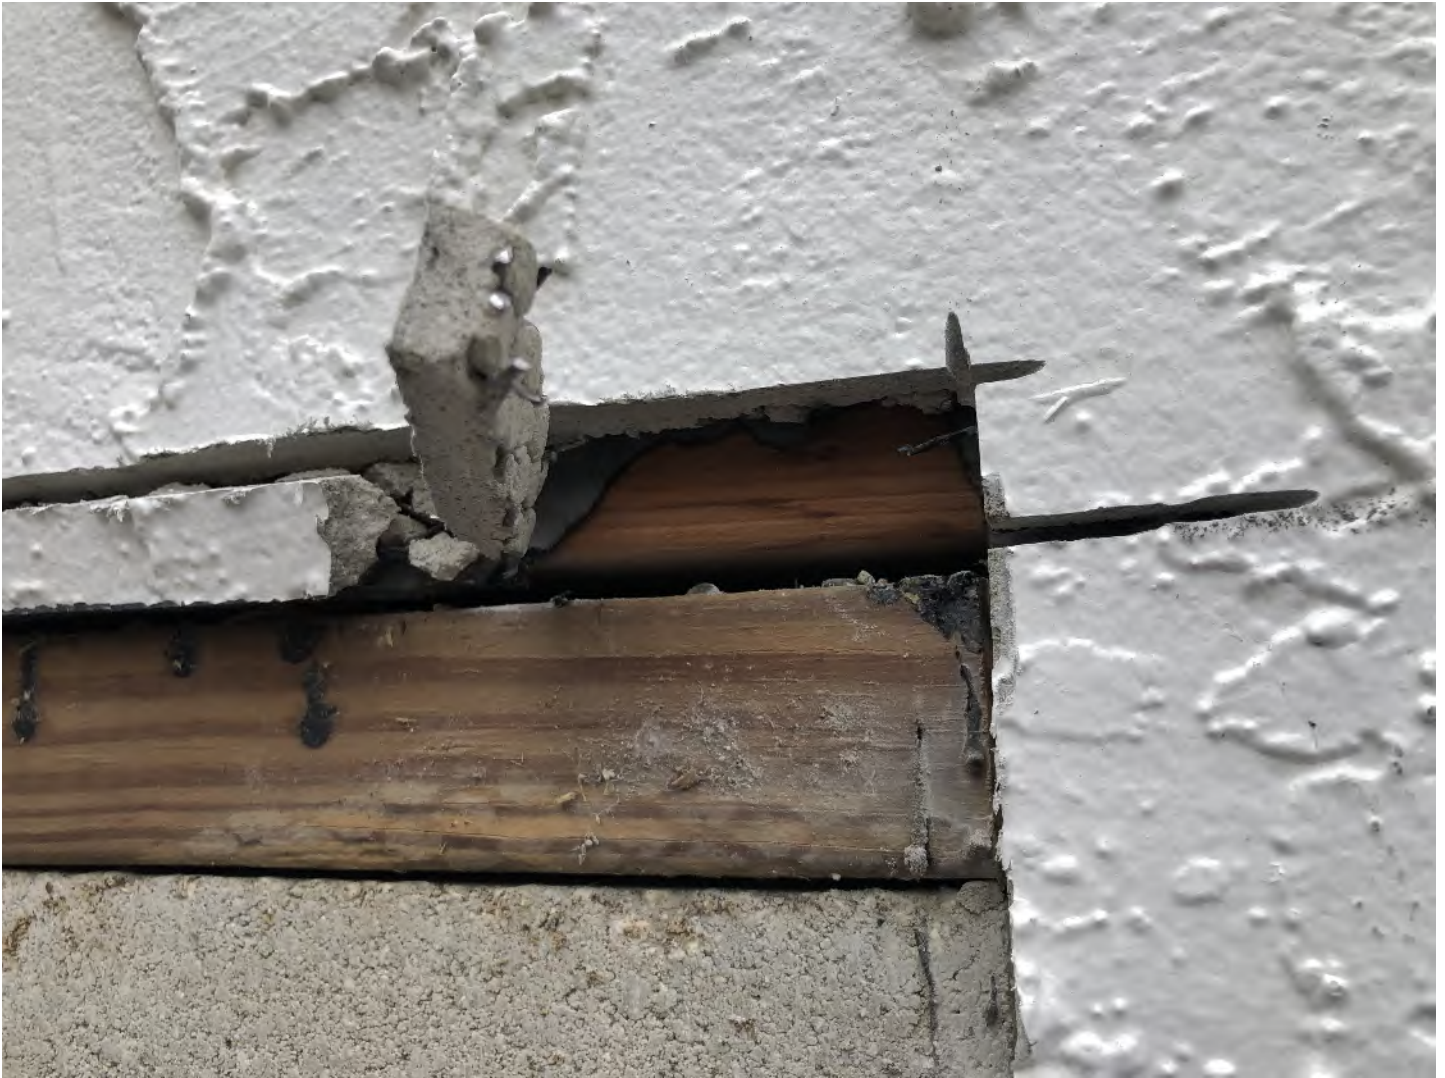
Stucco Cladding 1/2" Nominal Thickness - applied using South Florida Building Code requirement or using the ASTM "unless specified otherwise" provision. No cracks anywhere.
