Newsletter NL 104.0

35 Year old Stucco Walls Performing
Flawlessly!
2nd Story Wood Sheathed Wall Over Block
1st Story.

01/12/2019

THE STUCCO INSTITUTE NEWS LETTER

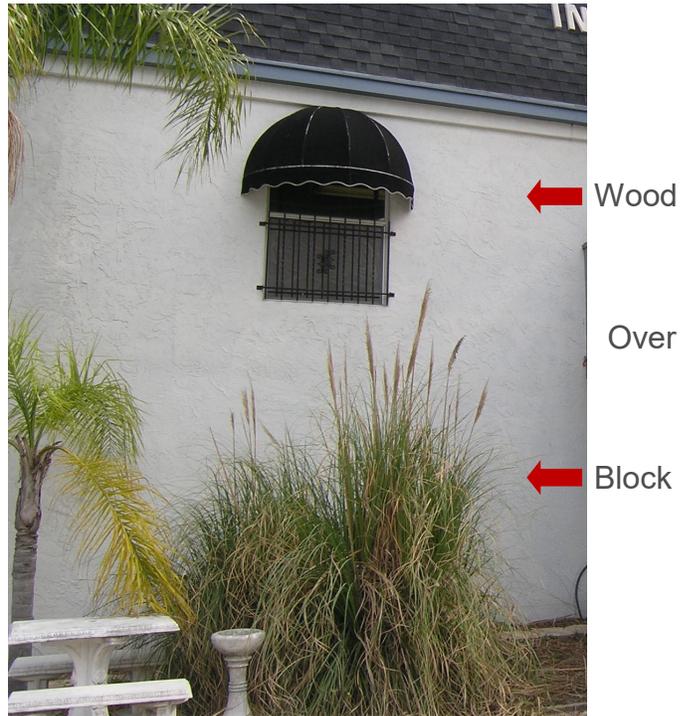
Look Mom! No weeps, No control joints, No casing beads separating windows, No cracks, No leaks, No flaws, No faults! 35 years old - perfect performance!

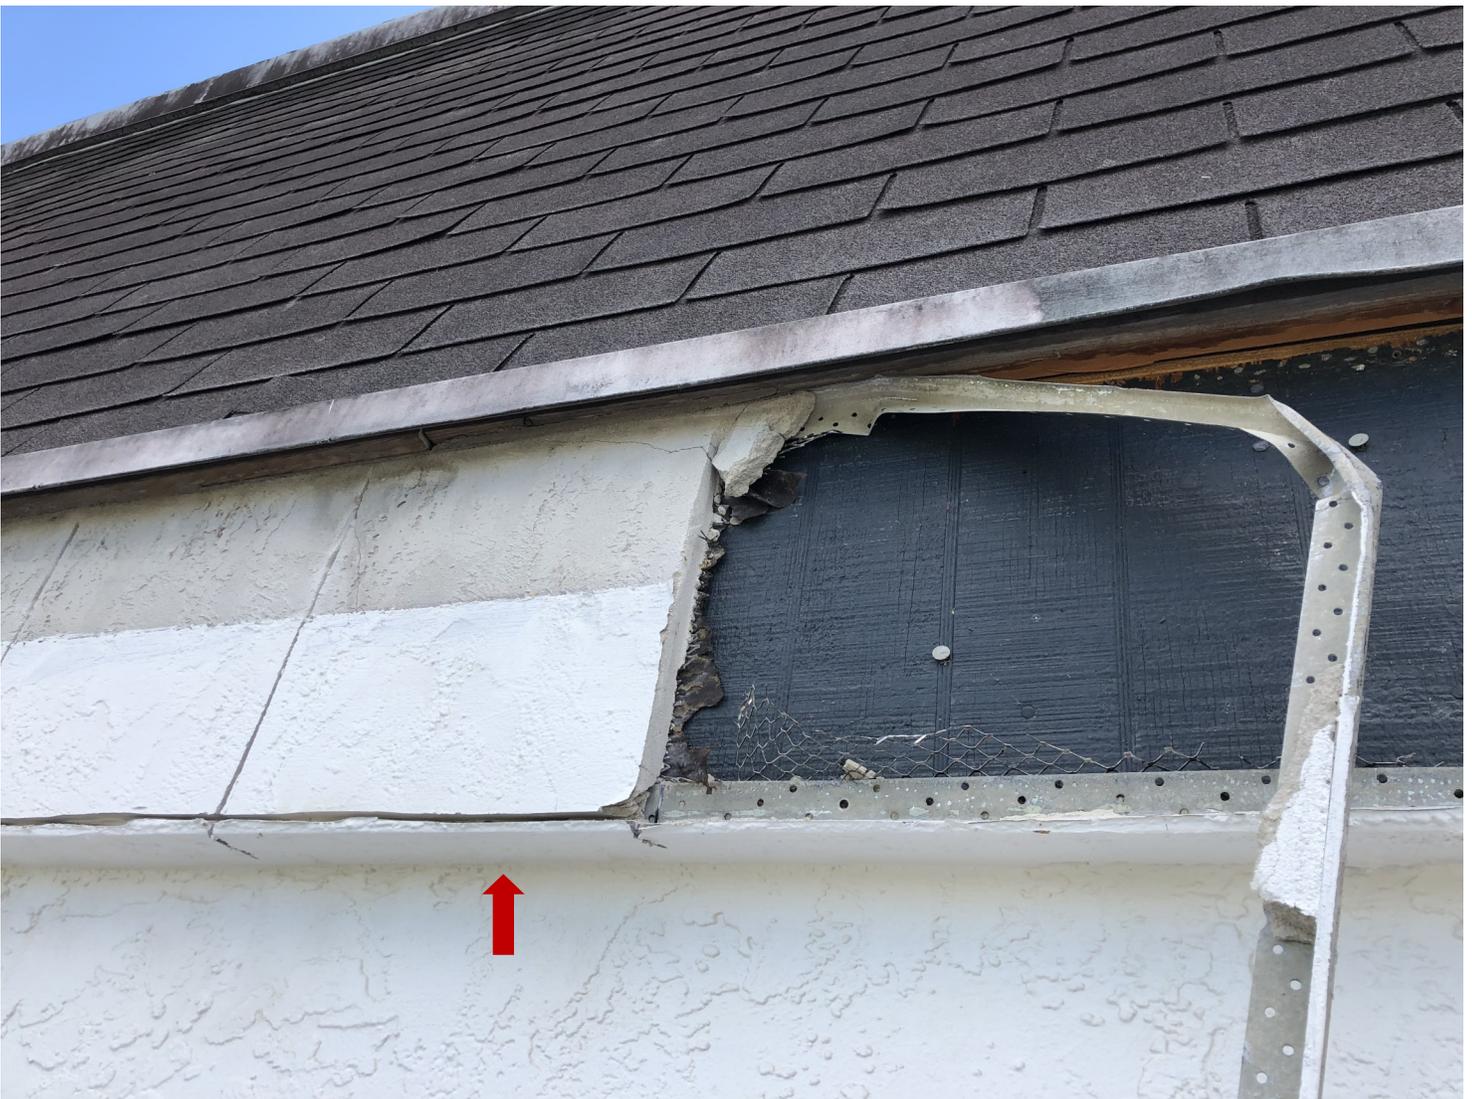
Upper section of rear wall with Stucco Fascia removed ready for lower back stucco wall cladding removal.

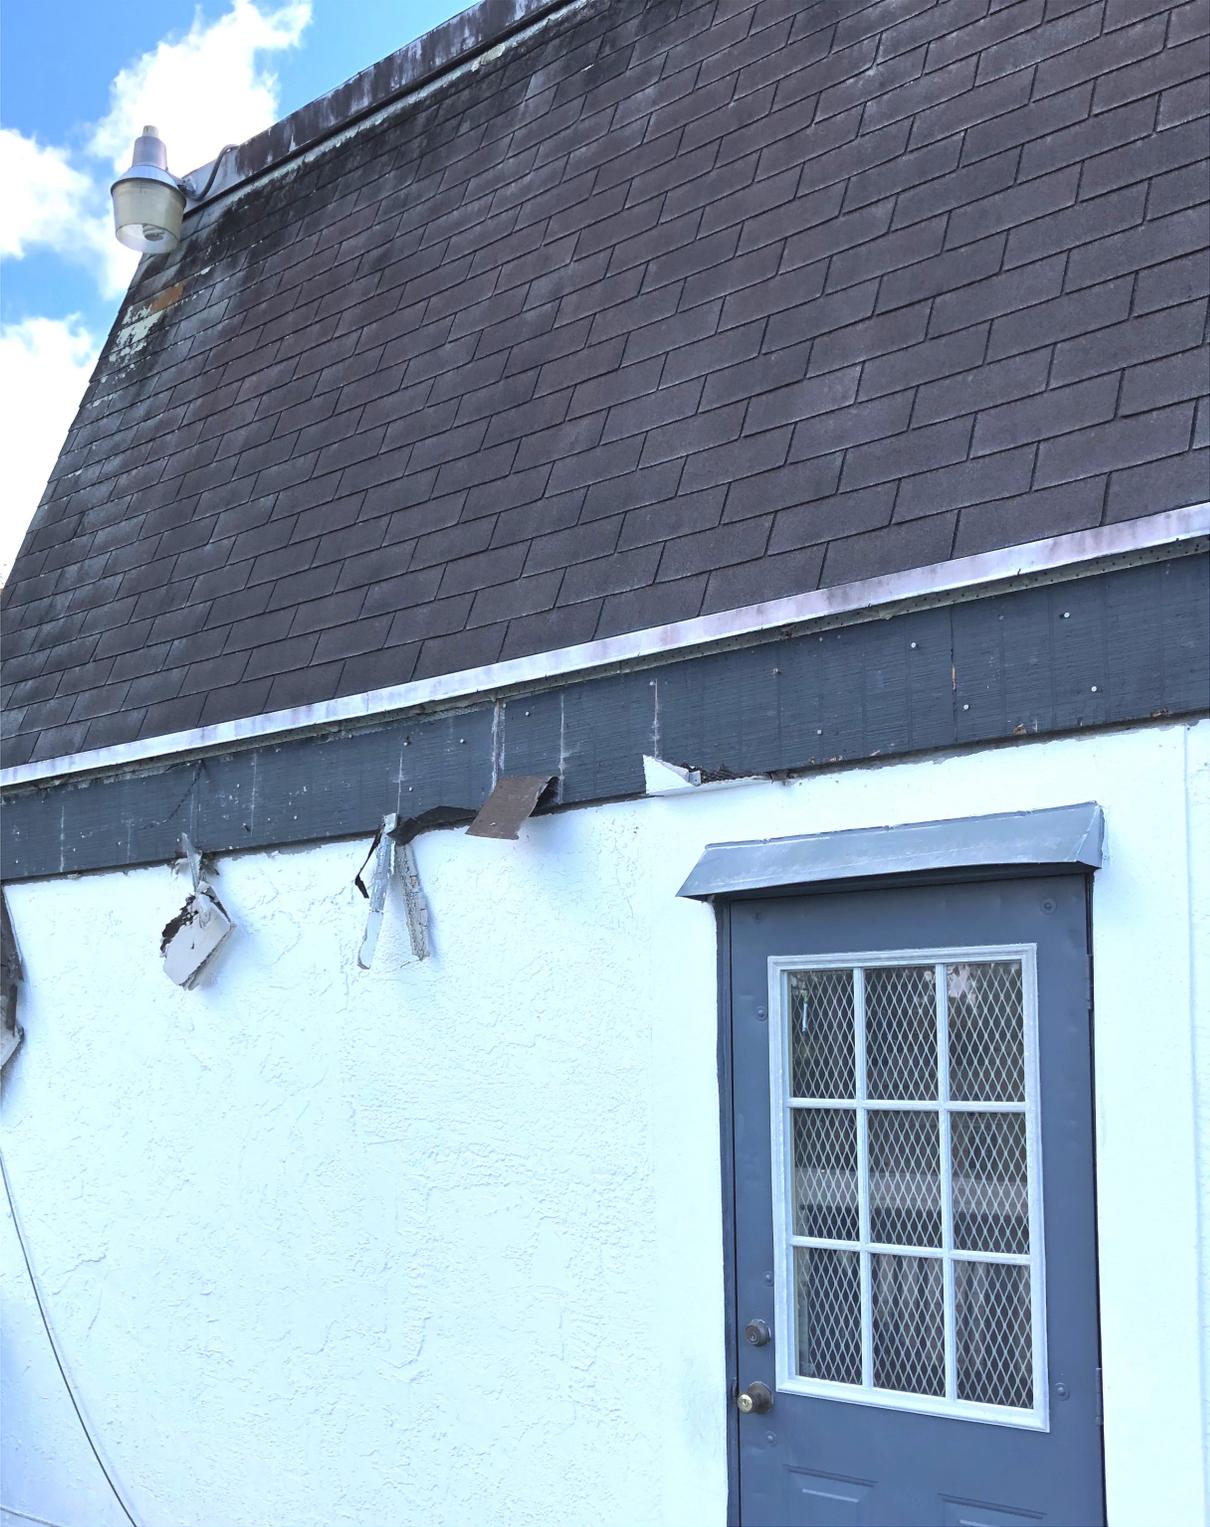
Rear Wall with scoring to remove stucco system. Stucco Cladding had zero cracks, zero leaks, zero faults. We will later look at the back side of the lath.

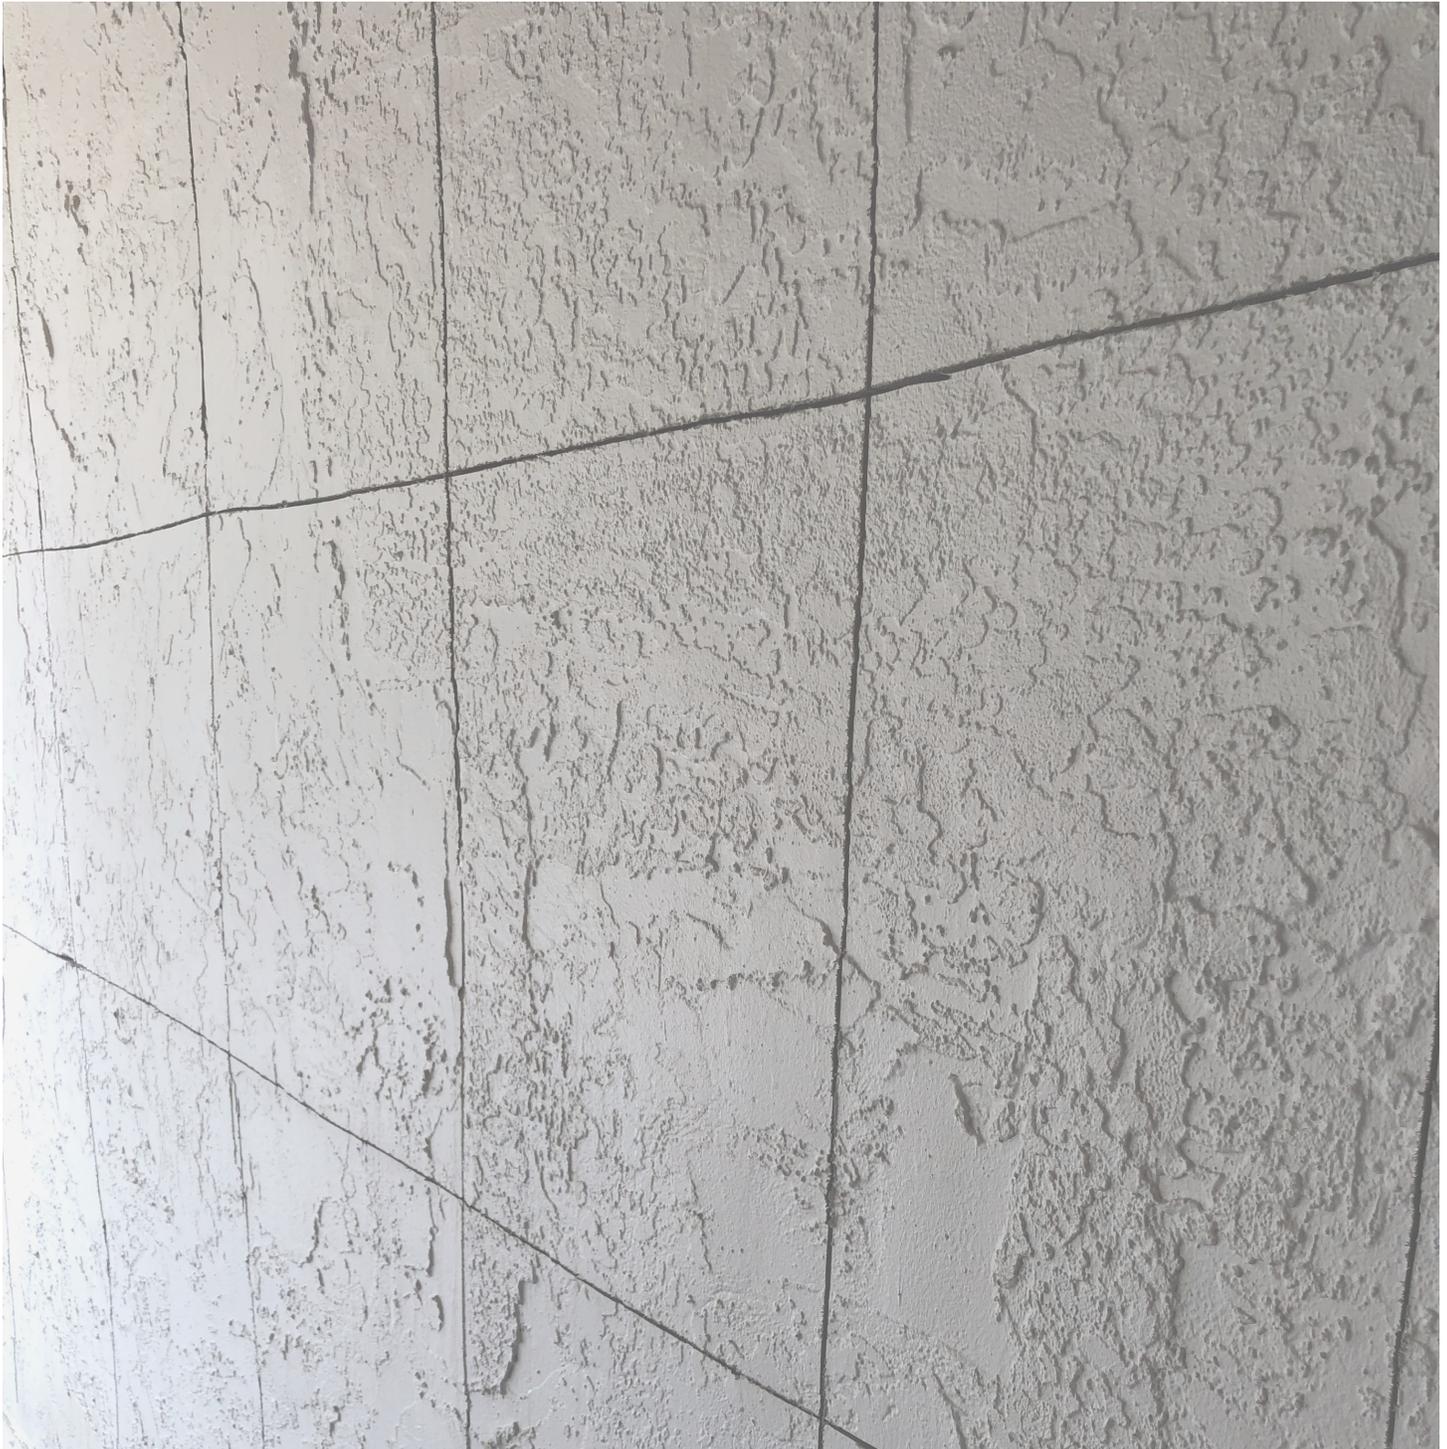
Exterior wall plywood pristine after 35 years covered with stucco cladding.
Note: Stucco scored deep to aid in plywood removal for examination.

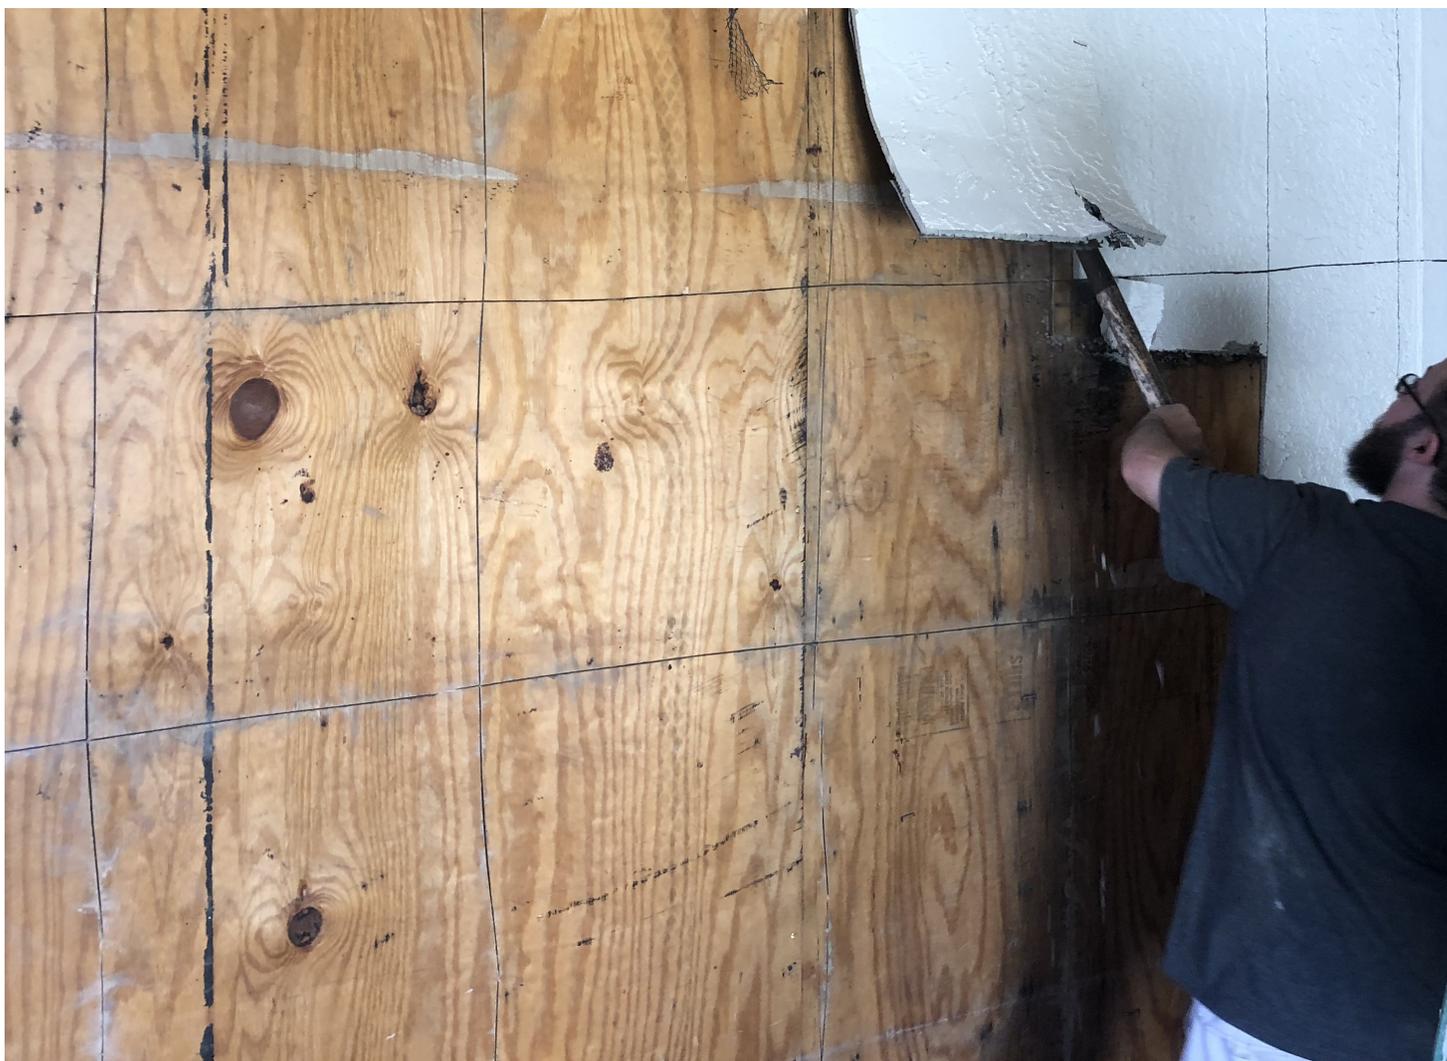
Exterior wall plywood pristine after 35 years covered with stucco cladding.
Note: Stucco scored deep to aid in plywood removal for examination only.

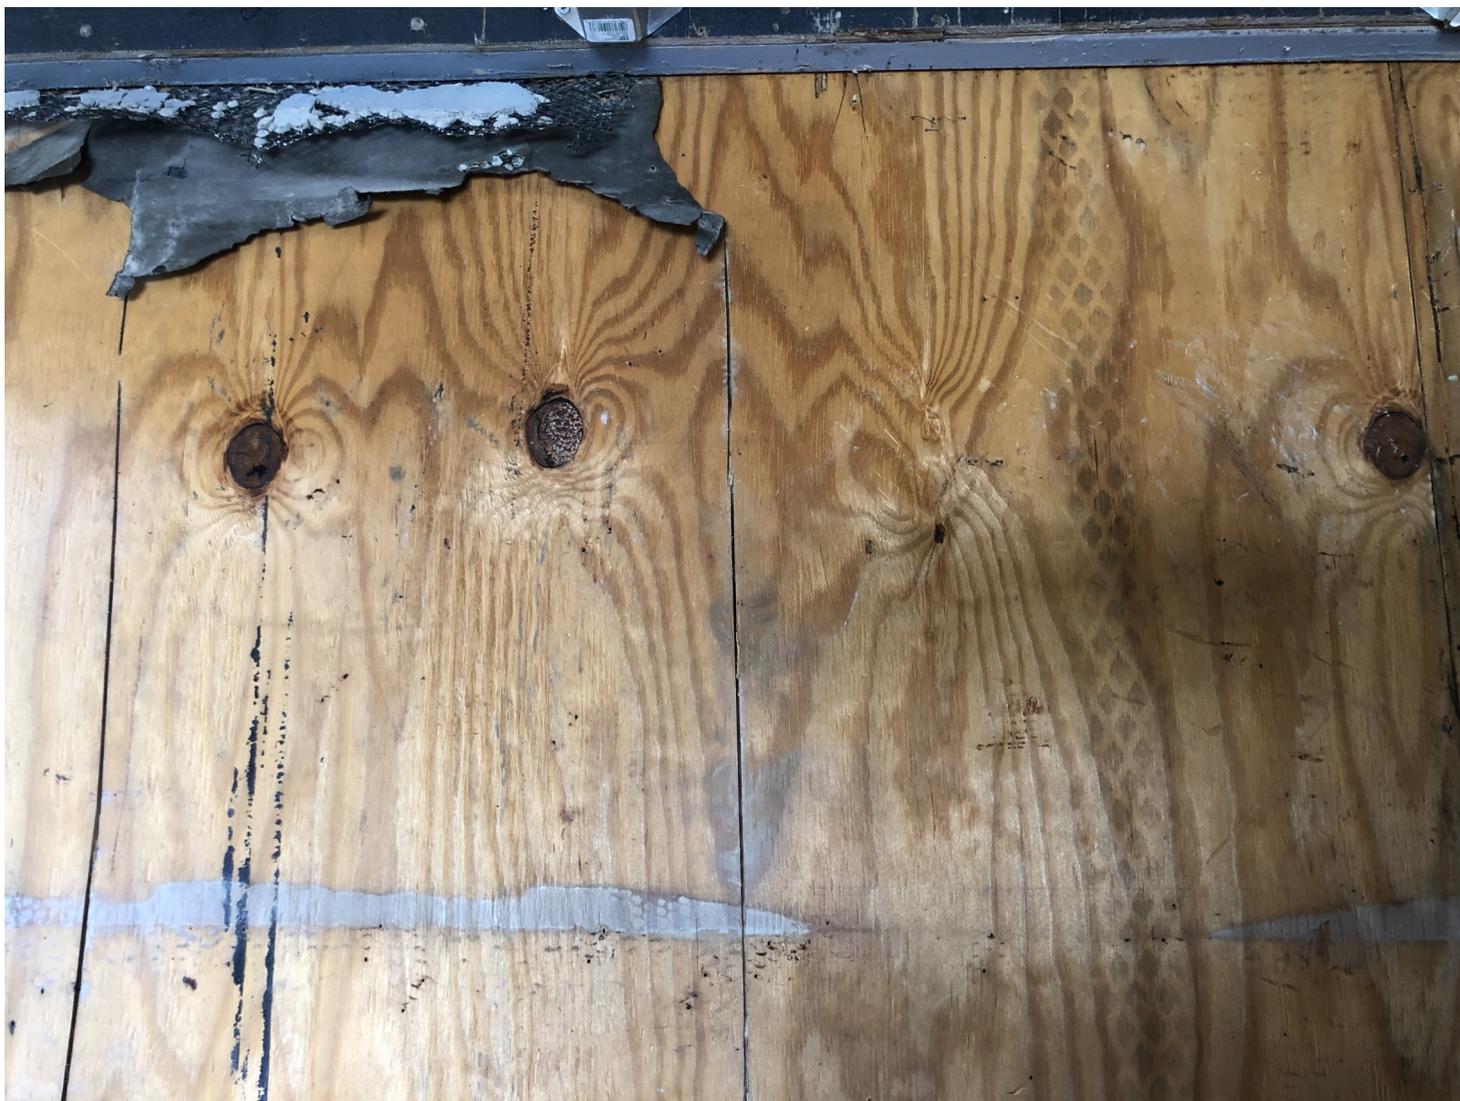
Exterior wall plywood pristine after 35 years covered with stucco cladding.

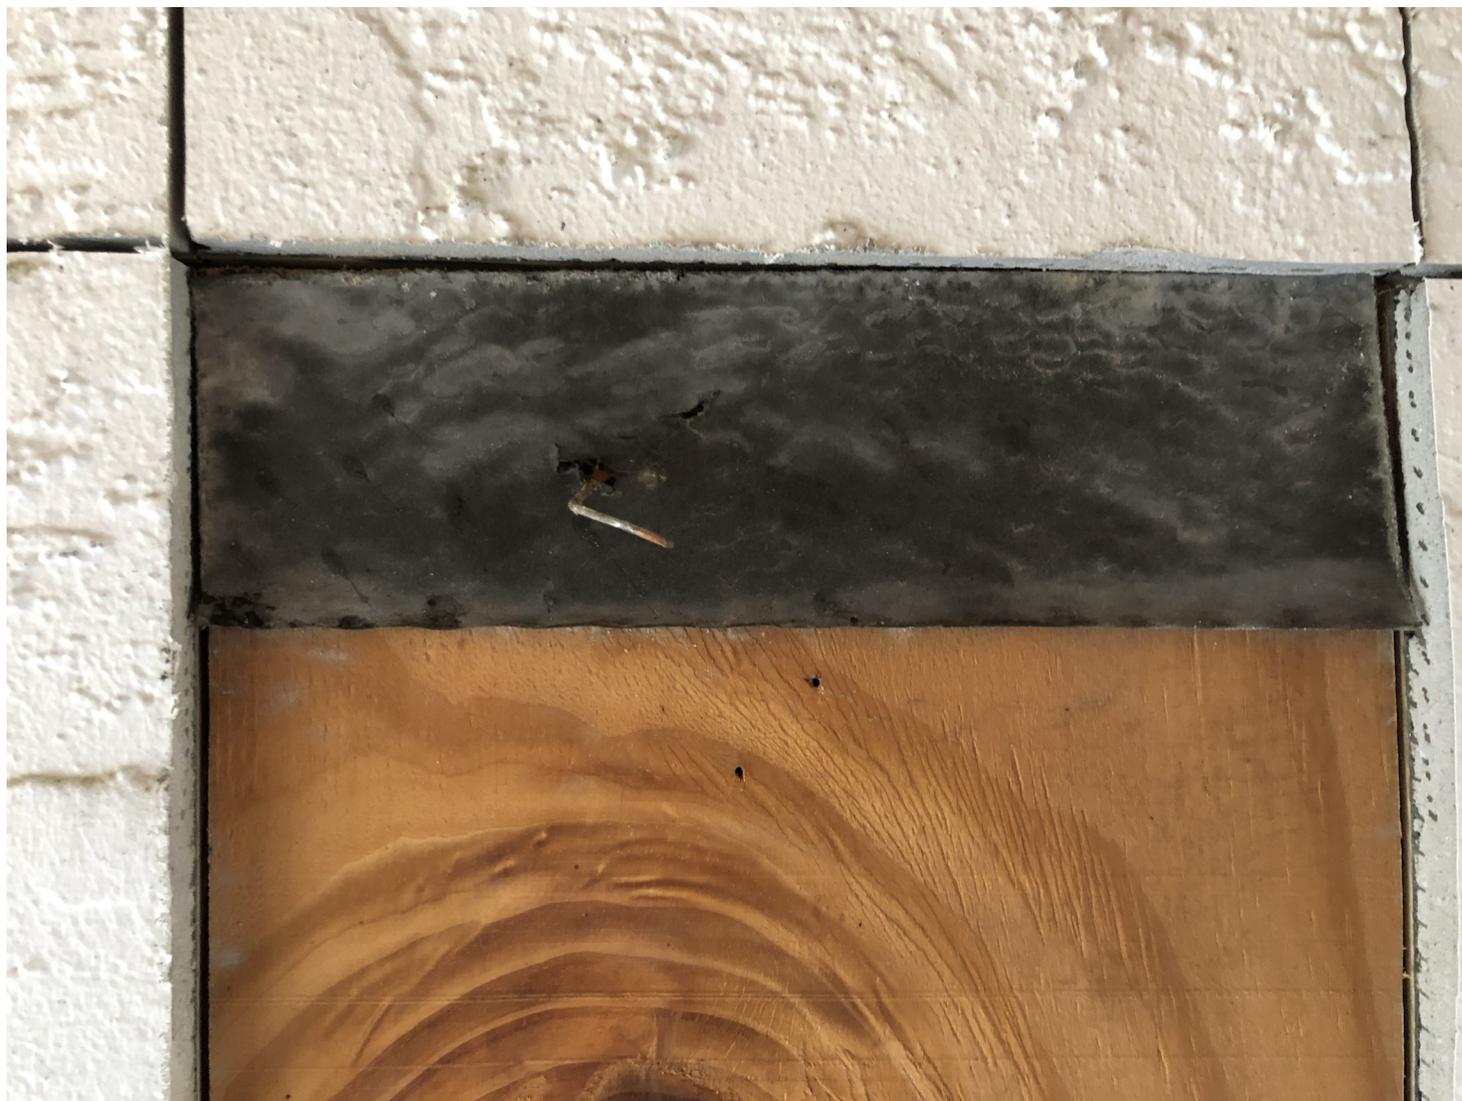
Exterior wall plywood pristine after 35 years covered with stucco cladding.

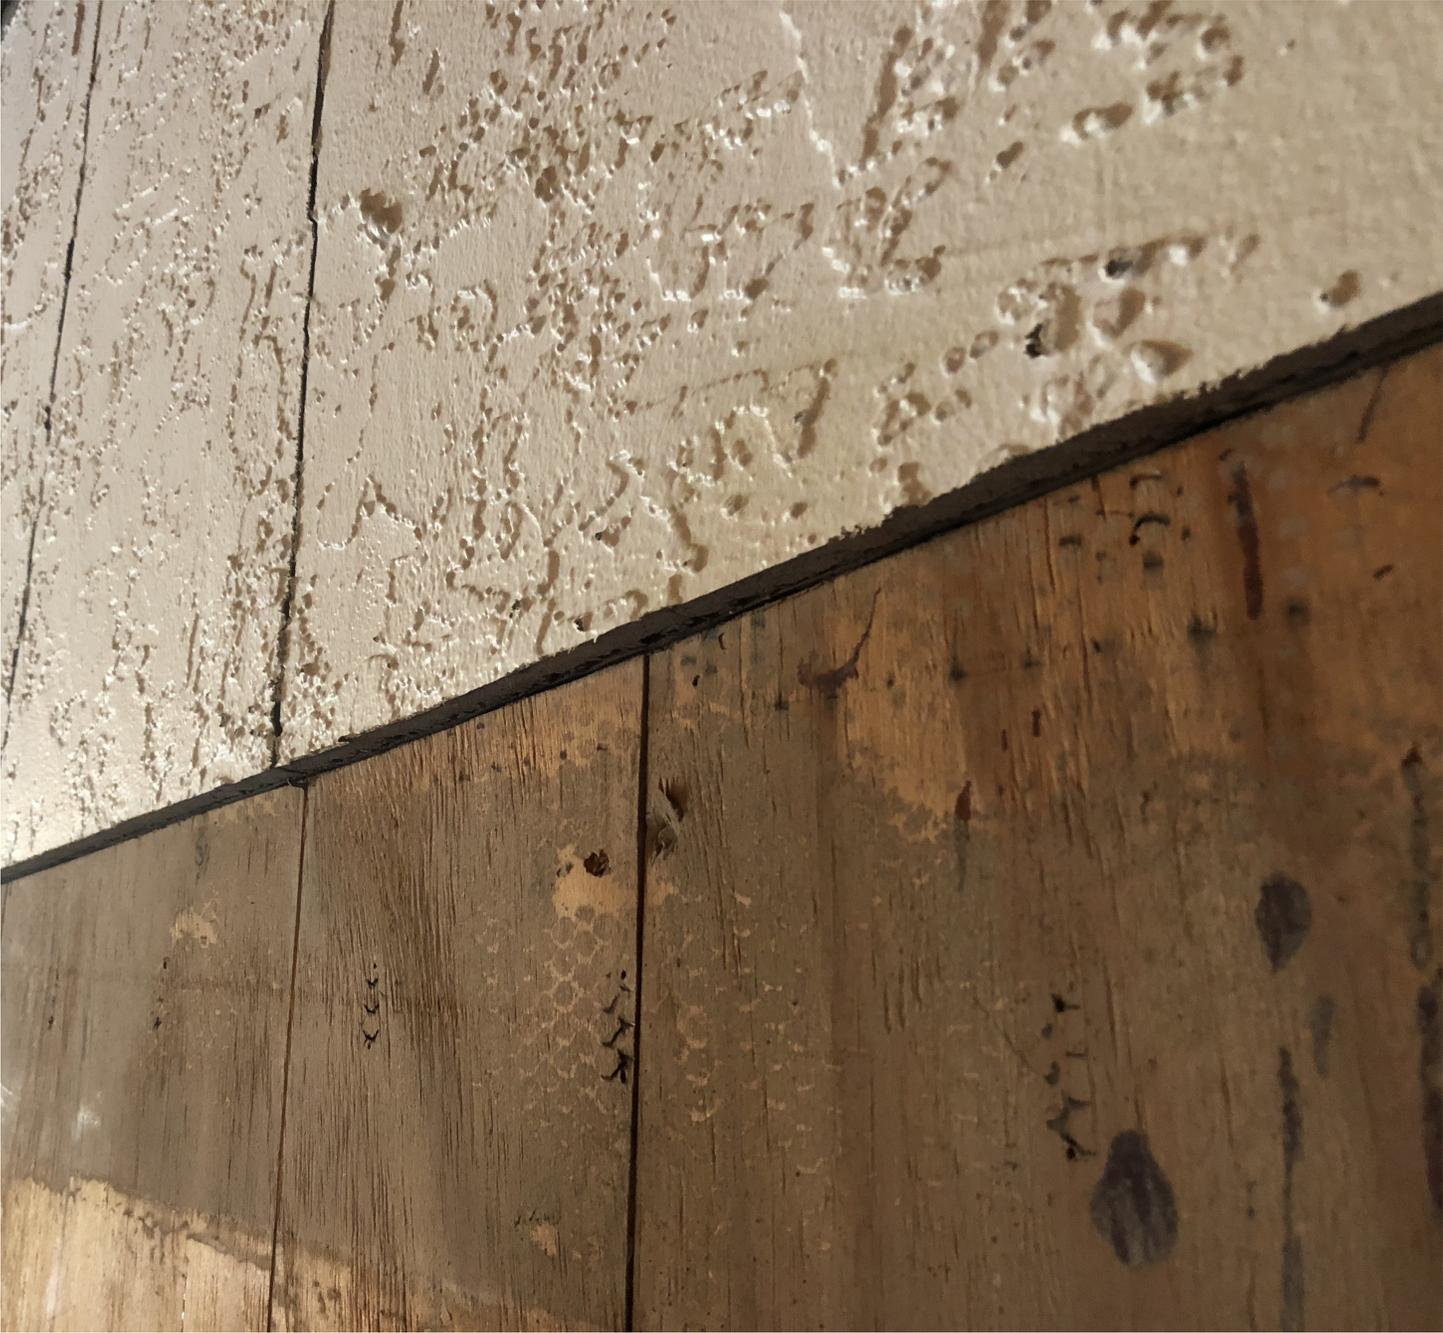
Un-Galvanized (black) FLAT metal lath (no dimples or furring), no rust, no degradation, no water stains, no moisture deterioration. Just like the day it was put on 35 years ago and has remained fully exposed to all elements since.

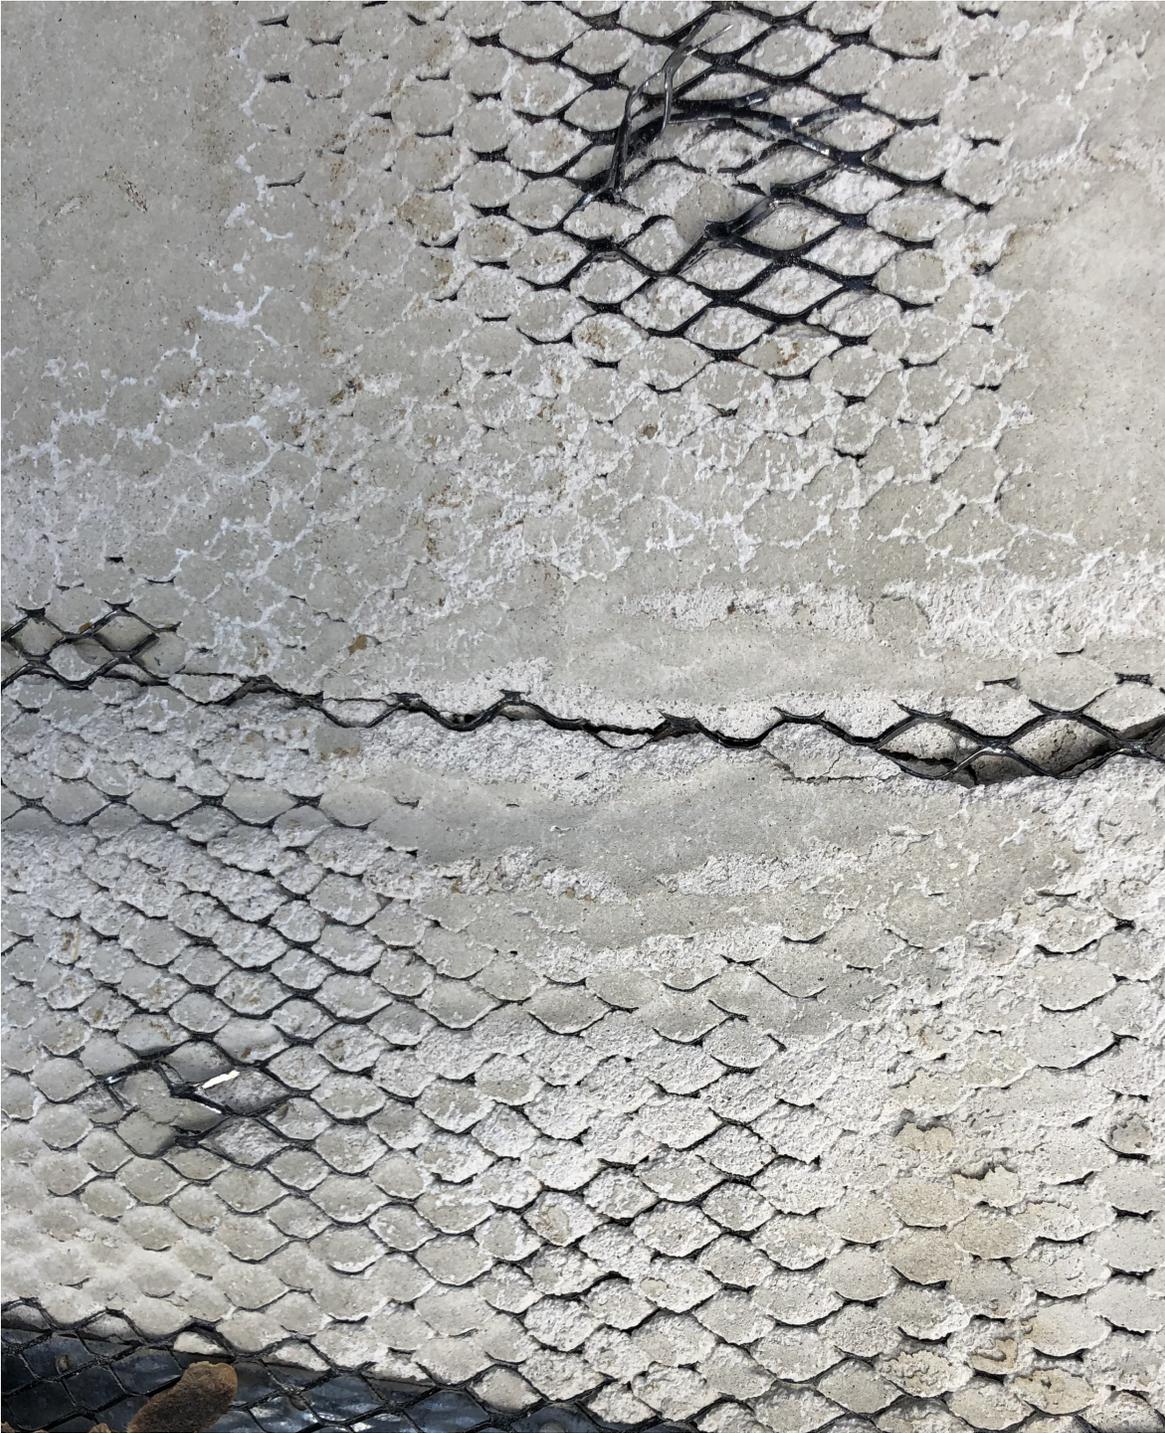
Un-Galvanized flat metal lath, no rust, no degradation, no water stains, no moisture deterioration. Just like the day it was put on 35 years ago. Lath shiny where cut through.

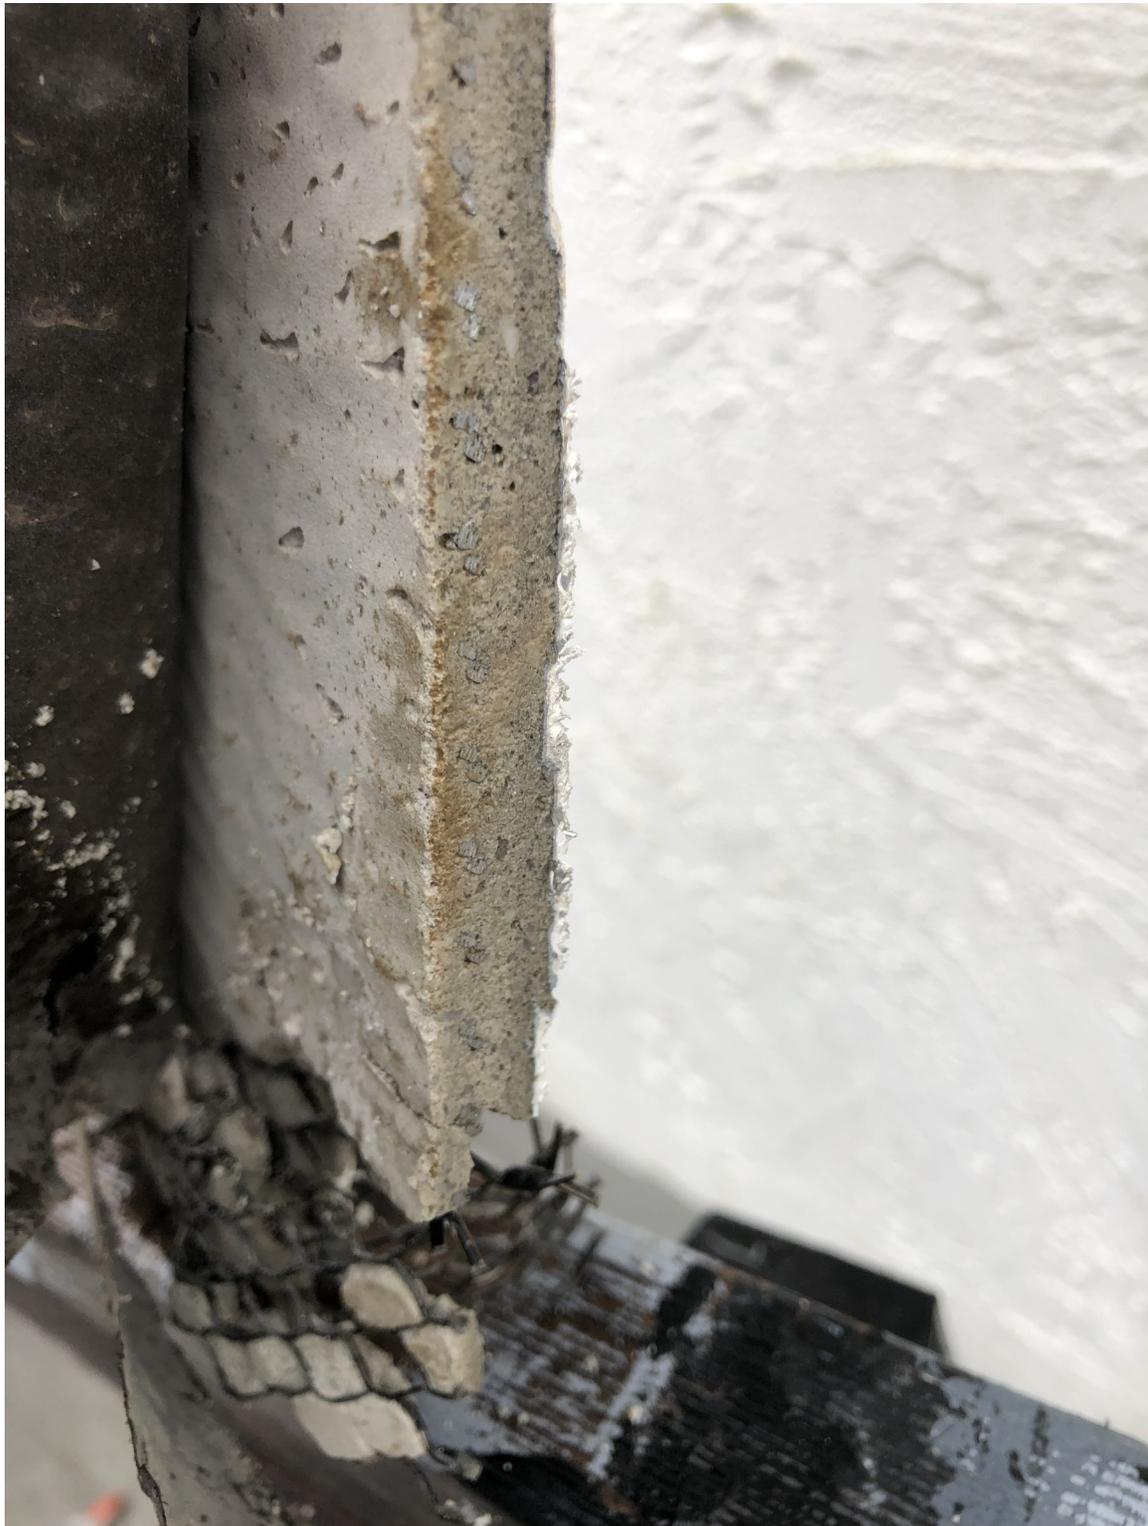
Stucco Cladding 1/2" thick - applied using South Florida Building Code requirement or using the ASTM "unless otherwise specified" provision. No cracks anywhere. Metal shiny where cut through sample.

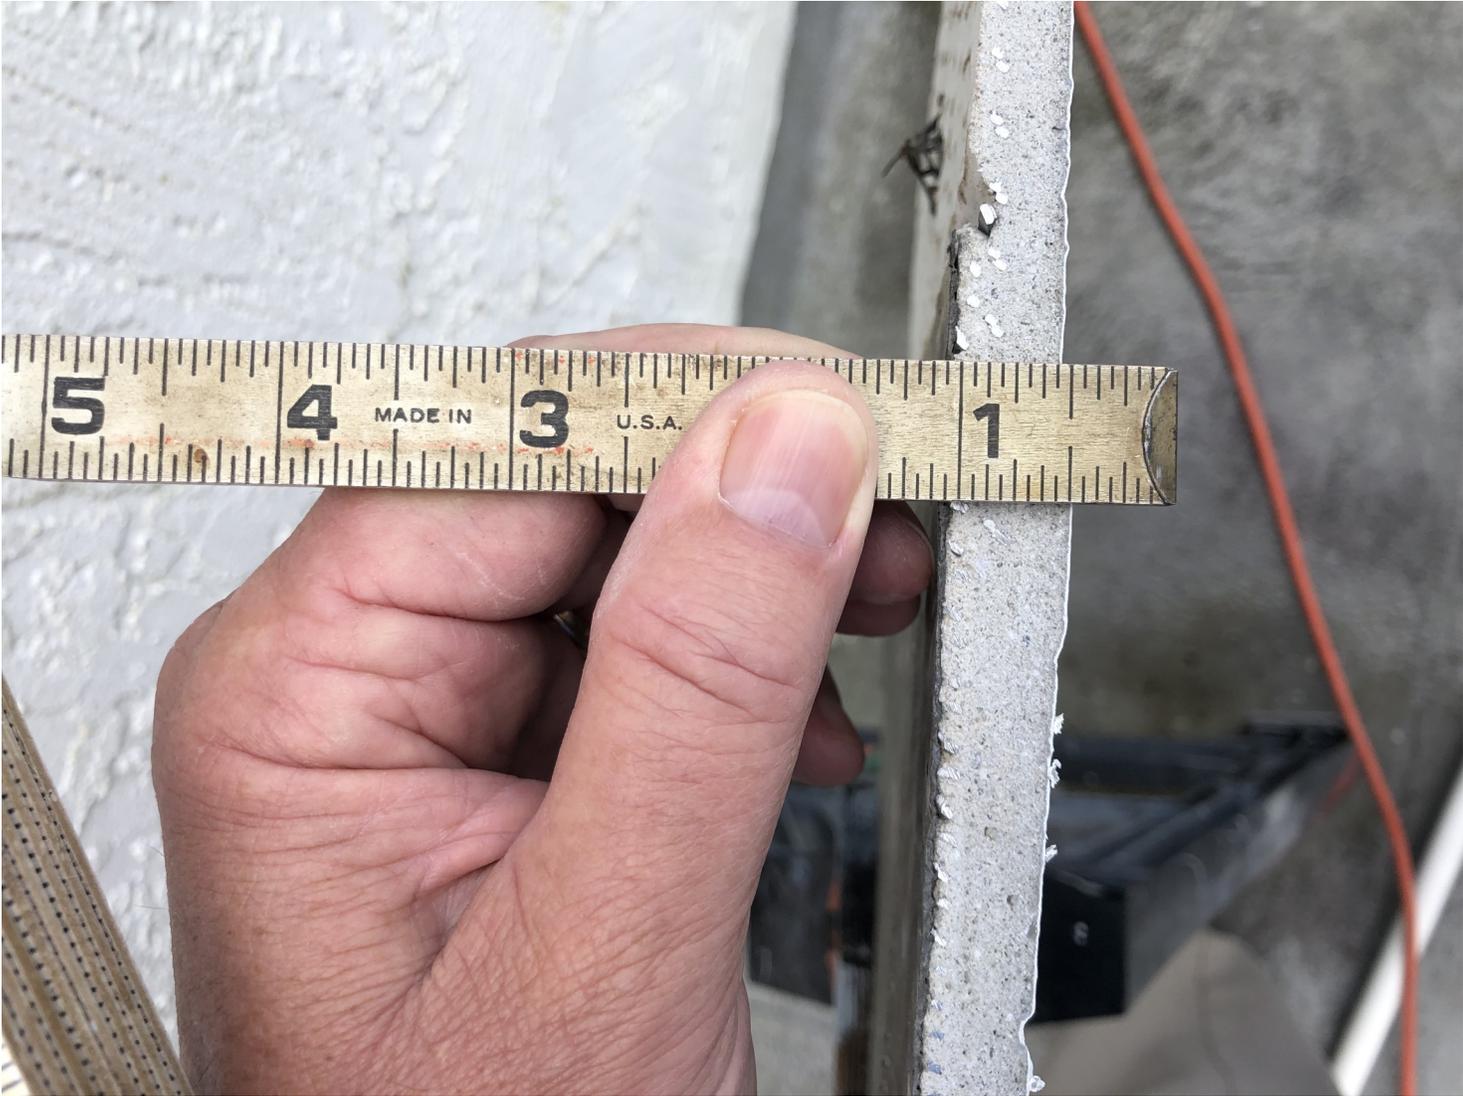
2 Inch lath lap - No cracks. Metal pristine. Metal shiny like new where cut through sample.

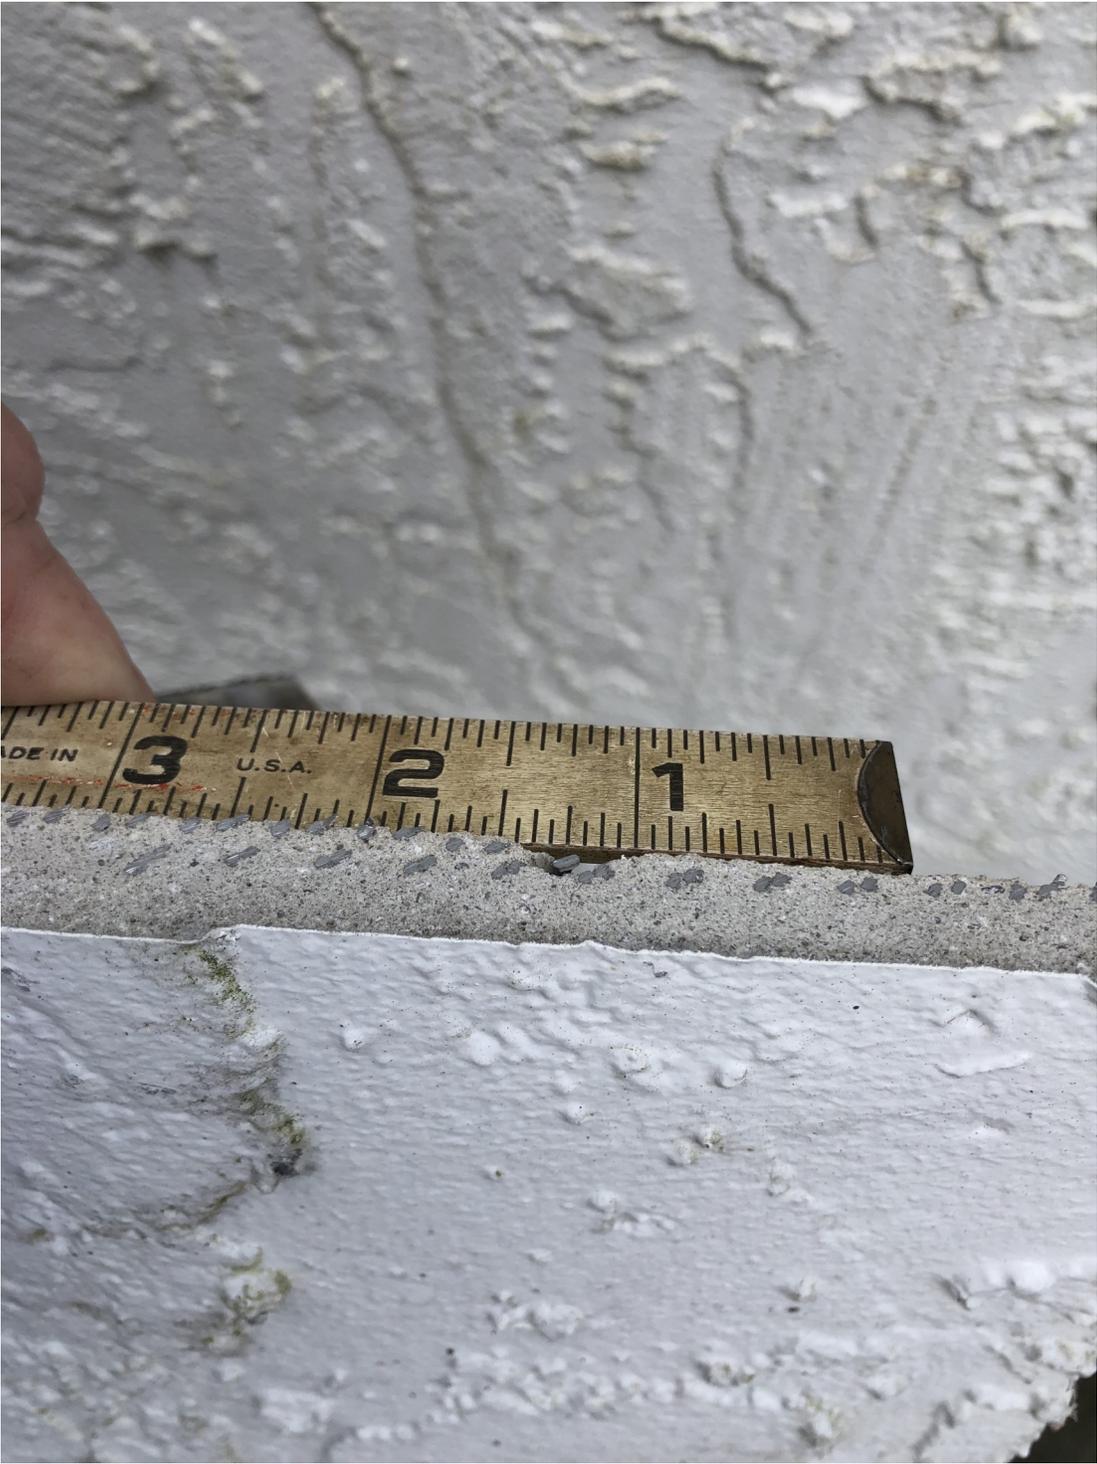
Stucco Cladding 3/8" thick in one area - Still no cracks, No rust, No faults.

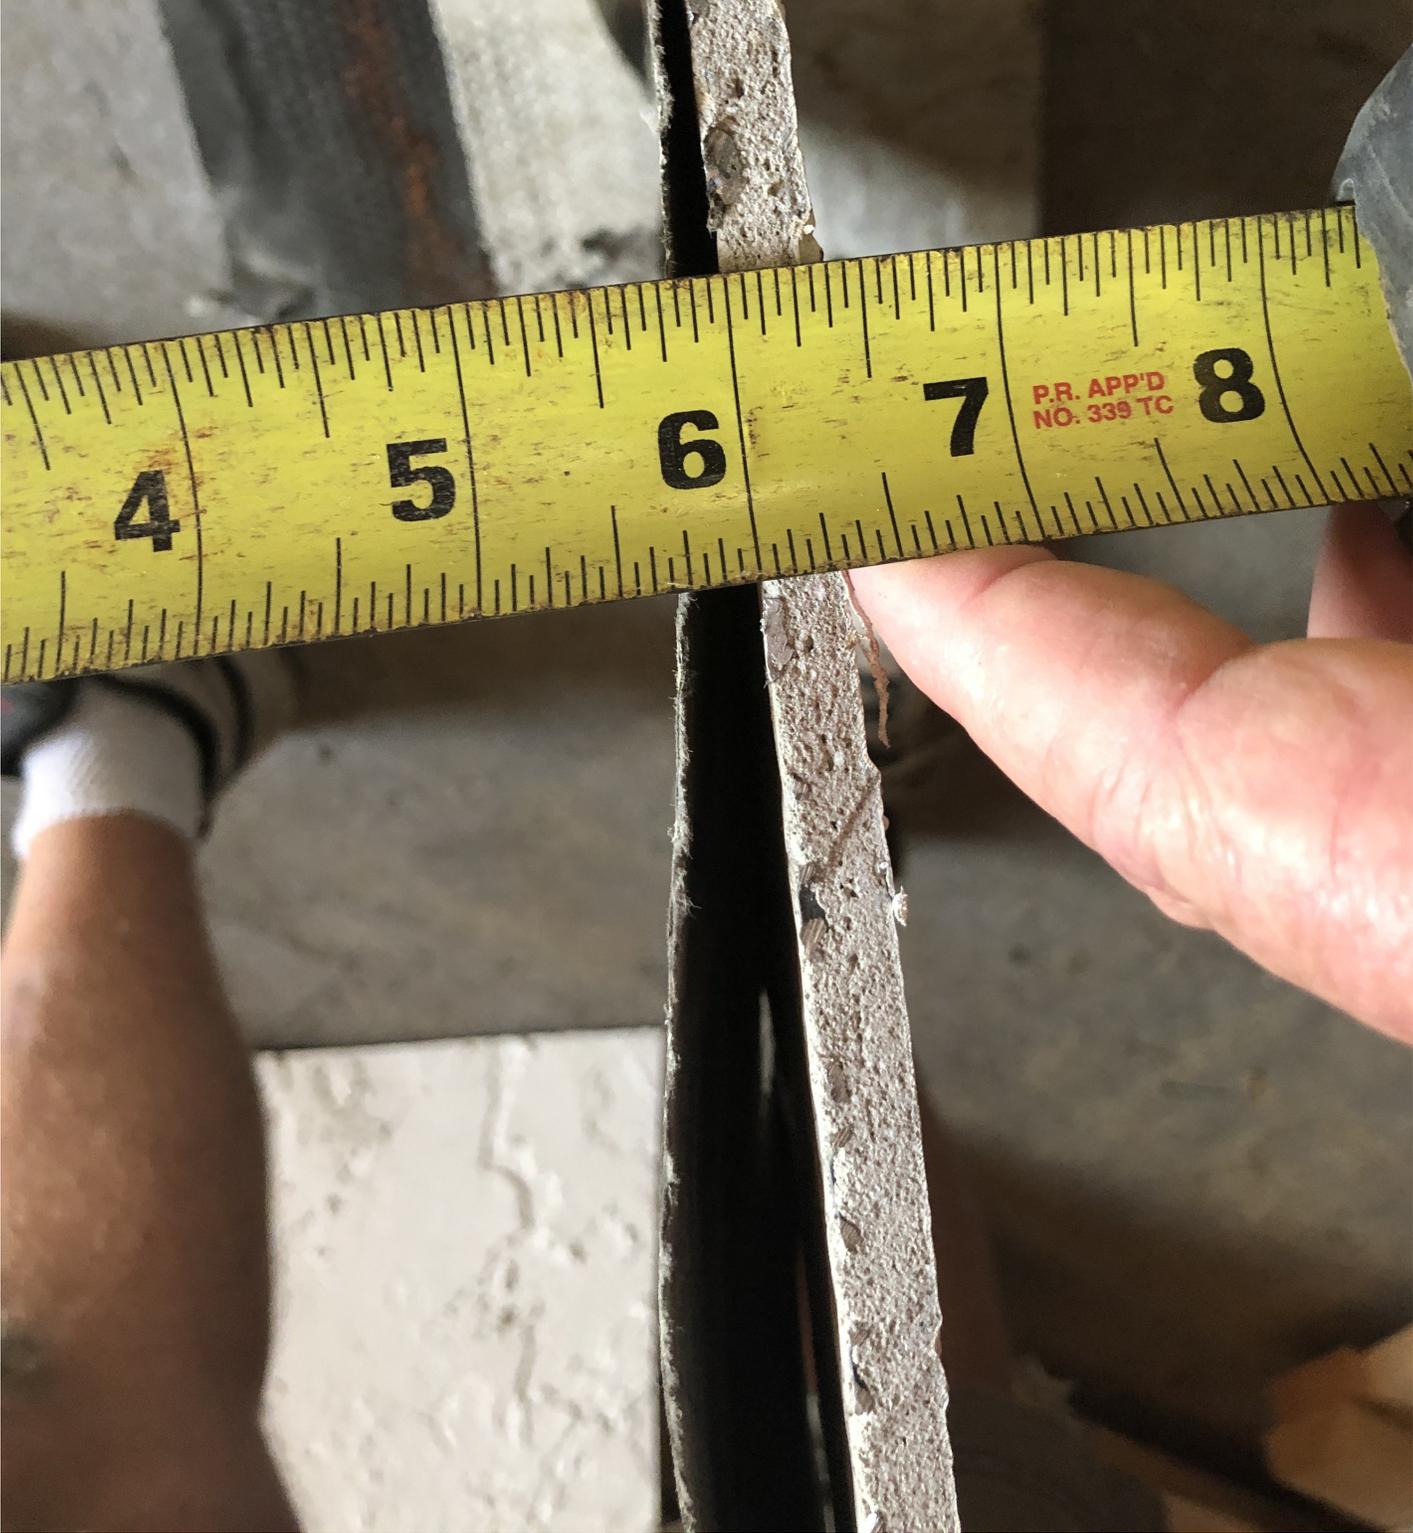
Un-Galvanized flat metal lath, no rust, no degradation, no water stains, no moisture deterioration. Just like the day it was put on 35 years ago.
