Newsletter NL 104.0

35 Year old Stucco Walls Performing
Flawlessly!
2nd Story Wood Sheathed Wall Over Block
1st Story.

01/12/2019

THE STUCCO INSTITUTE NEWS LETTER

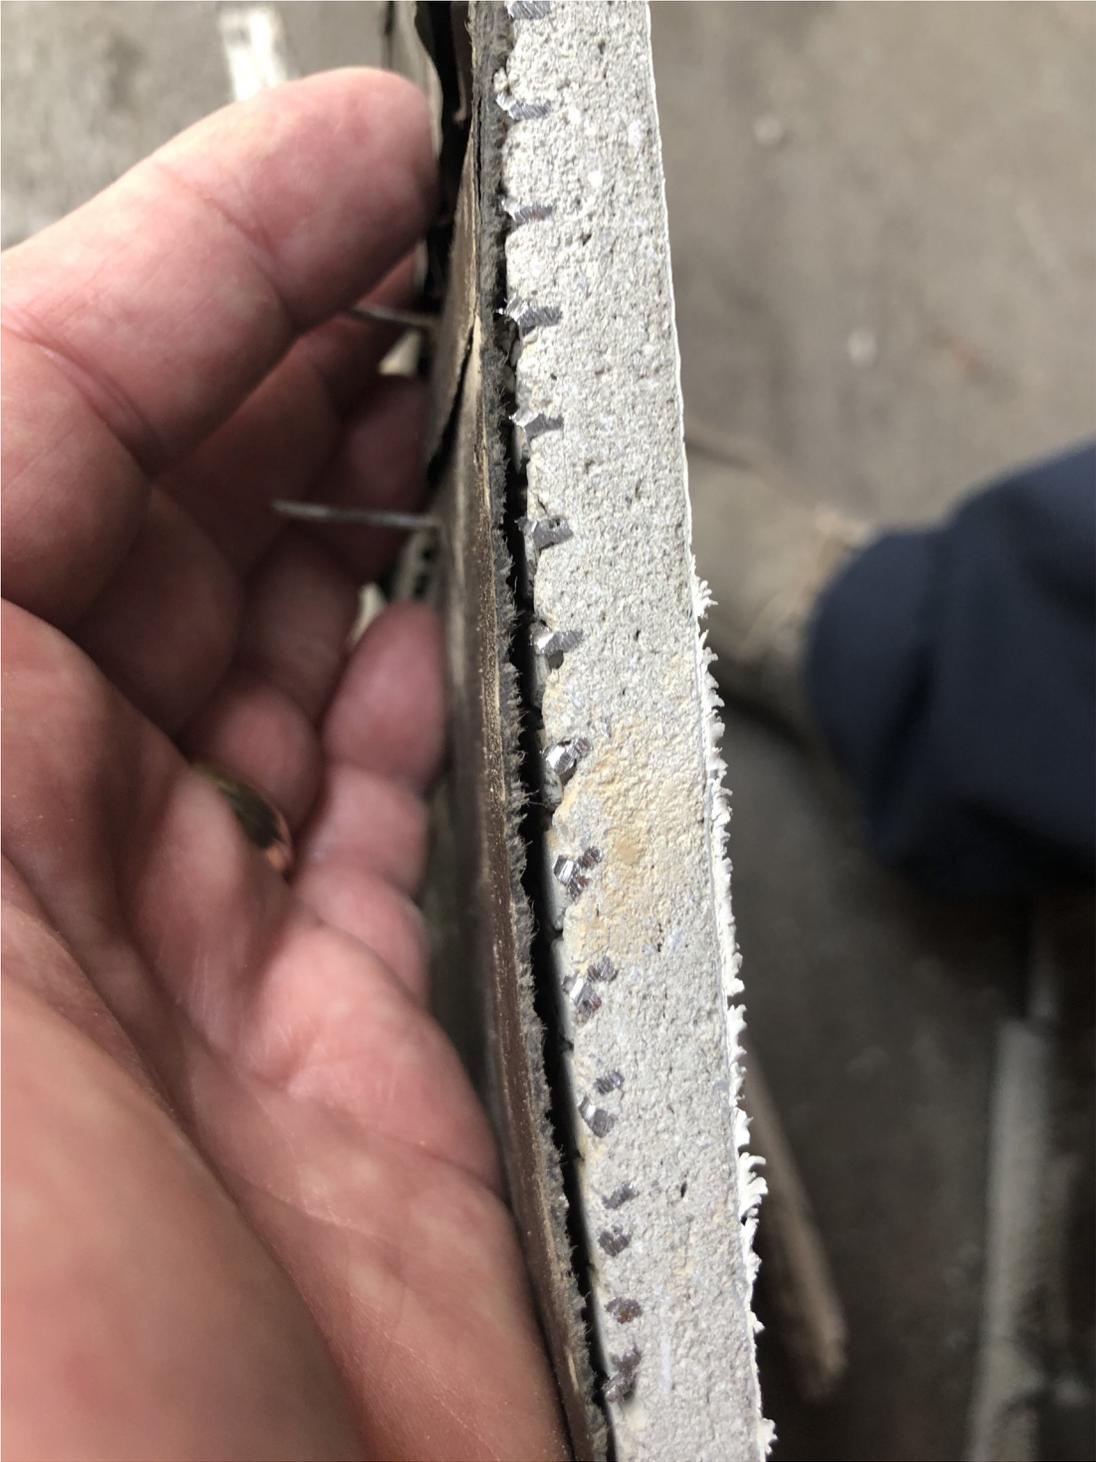
Un-Galvanized flat metal lath, no rust, no degradation, no water stains, no moisture deterioration. Just like the day it was put on 35 years ago. Stucco system had constant weather exposure to Florida’s environment (no building overhang).

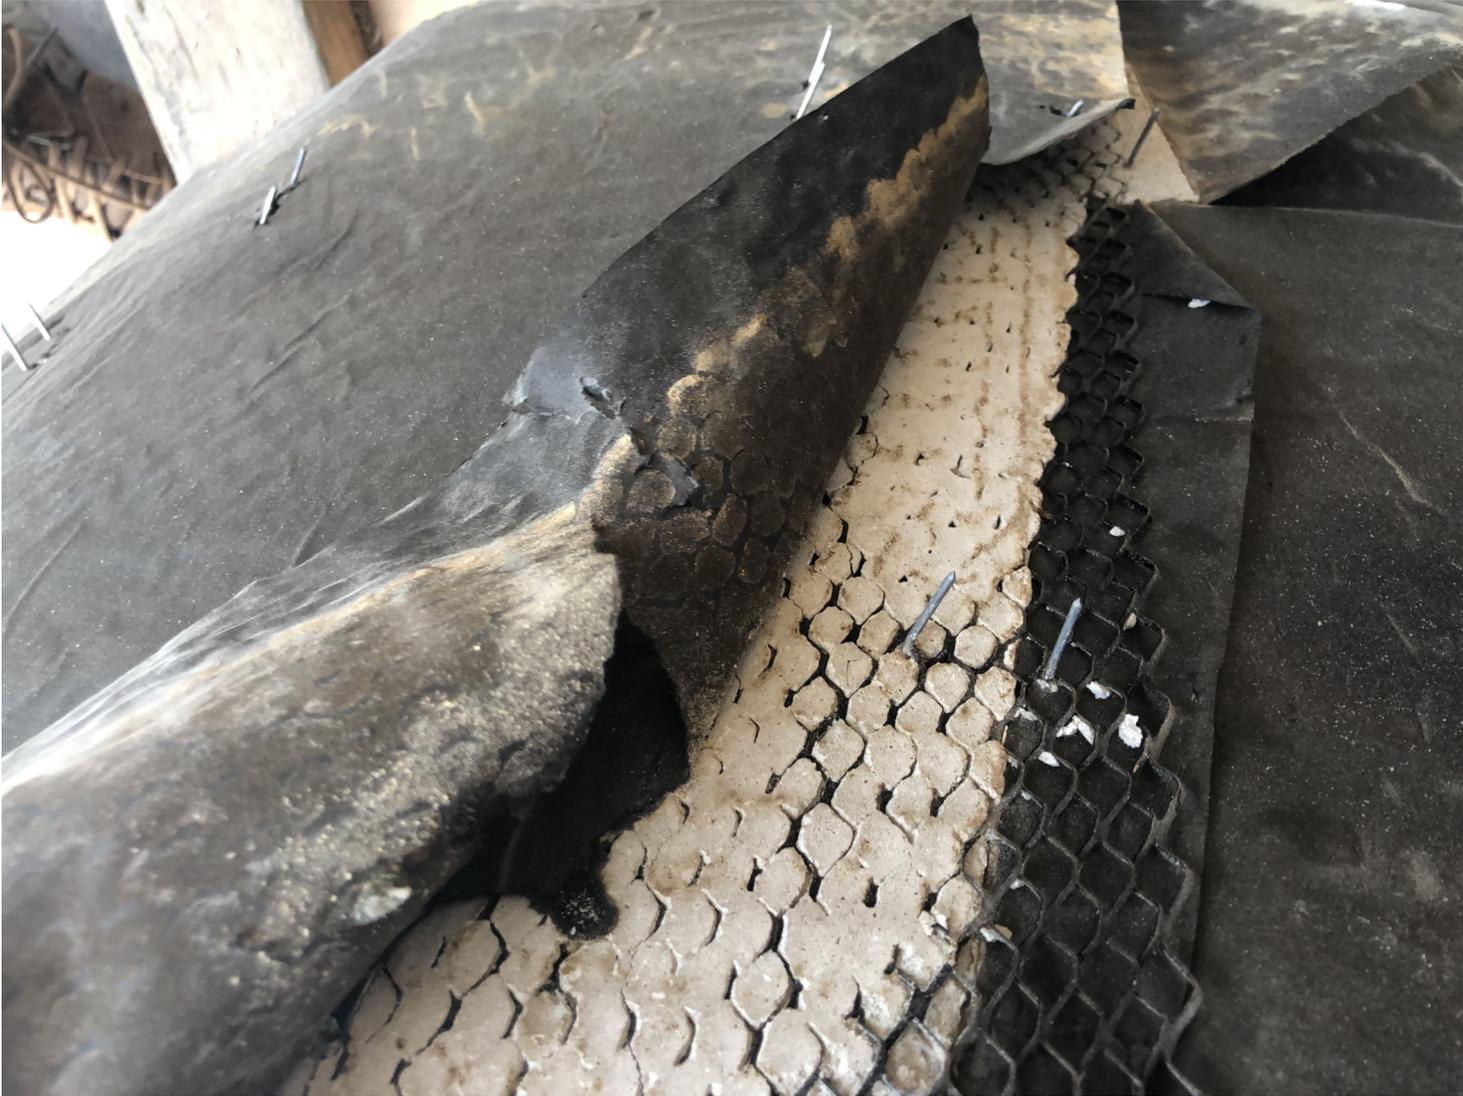
Back side of 1/2" exterior expanded flange casing stop used at bottom of stucco fascia. No weep, nor drainage accessory, 35 years exposed to the weather, looks like the day it was installed. No leaks, No faults, No flaws, No cracks, No rust.

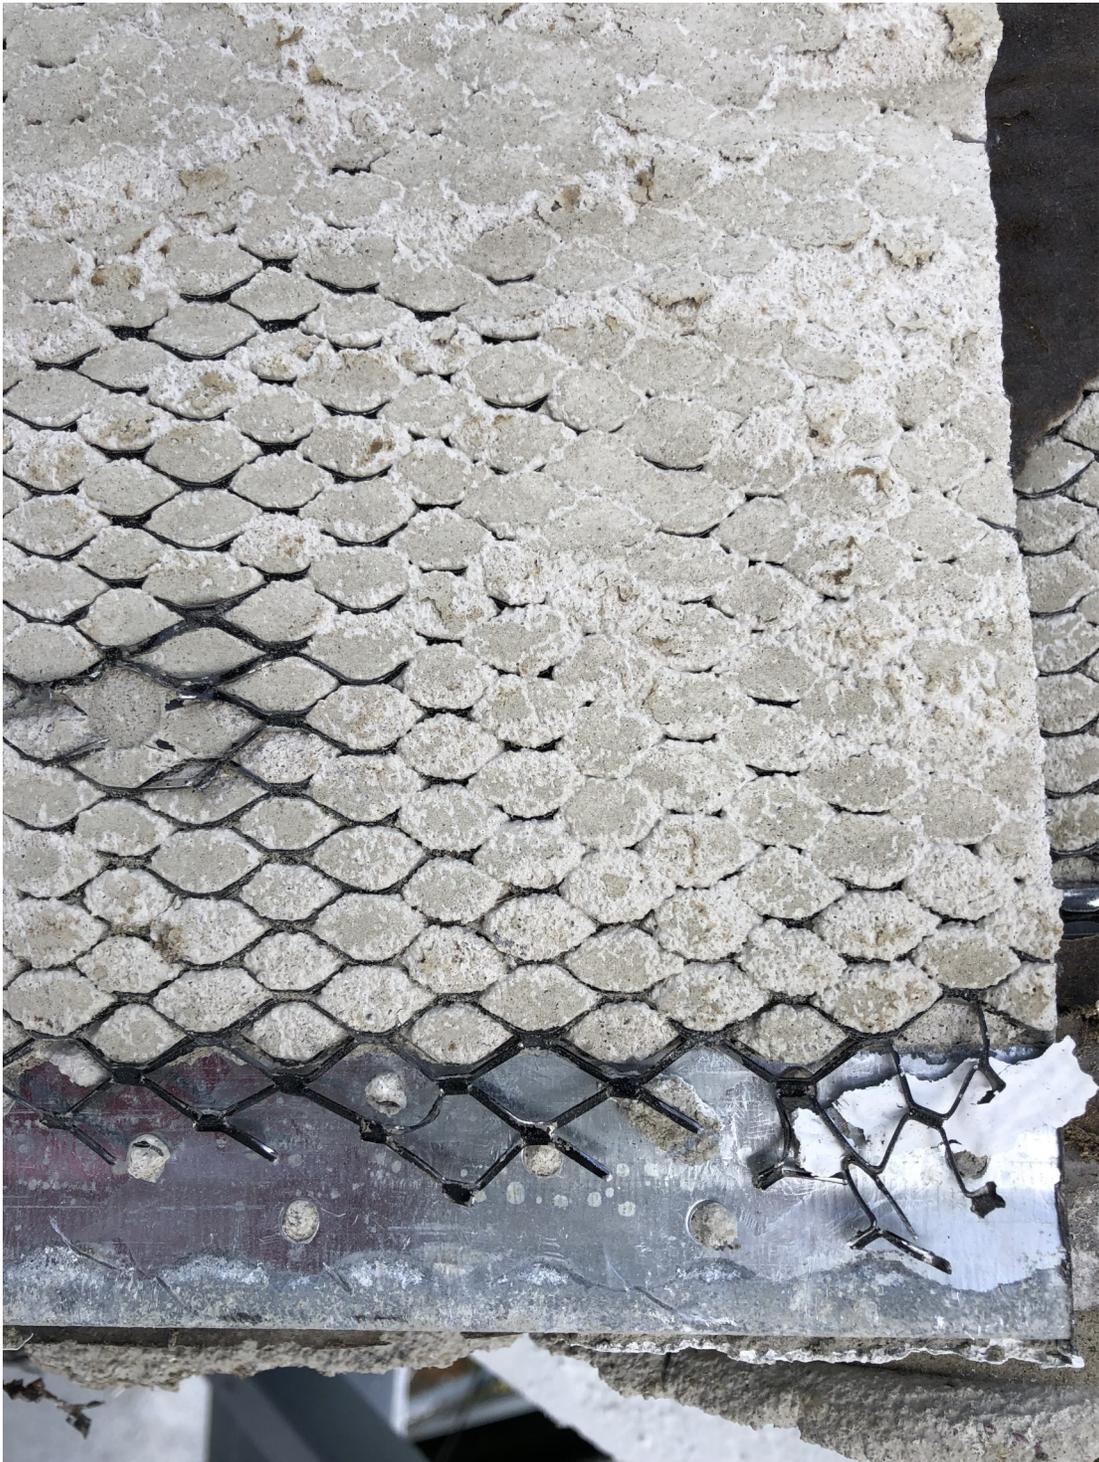
Back side of 1/2" exterior expanded flange casing stop used at bottom of stucco fascia. No weep, nor drainage, 35 years exposed to the weather, looks like the day it was installed. No leaks, No faults, No flaws, No cracks, No rust.

Note how wet plaster was pushed through flanges and exudes out of the nail holes in the casing's solid flange. Exposed lath is where it was pried off its attachment.

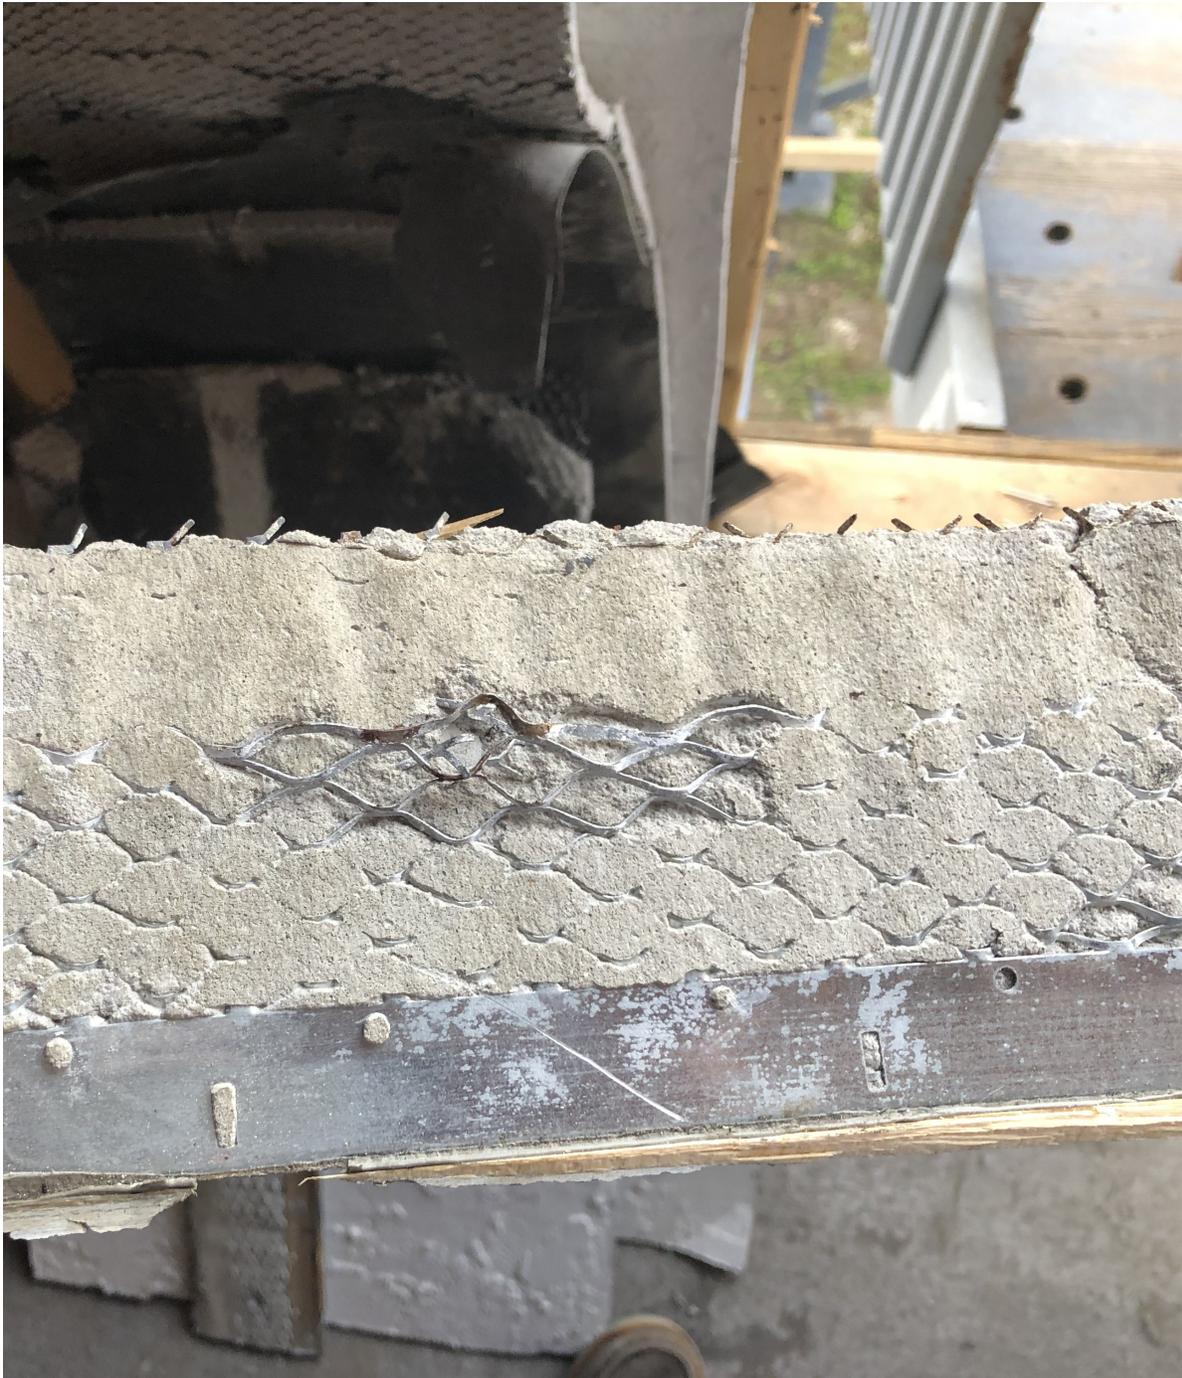
Stucco Cladding painted twice in 35 years, original paint and white re-paint. Both followed standard painting instructions and was applied with rollers to the standard 12 mil dry film thickness (DFT) required for exterior cement plaster installation. This is a "Face Sealed System" *a/k/a* Face Barrier System as defined in ASTM, Architectural and other design documents.

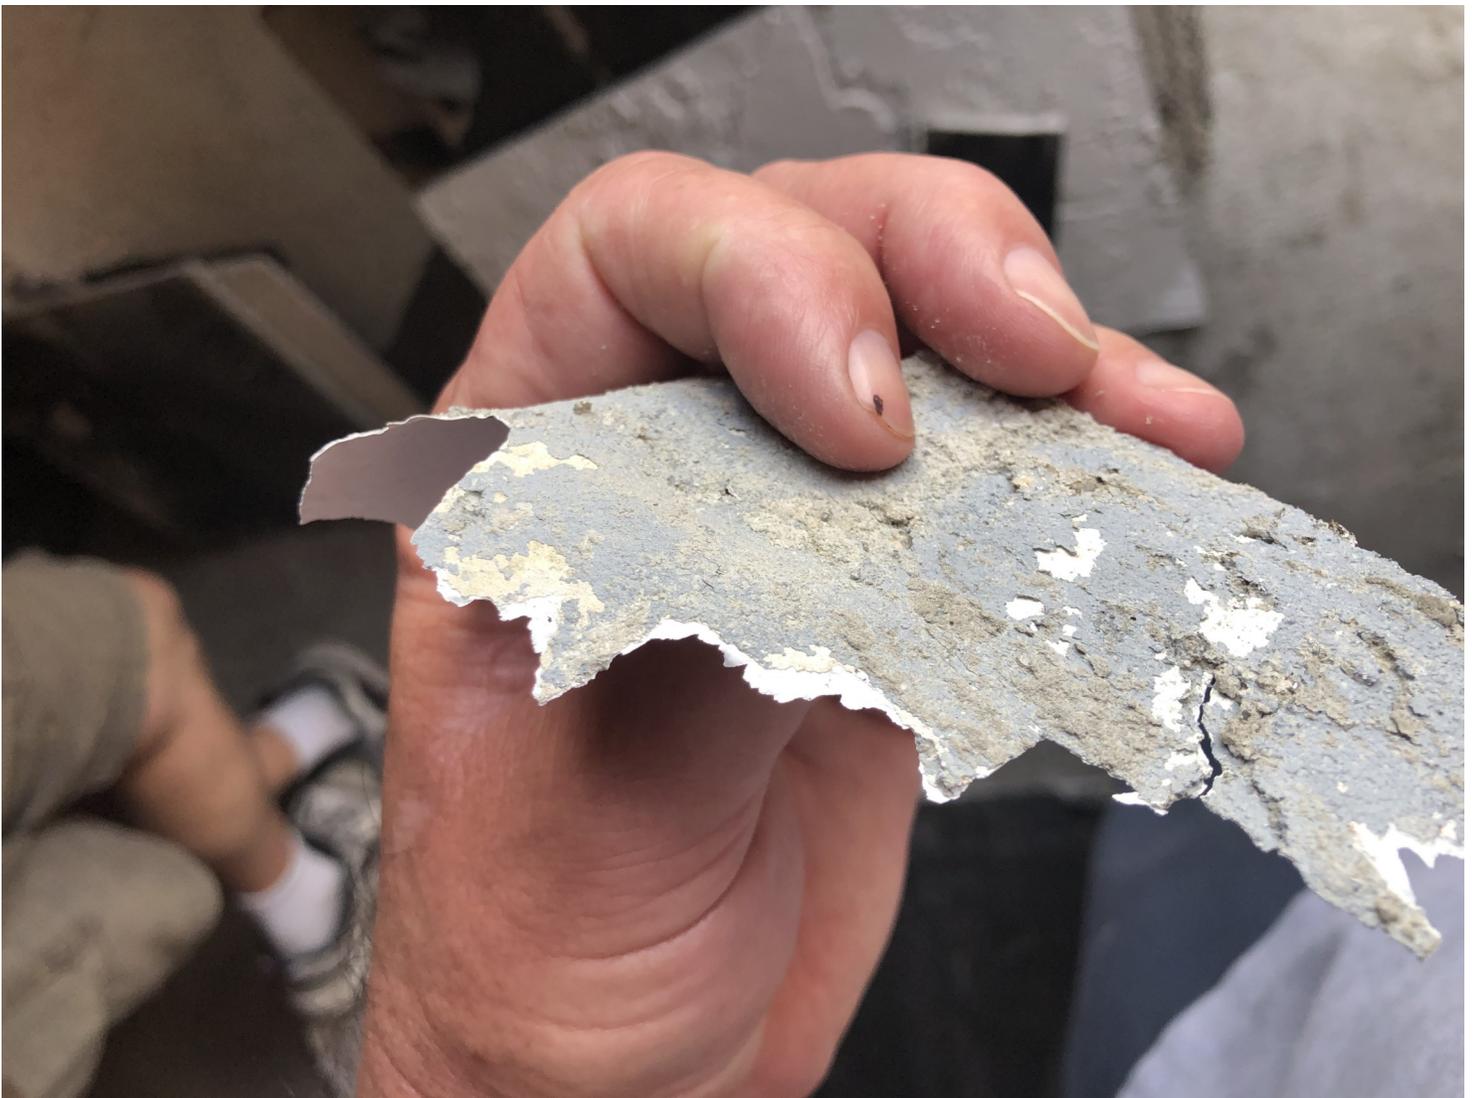
Stucco Cladding painted twice in 35 years, original paint and white re-paint. Both followed standard painting instructions and was applied with rollers to the standard 12 mil thickness required by the manufacturer. This is a "Face Sealed System" *a/k/a* Face Barrier System as defined in ASTM, Architectural and other design documents.

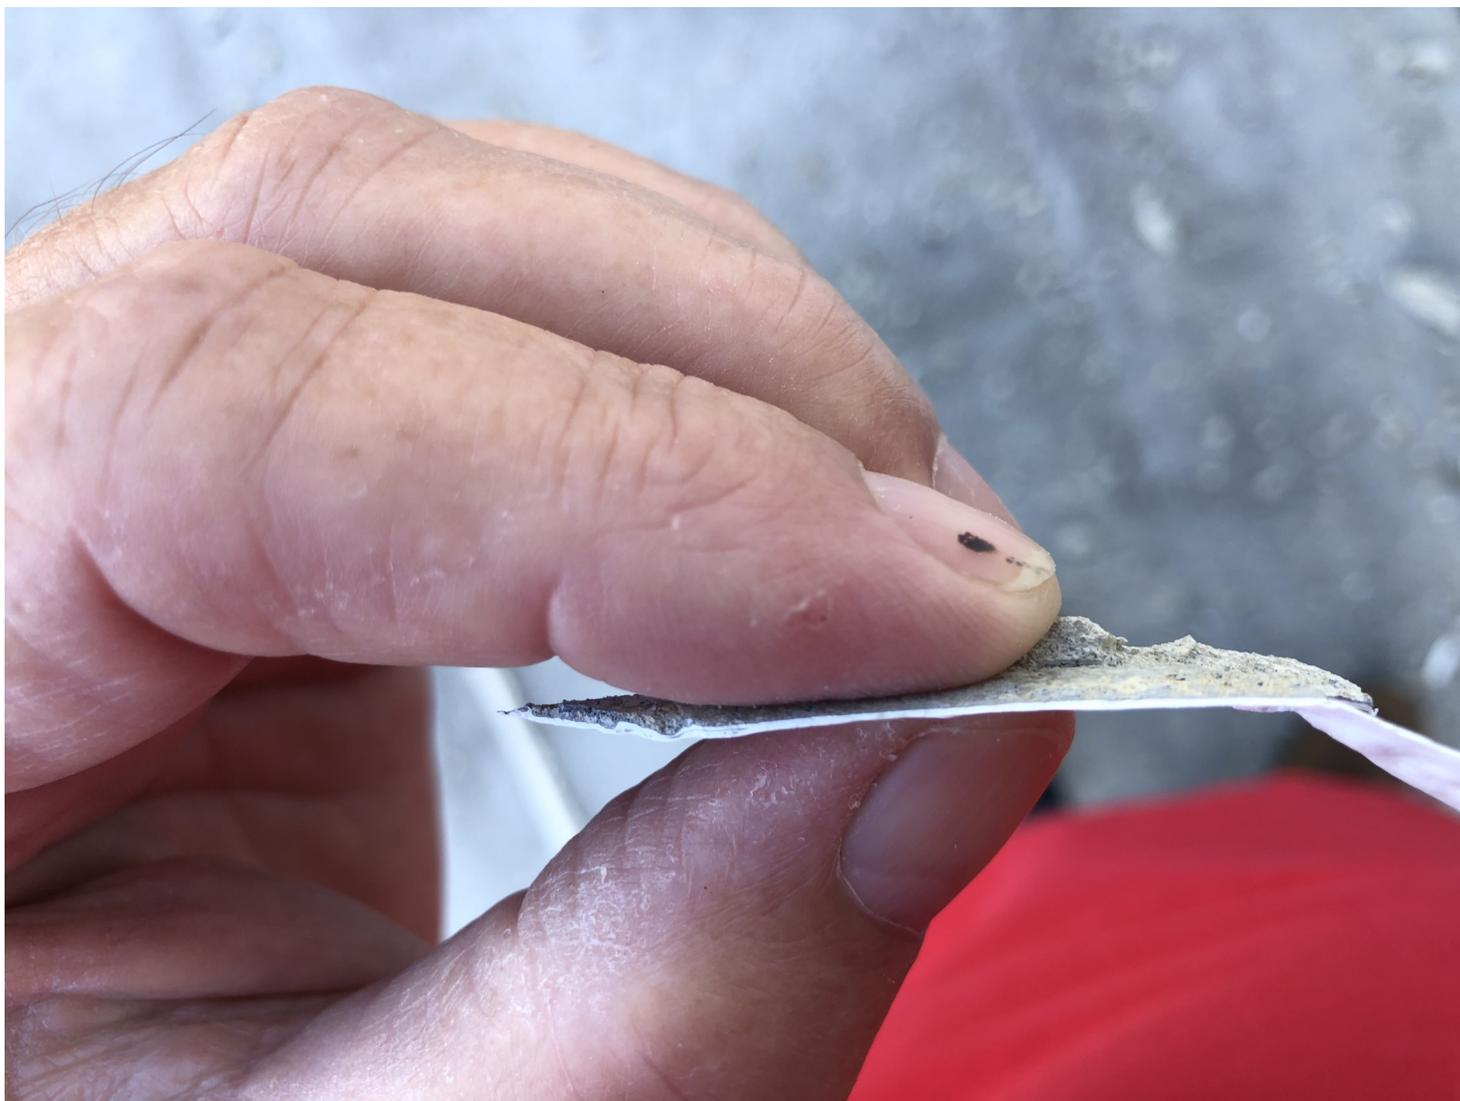
Back side of metal lath on the wall - Un-Galvanized metal lath, no rust, no degradation, no water stains, no moisture deterioration. Just like the day it was put on 35 years ago. Constant weather exposure in Florida's environment. Lap paper over metal. Still no Cracks, No faults, No flaws. Note staple attachment.

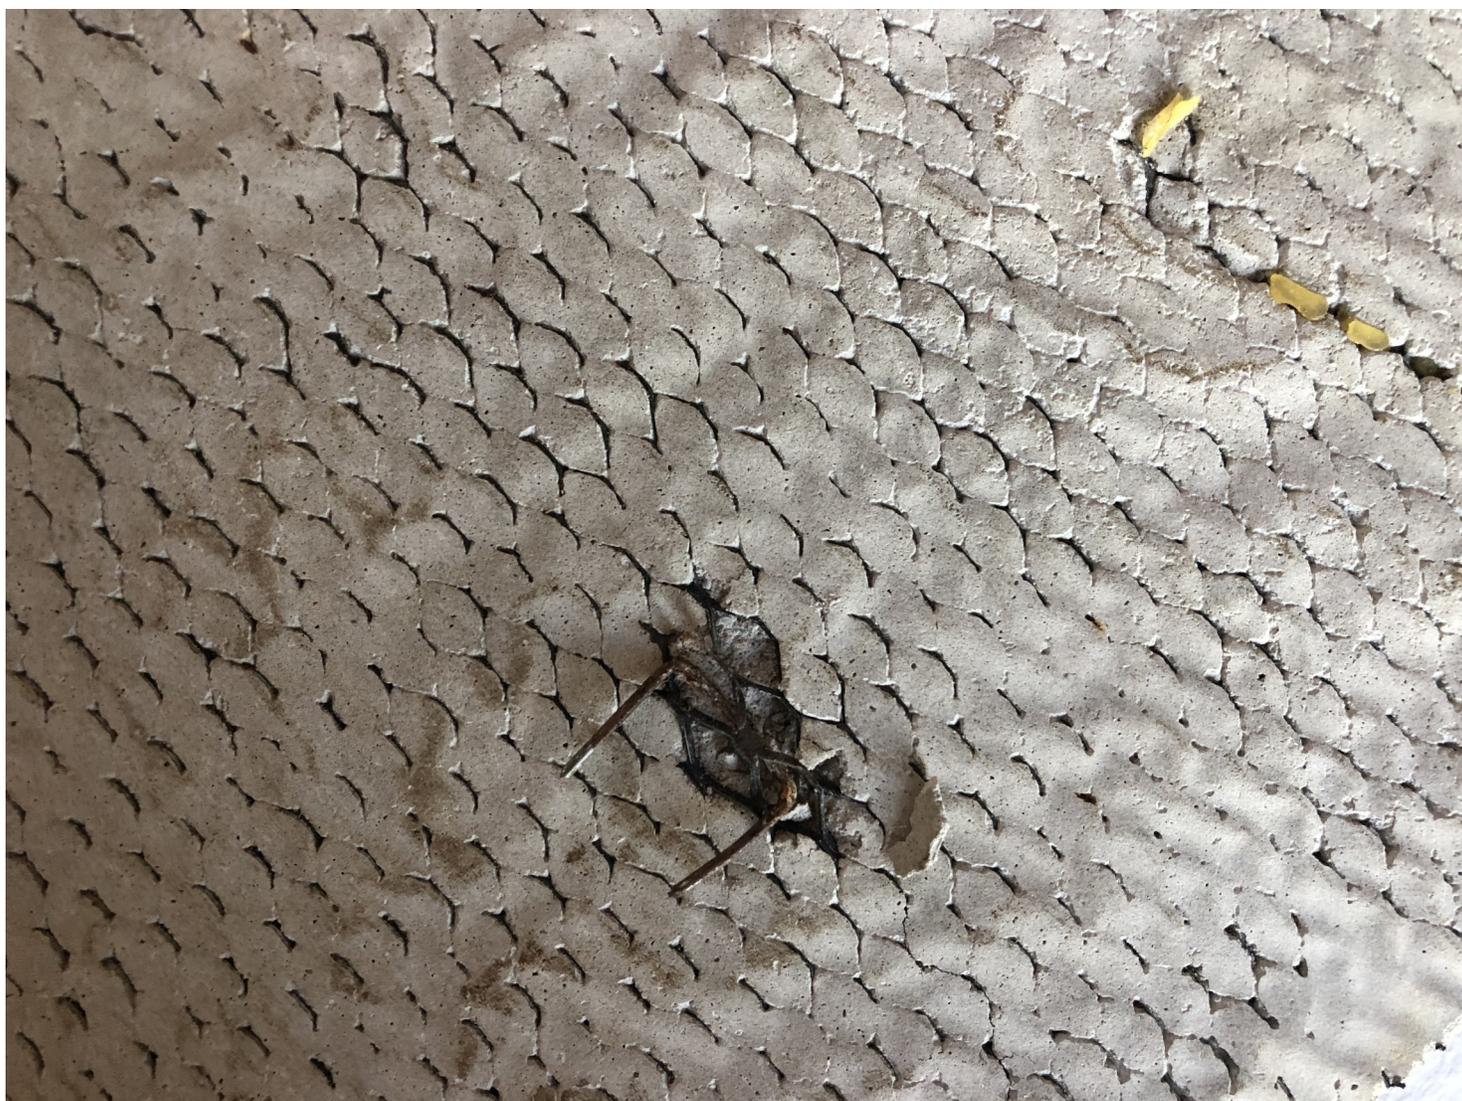
Paper over lath & back lap - No cracks, No leaks and No faults.

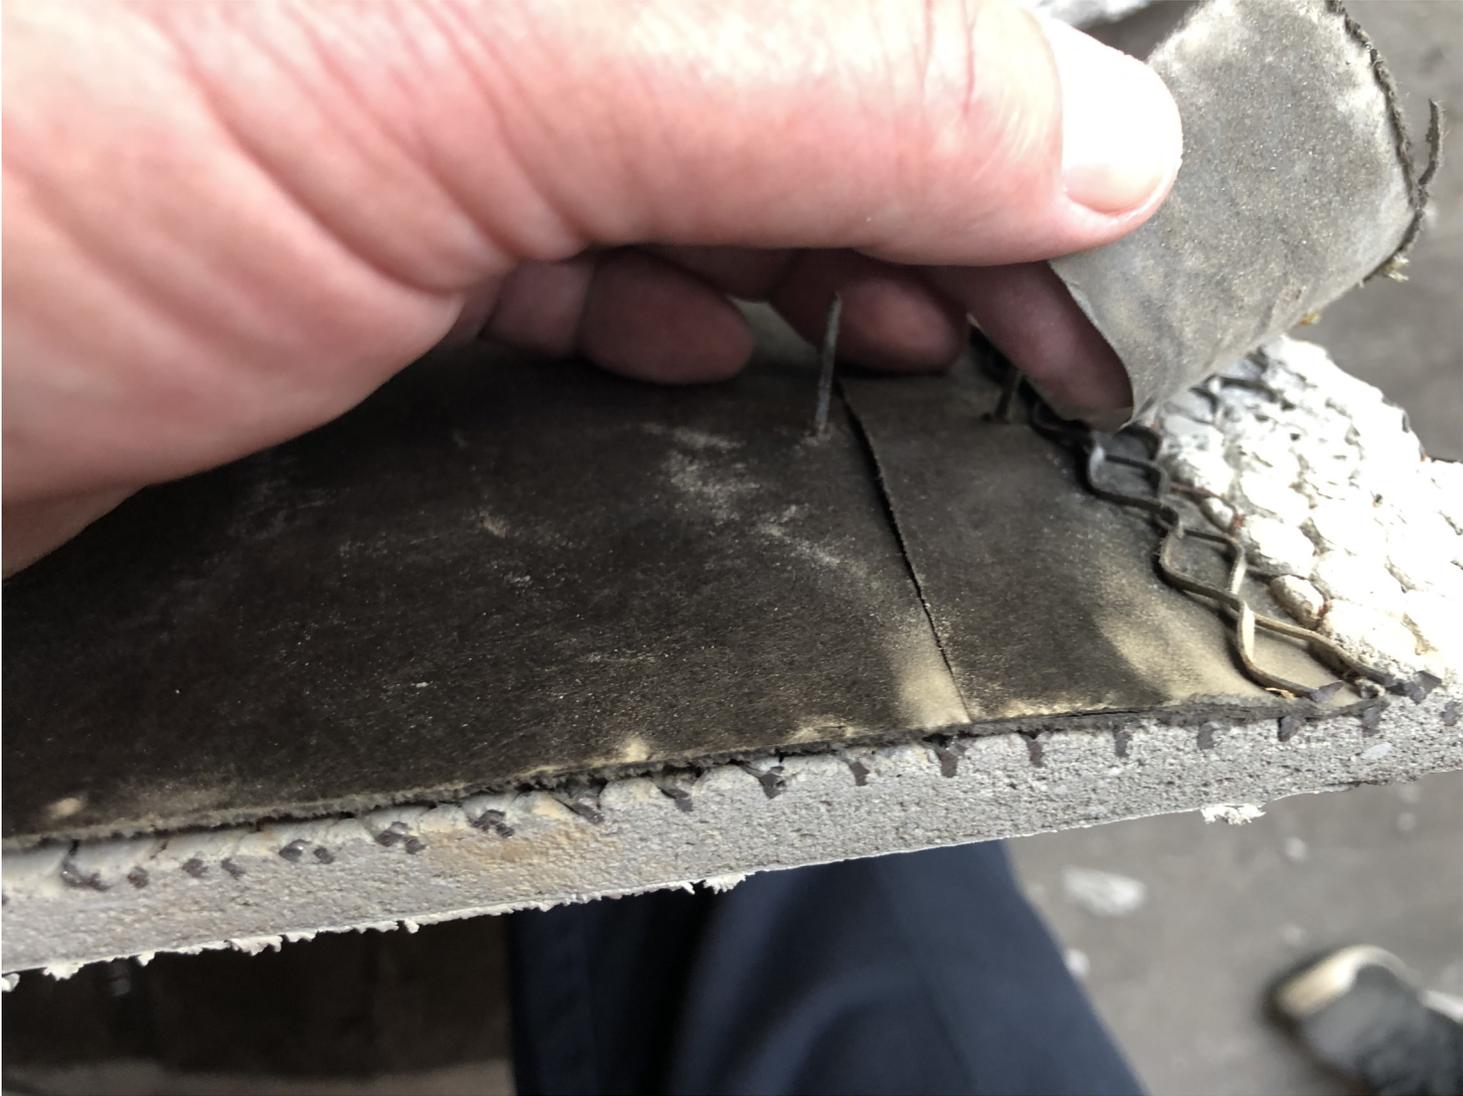
Un-Galvanized metal lath, no rust, no degradation, no water stains, no moisture deterioration. Just like the day it was put on 35 years ago. Constant weather exposure in Florida's environment. Lap is paper over metal. Still no Cracks, No faults, No flaws. Note: Cracks seen in section samples underneath in rubbish pile were broken during removal. This installation methodology does not depend upon a drainage plane - it prevents water from entering at it face thereby protecting the system integrity.

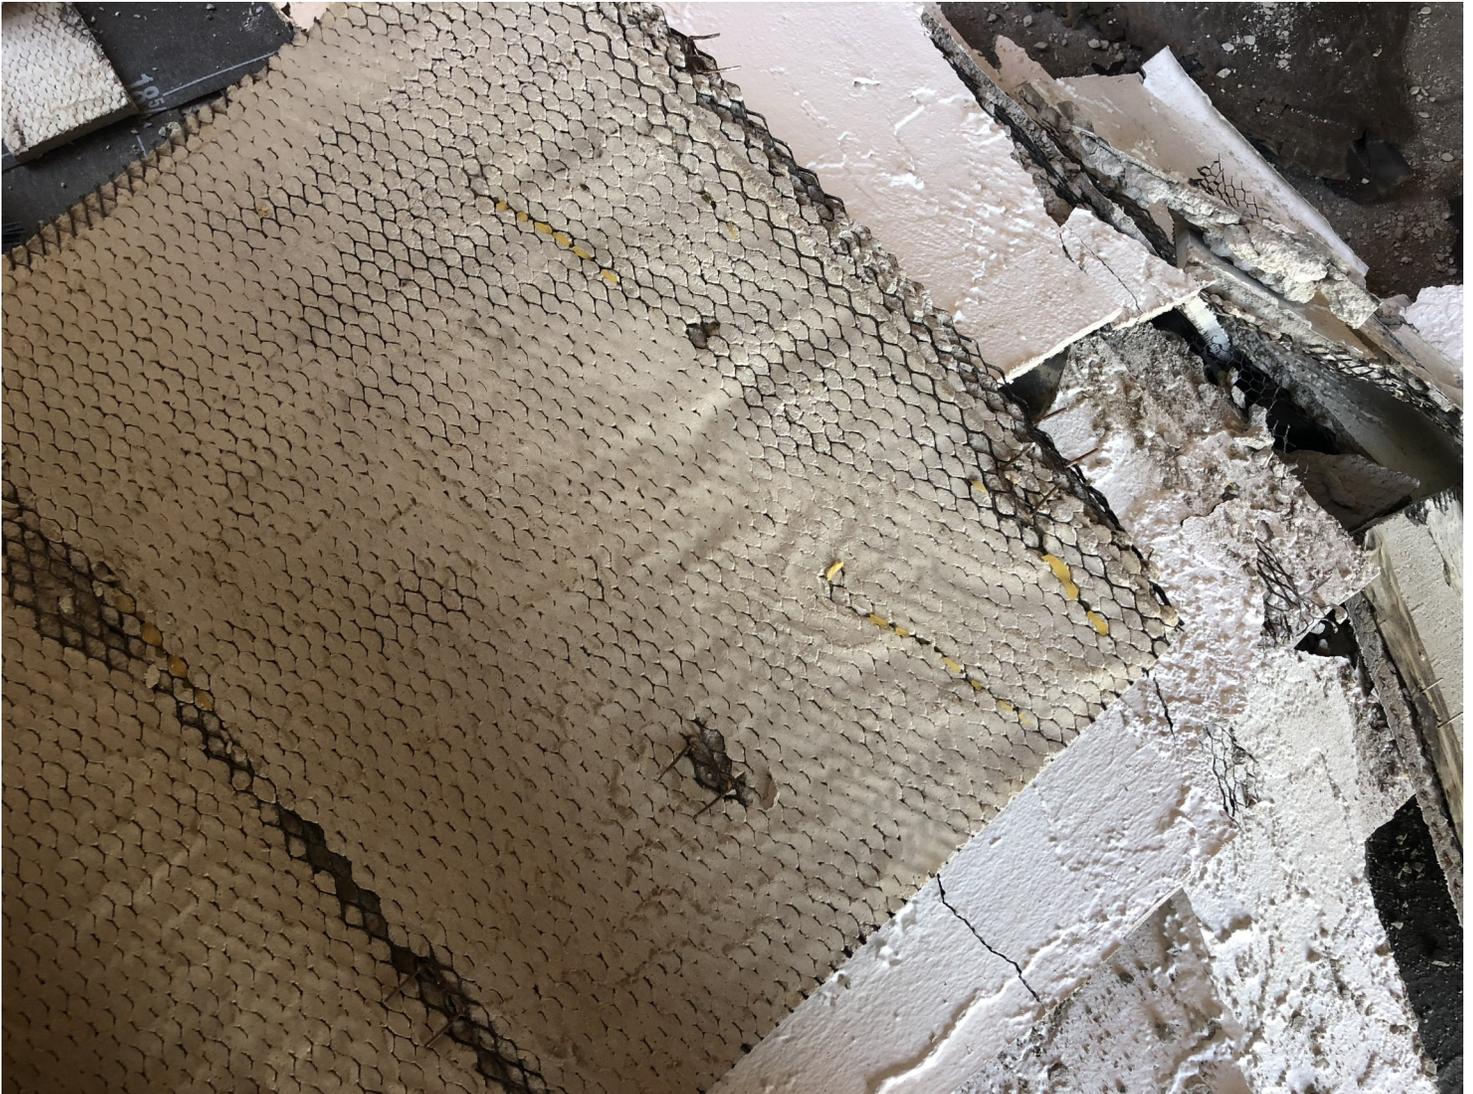
Un-Galvanized metal lath, no rust, no degradation, no water stains, no moisture deterioration. Just like the day it was put on 35 years ago. Constant weather exposure in Florida's environment. Lap paper over metal. Still no Cracks, No faults, No flaws. Photo from back side of removed panel. This installation methodology does not depend upon a drainage plane - it prevents water from entering at it face thereby protecting the system integrity.

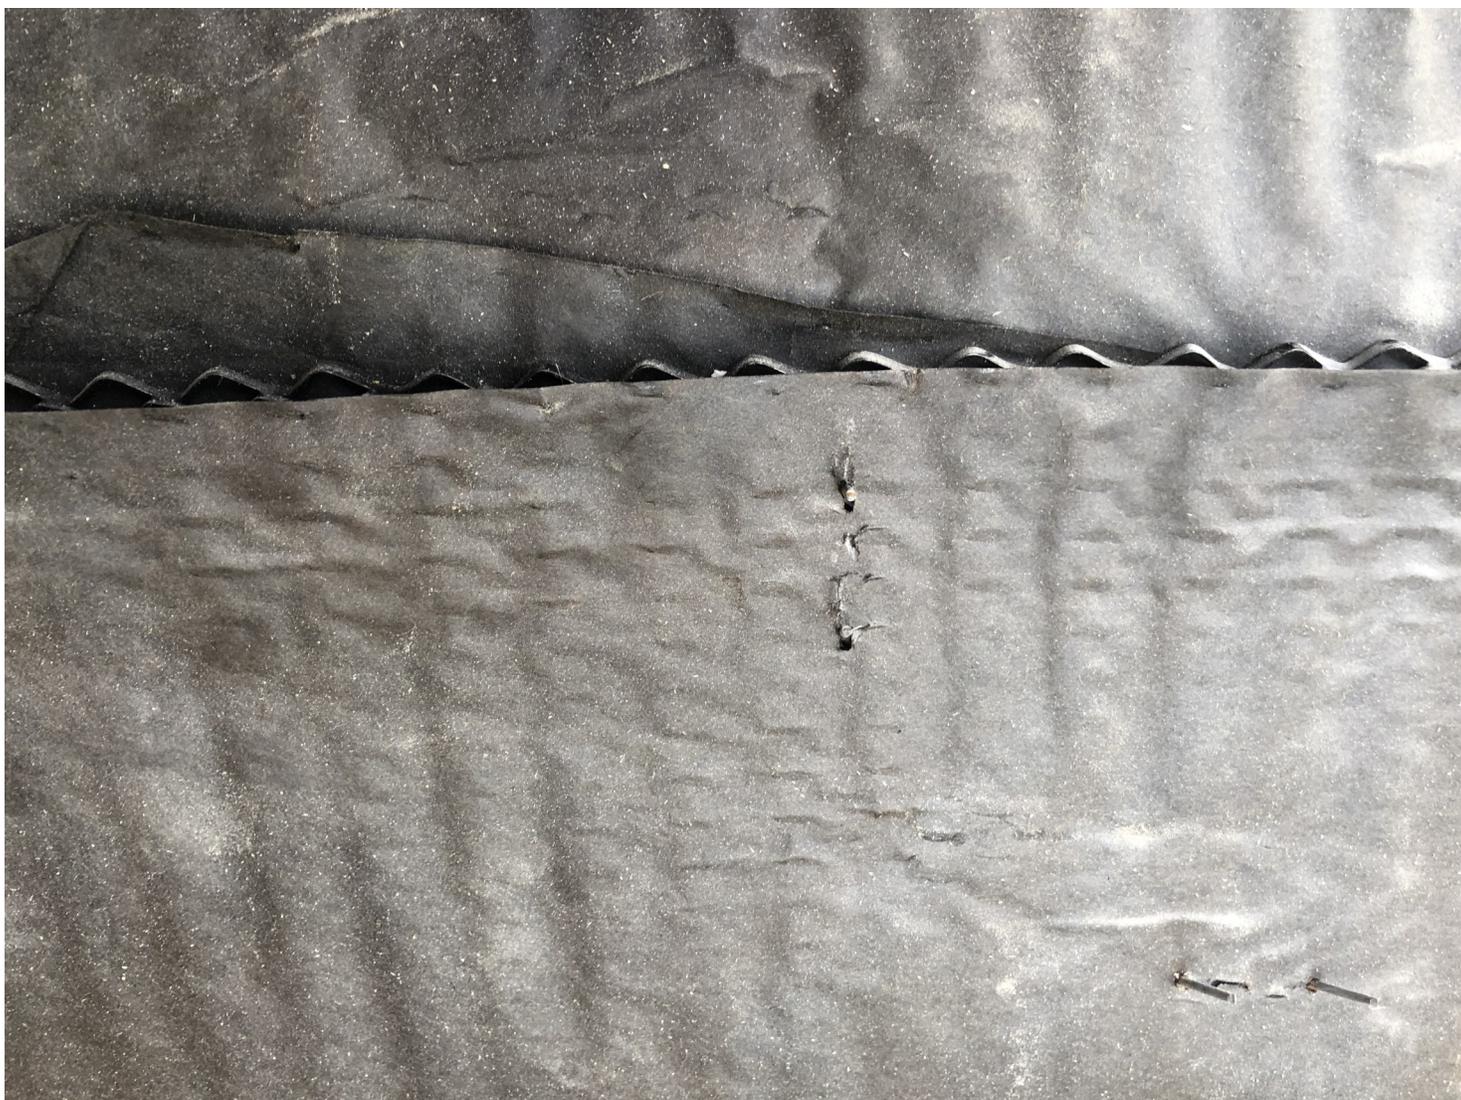
Un-Galvanized metal lath, no rust, no degradation, no water stains, no moisture deterioration. Just like the day it was put on 35 years ago. Constant weather exposure in Florida's environment. Note paper over lath - No cracks, No faults, No flaws.

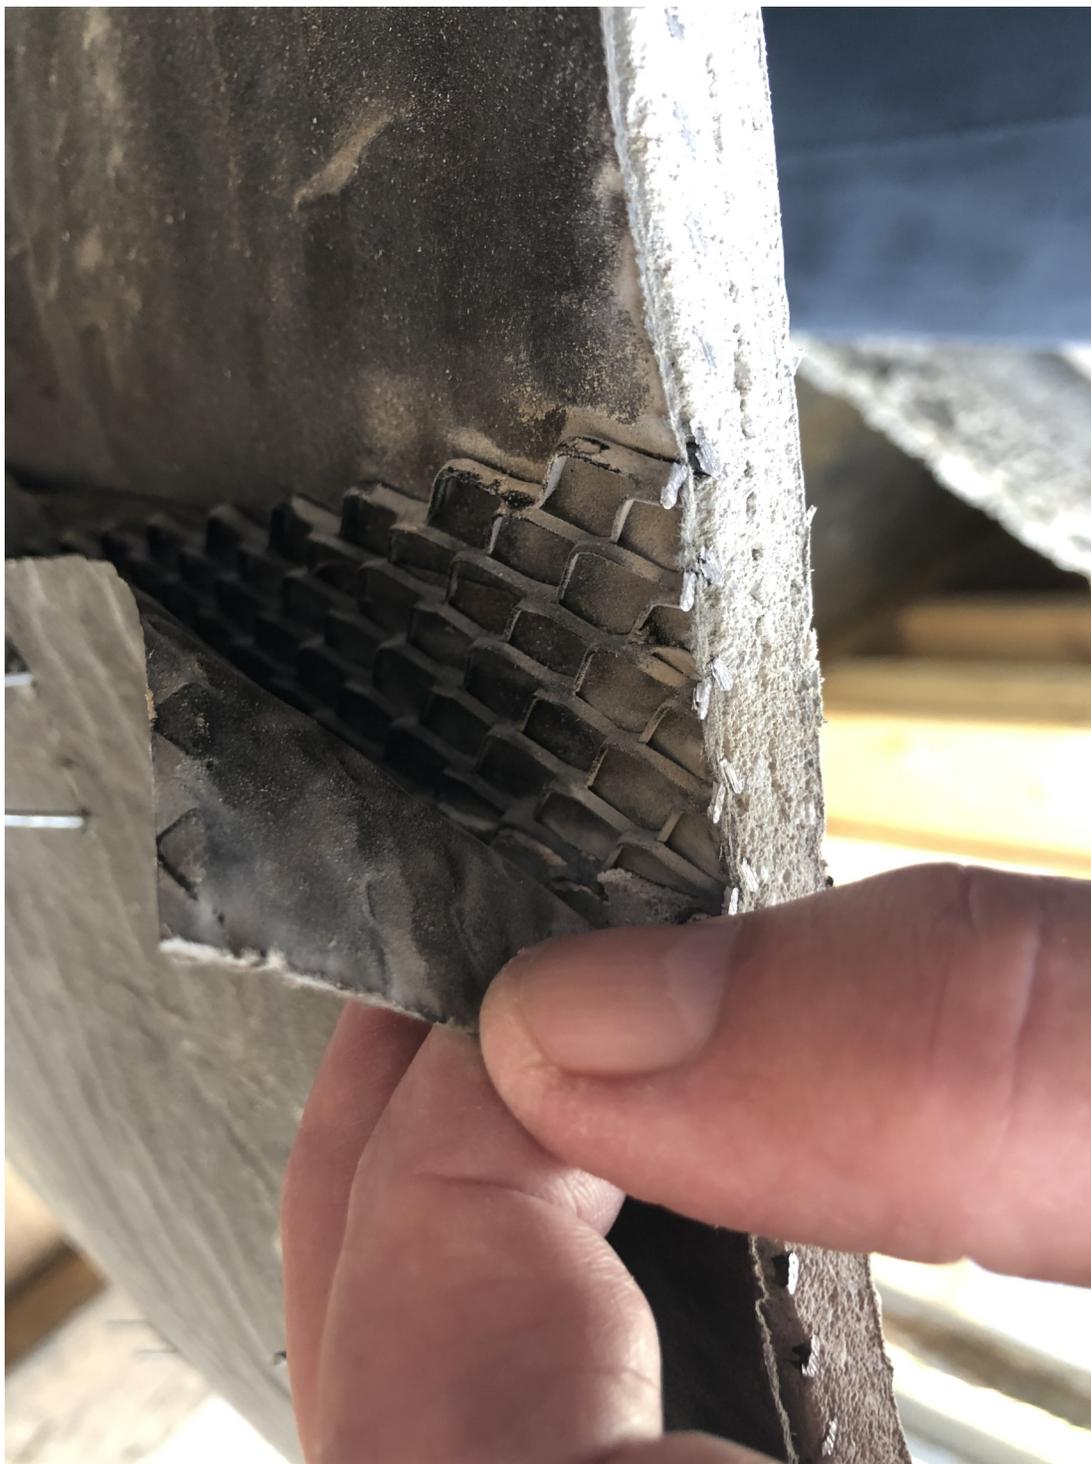
No Weep Screed—Lath brought over block and stub-nailed (at arrow) - Then stucco applied in one continual plane. Un-Galvanized metal lath, no rust, no degradation, no water stains, no moisture deterioration. Just like the day it was put on 35 years ago. Constant weather exposure in Florida’s environment. No wood degradation whatsoever. Note: Visible crack below lath was induced from prybar when dislodging the lath from the stub nail for documentation.

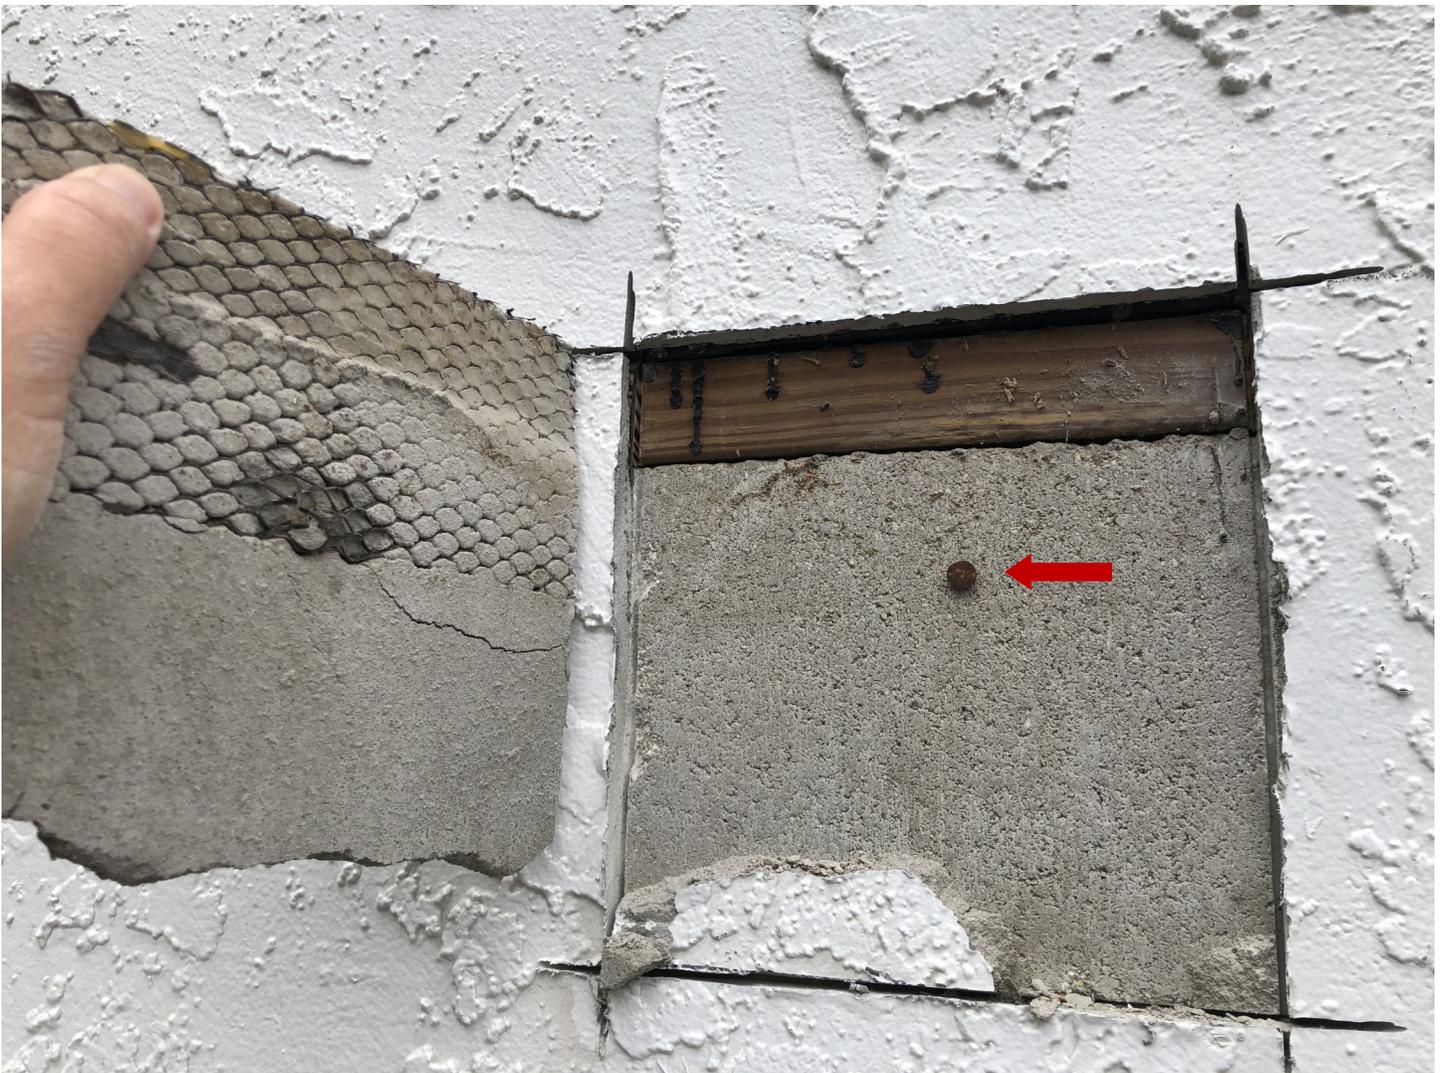
35 year old frame to block wall transition. Un-Galvanized metal lath, no weep, no rust, no degradation, no water stains, no moisture deterioration. Just like the day it was put on 35 years ago. Constant weather exposure in Florida's environment. Lap paper over metal. Still no Cracks, No faults, No flaws, and No weed screed.

Note: Visible crack below lath was induced from prybar when dislodging the lath from the stub nail for documentation.

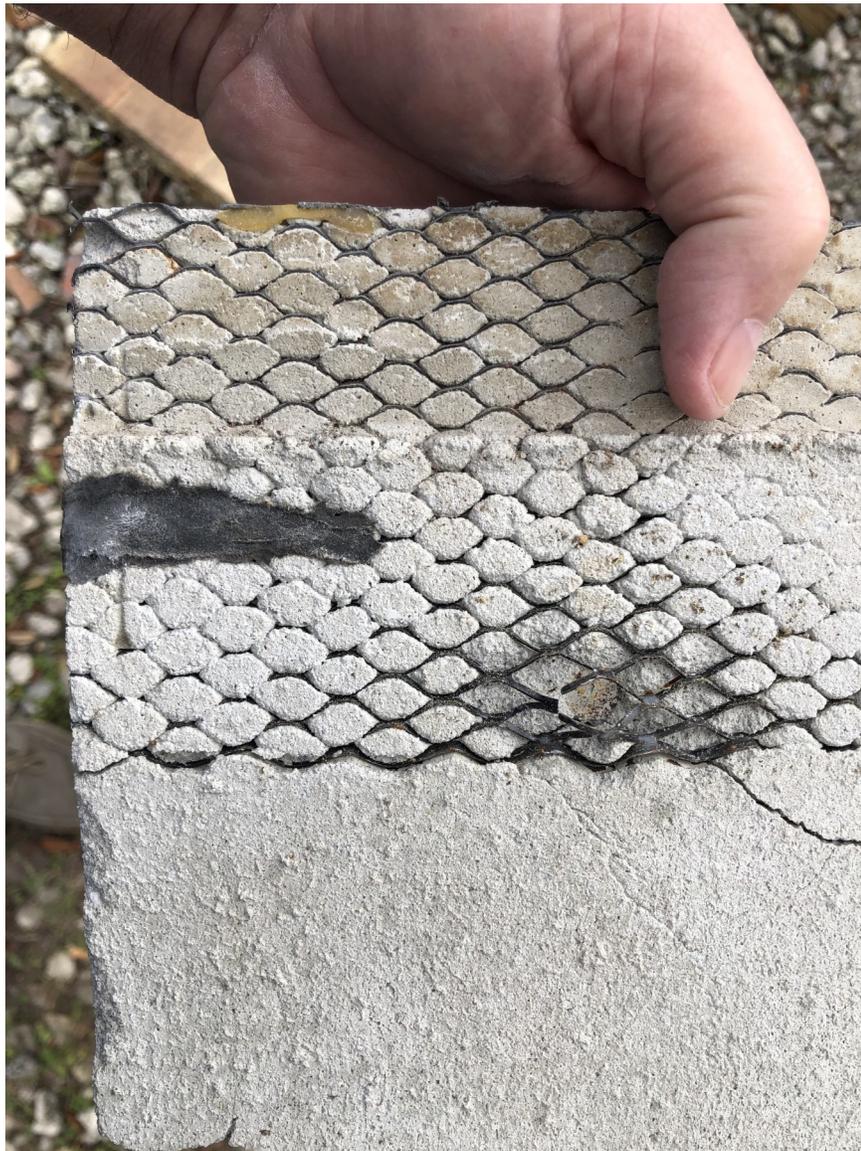
No Weep Screed—Lath brought over block and stub-nailed. Un-Galvanized metal lath, no rust, no degradation, no water stains, no moisture deterioration. Just like the day it was put on 35 years ago. Constant weather exposure in Florida’s environment. No wood degradation whatsoever on sheathing.

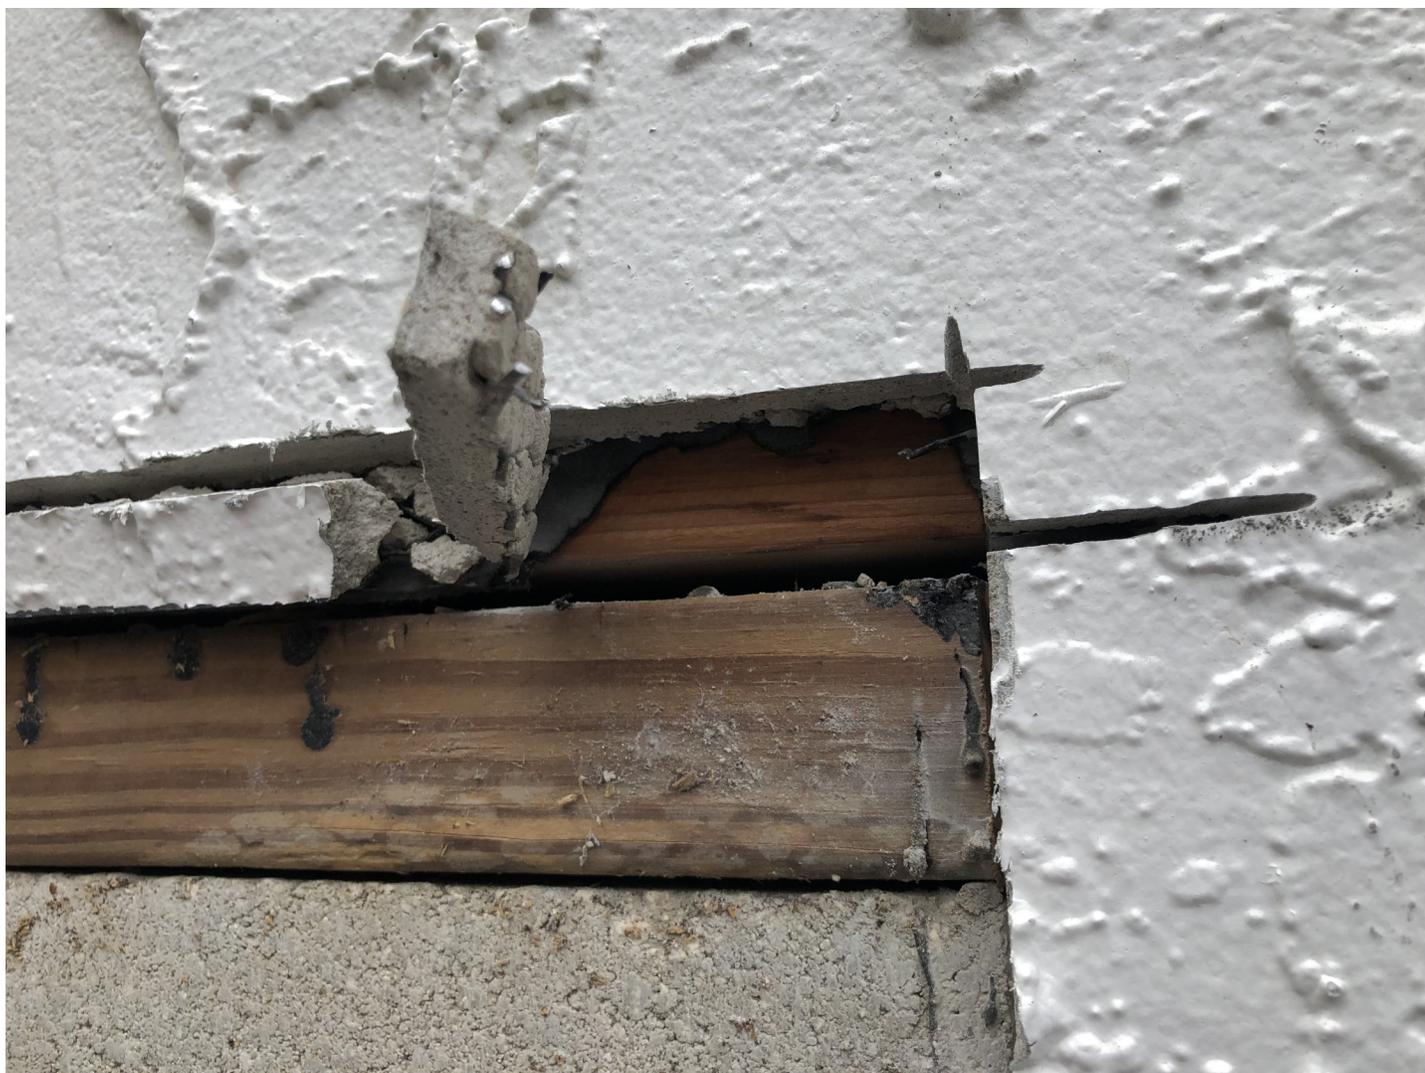
Stucco Cladding 1/2" Nominal Thickness - applied using South Florida Building Code requirement or using the ASTM "unless specified otherwise" provision. No cracks anywhere. Fully code compliant with the Florida and South Florida Stucco Code provisions.
