CONTRACTORS INSTITUTE

The Truth about Florida Stucco and Stucco Litigation
The Role of the Designer, Builder, Inspector and Owner

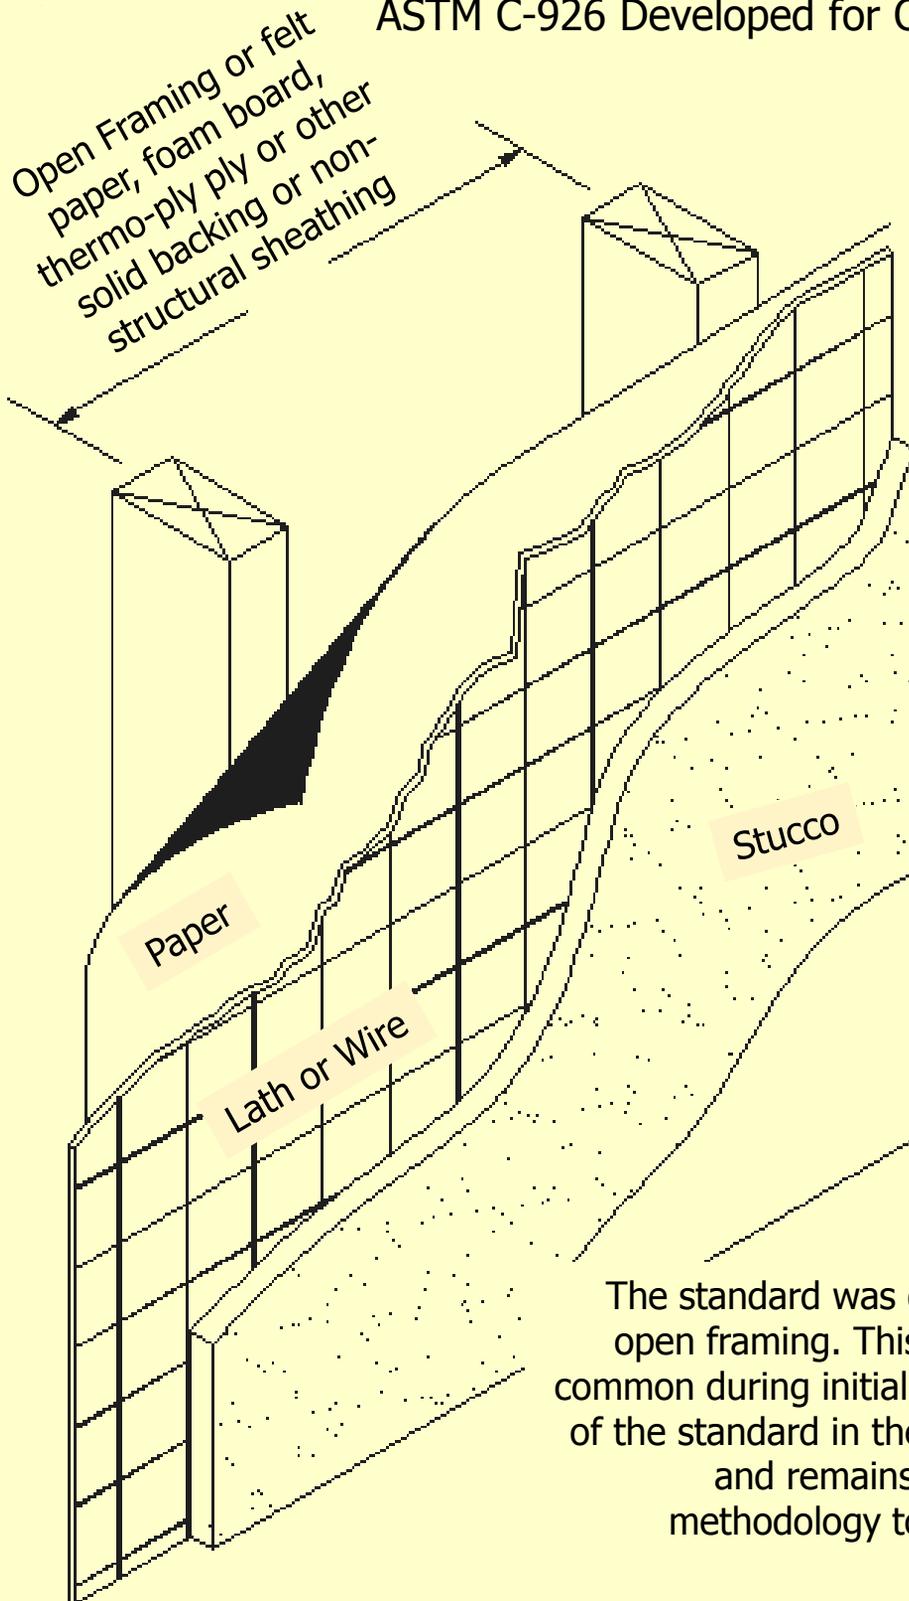
ASTM C-926 Developed for Open Framing

The standard was developed for open framing. This method was common during initial development of the standard in the early 1970's and remains the common methodology today for most regions.

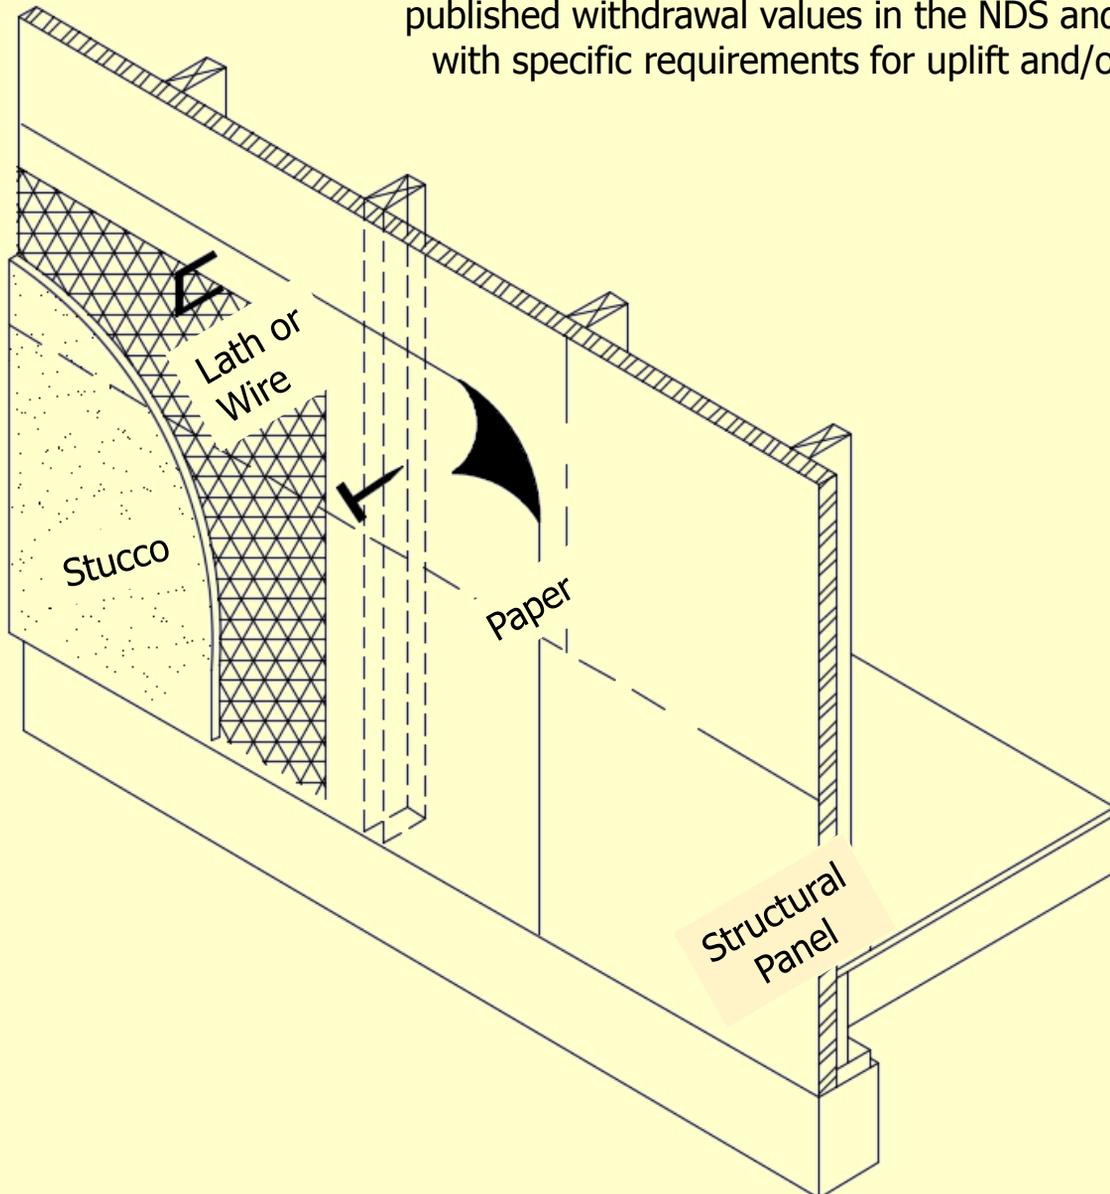
No Provisional Modification for Structural Framing

Structural Framing - Structural Sheathing forming a structural wall covering. Sheathing has published withdrawal values in the NDS and nailed with specific requirements for uplift and/or shear

The ASTM C-926 standard was NOT developed for structural framing - this concept developed as a regional practice long after the development of the ASTM C-926 standard. This regionally mandated protocol was the result from implementation of more modern wind loading provisions in hurricane prone regions such as Florida Coastlines.

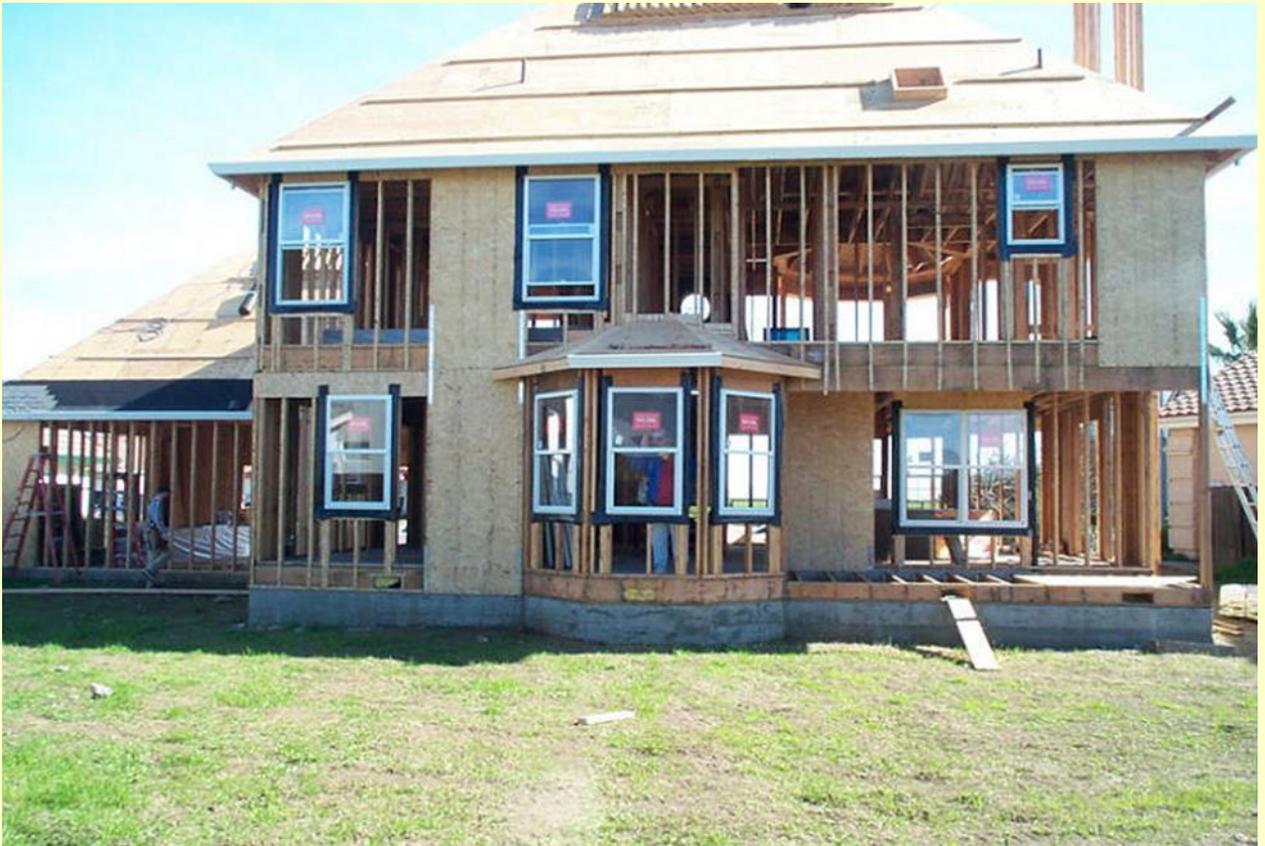
Open Framing – Ready for Lath and Stucco

This house represents by far the most common national methodology; open framing. Note that all shear requirements are fulfilled with shear wall segments. The studs may have felt, foam insulation, Thermo-Ply or similar non structural solid backing or sheathing. The ASTM has a provision that requires the lath fasteners to be in the vertical studs; no kidding, as opposed to what? Placement in between the studs where nothing structural is located to nail into? Also, this will explain why the lath needs to be tied in-between the supports and the end laps need to be laced with wire – its because there is nothing structural between the studs!

Also note that the standard provides for a complete stucco finish – no painting or coating necessary. Use gray or white Portland cement and cement dyes to obtain any color you wish, no painting necessary – you can paint if you want, but its purpose can be decorative (color coat) only since it is not required by the standard's methodology.

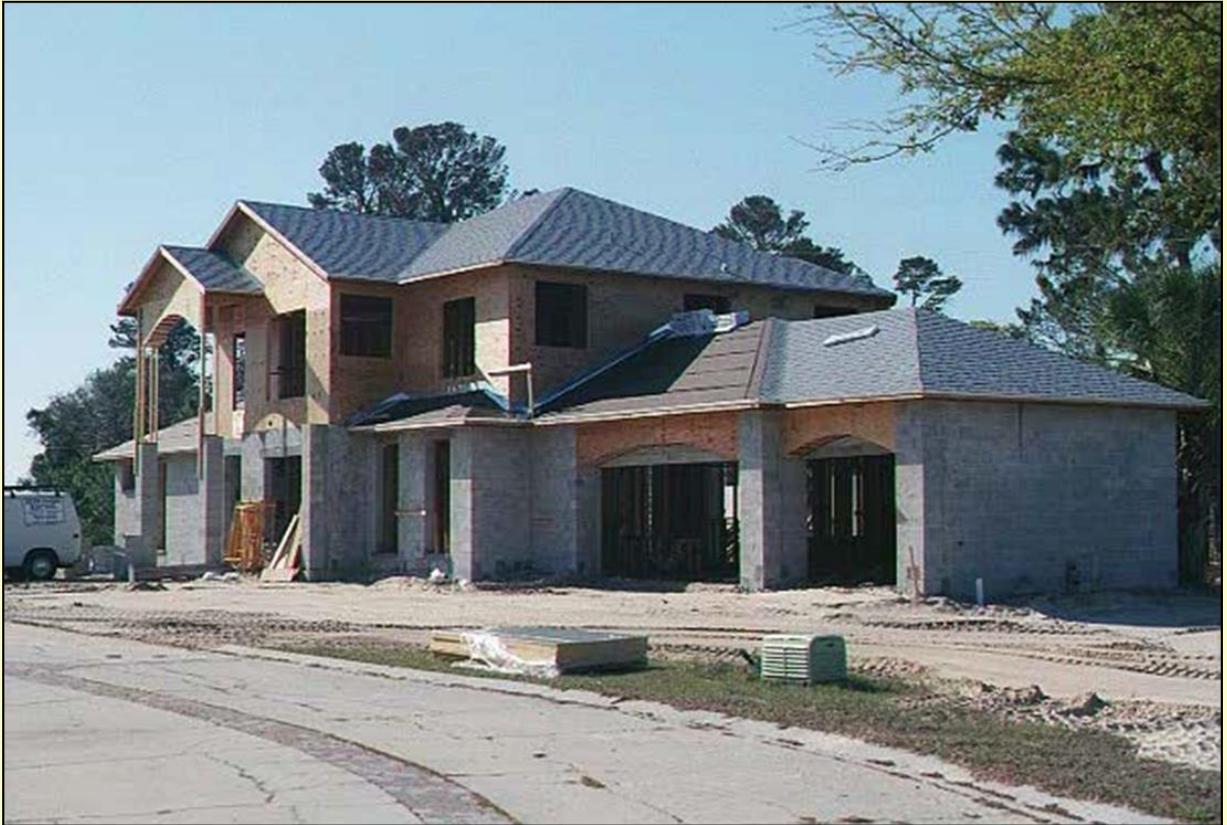
This house represents by far the most common Florida methodology; Structural Framing. Note that all walls are fully sheathed with structural panels. It is important to note that if the home was waterproofed by an application of coating, the house would be ready for its certificate of occupancy (regarding exterior wall coverings). All code elements of shear, fire and wall covering would have been met – the walls would just need the waterproofing by way of a waterproof **coating** or waterproof **cladding**.

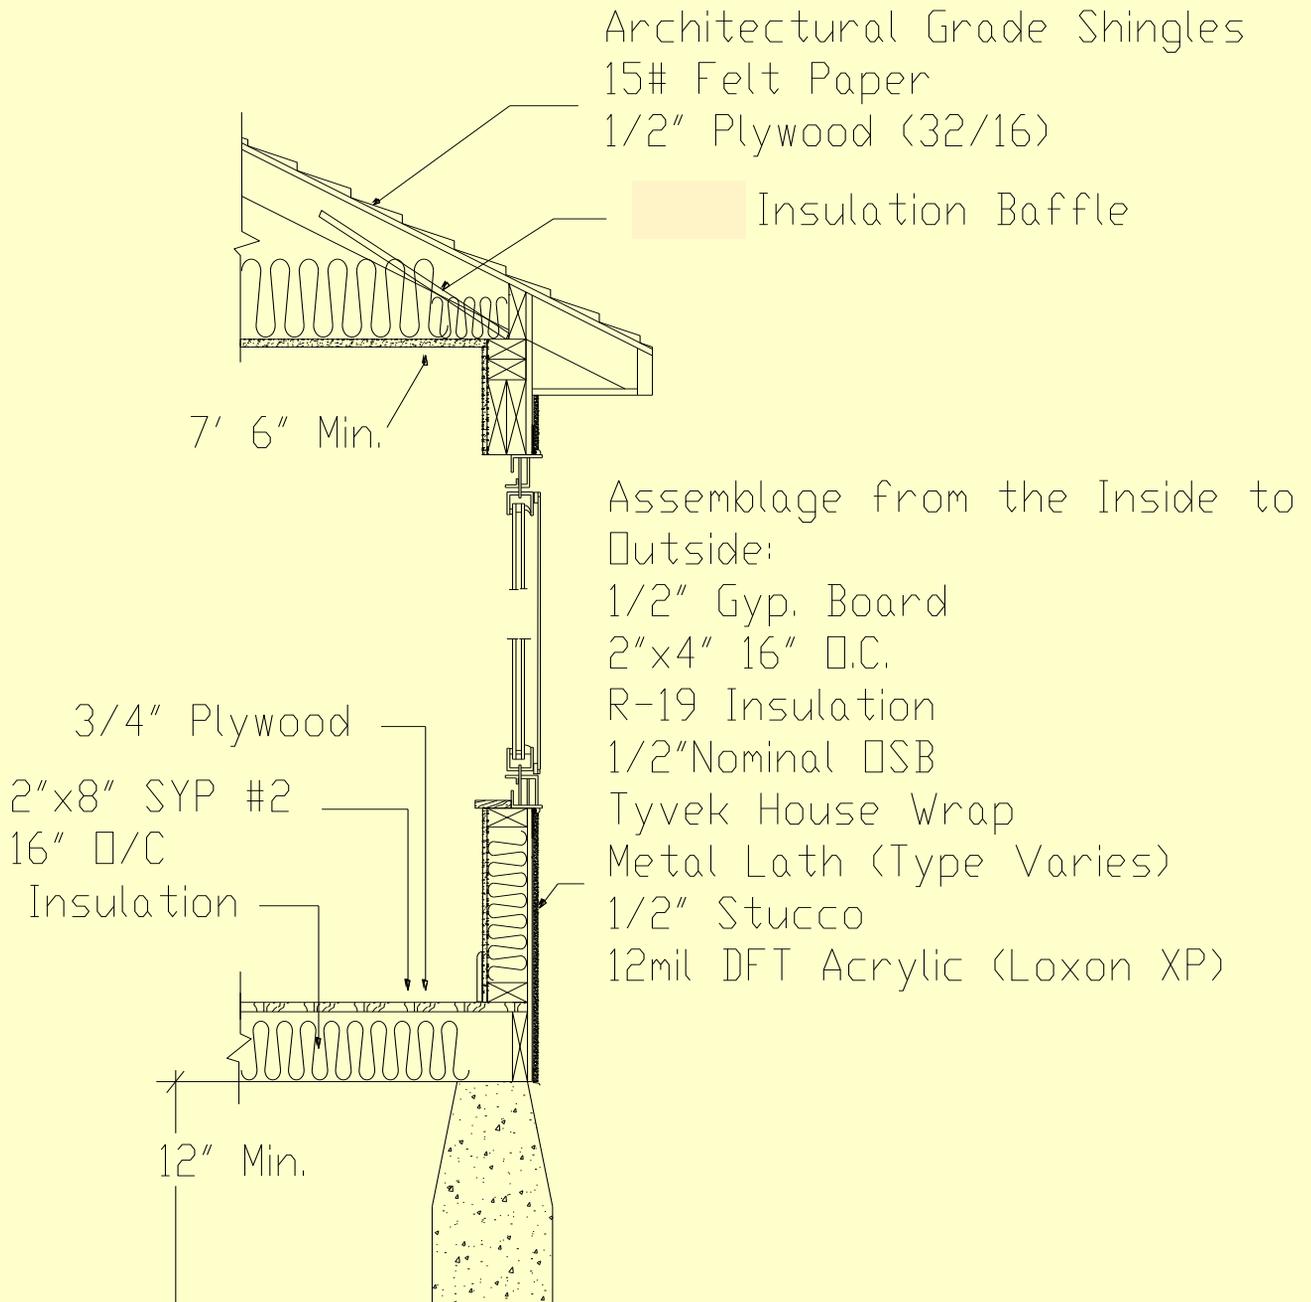
Figure 2 – Wall Section

- In Florida’s environment, air movement around and through the building’s envelope allows outside air (unconditioned air) to enter into interstitial (inside the exterior wall) elements and finally into the inside conditioned space.

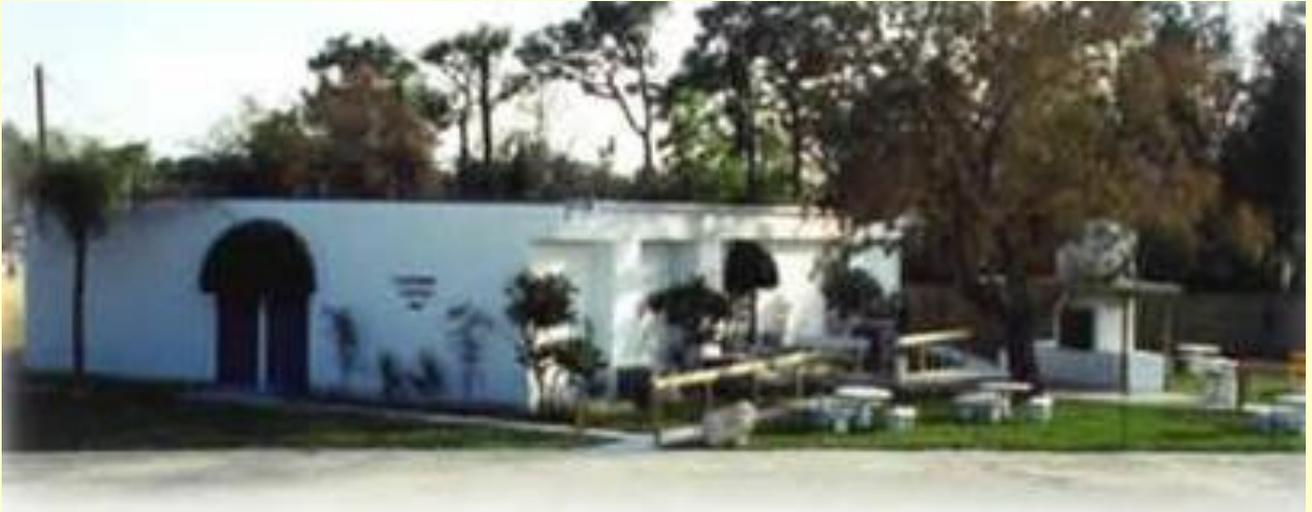
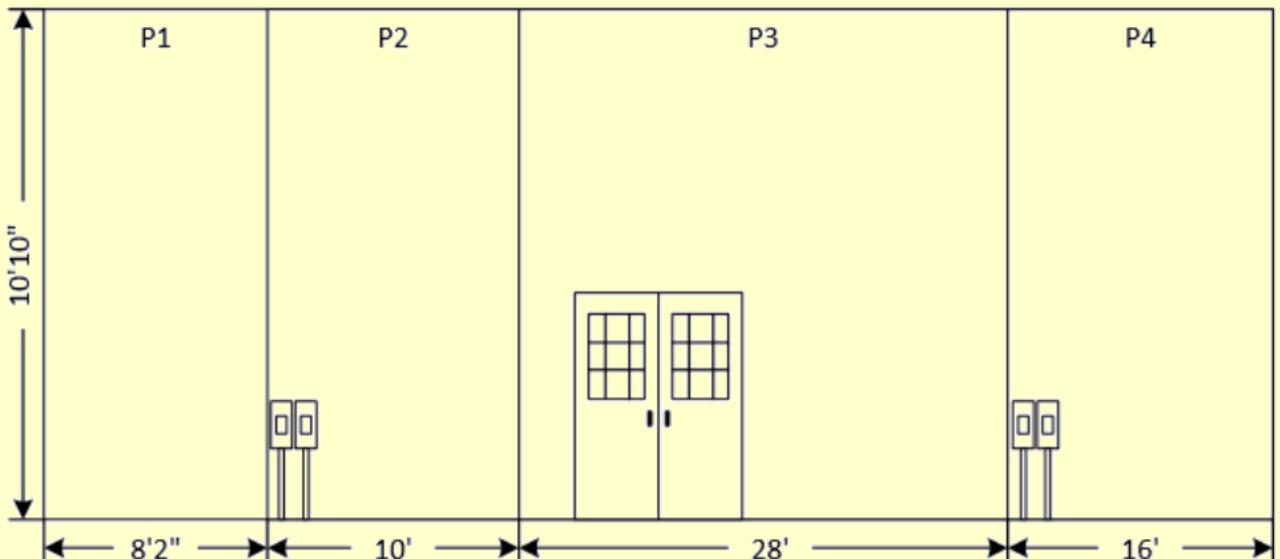
- 2001 – Original Installation - No cracks though the coating in any panel
- Uniform wall assemblage on outside – same occupancy use along inside of the entire wall
- 5/8" Stucco over paperbacked lath on 1/2" plywood. No weep screed.
- Panels 1 and 2 were coated using a standard airless sprayer (\approx 3 mil DFT), while panels 3 and 4 were rolled using tradition masonry nap roller (12 mil DFT minimum) as per the paint manufacturers recommendations.

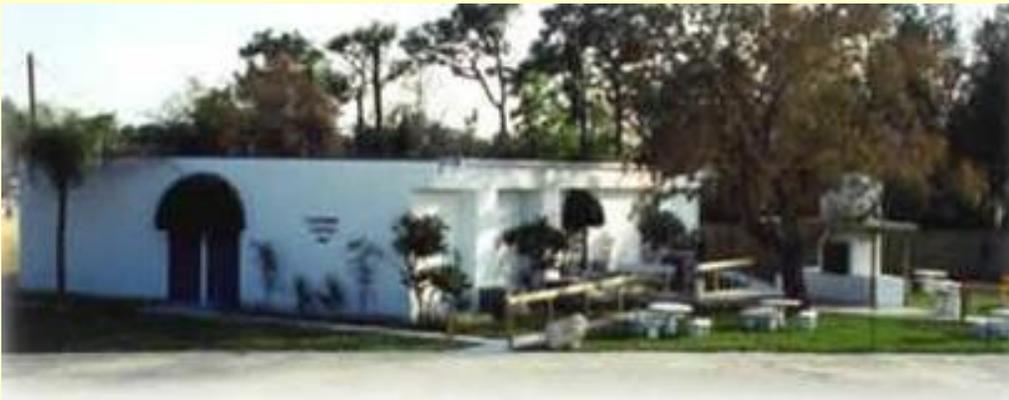
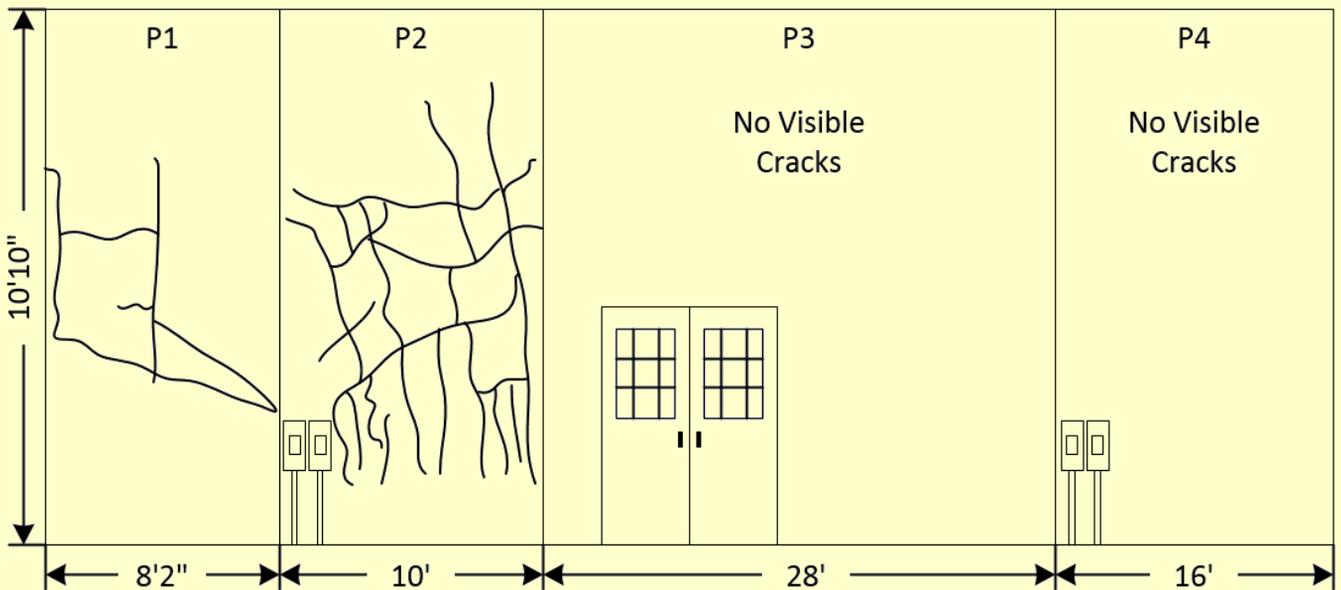
- By 2005 Panels P1 and P2 developed documentable cracking. By 2007, these cracks had expanded to a degree where it was necessary to patch the cracks and re-coat the panels in order to prevent substrate damage. They were coated this time to the required mil thickness using a roller.
- Panels P3 and P4 presented no cracking whatsoever in 2005. They remained crack free. They were recoated for in 2007 with Panels P1 and P2 to maintain appearance.
- Soffit and Fascia Sections (originally rolled to 12 mil DFT minimum) remained crack free performing as Panels P3 and P4

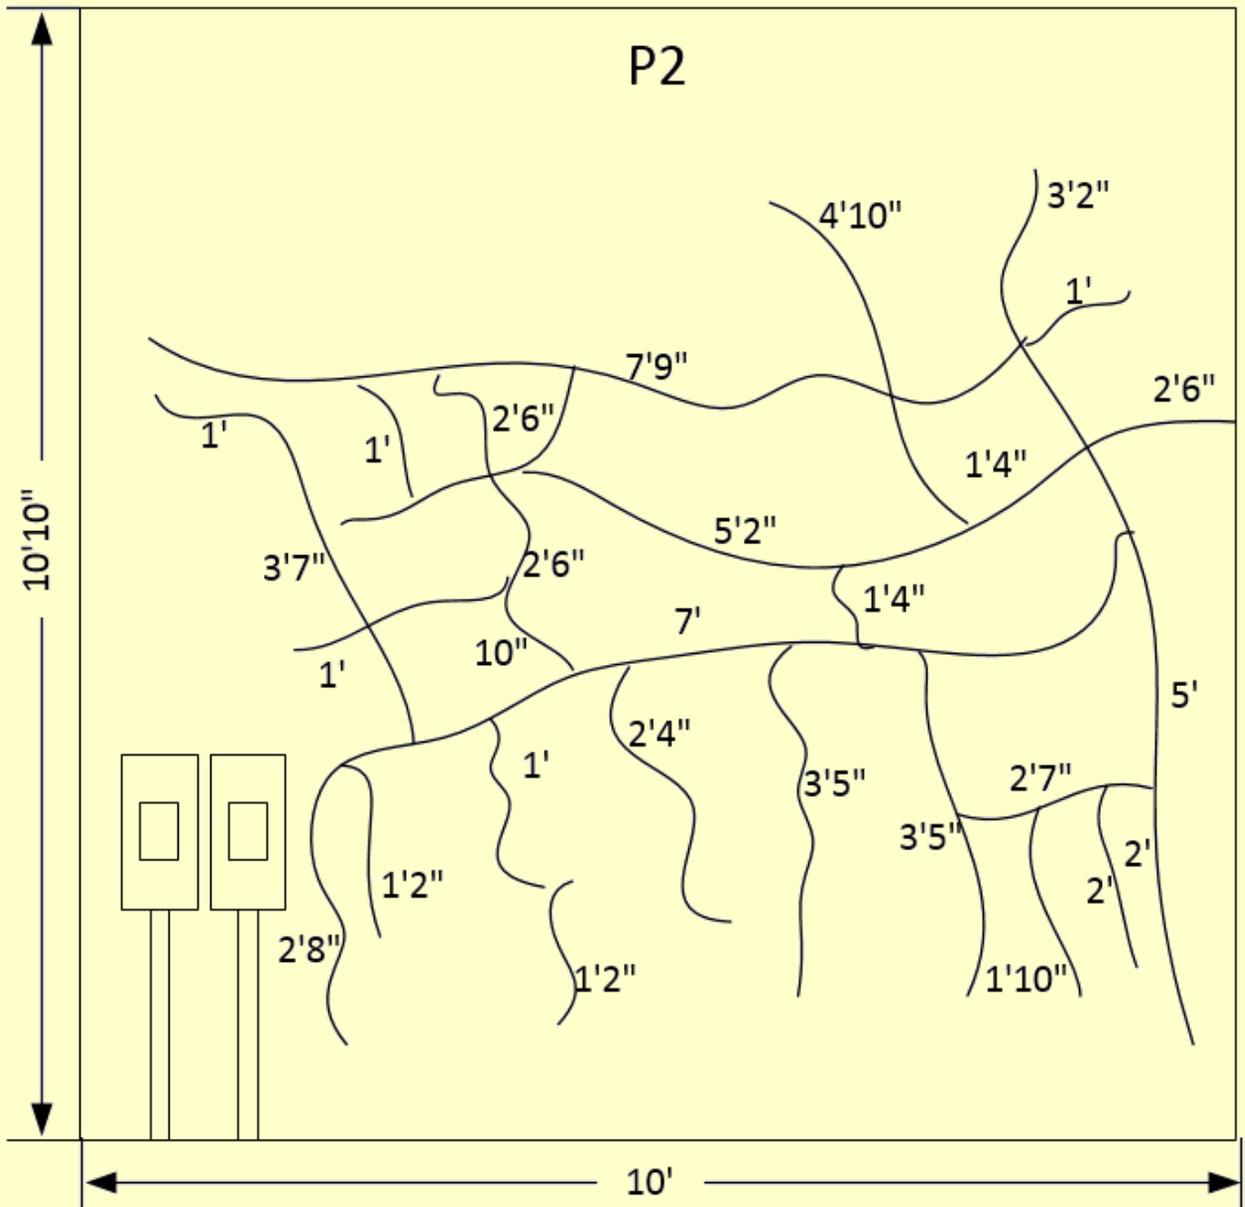
Area in SF	LF Cracks	LF Cracks PSF
108.3	75.08	.70

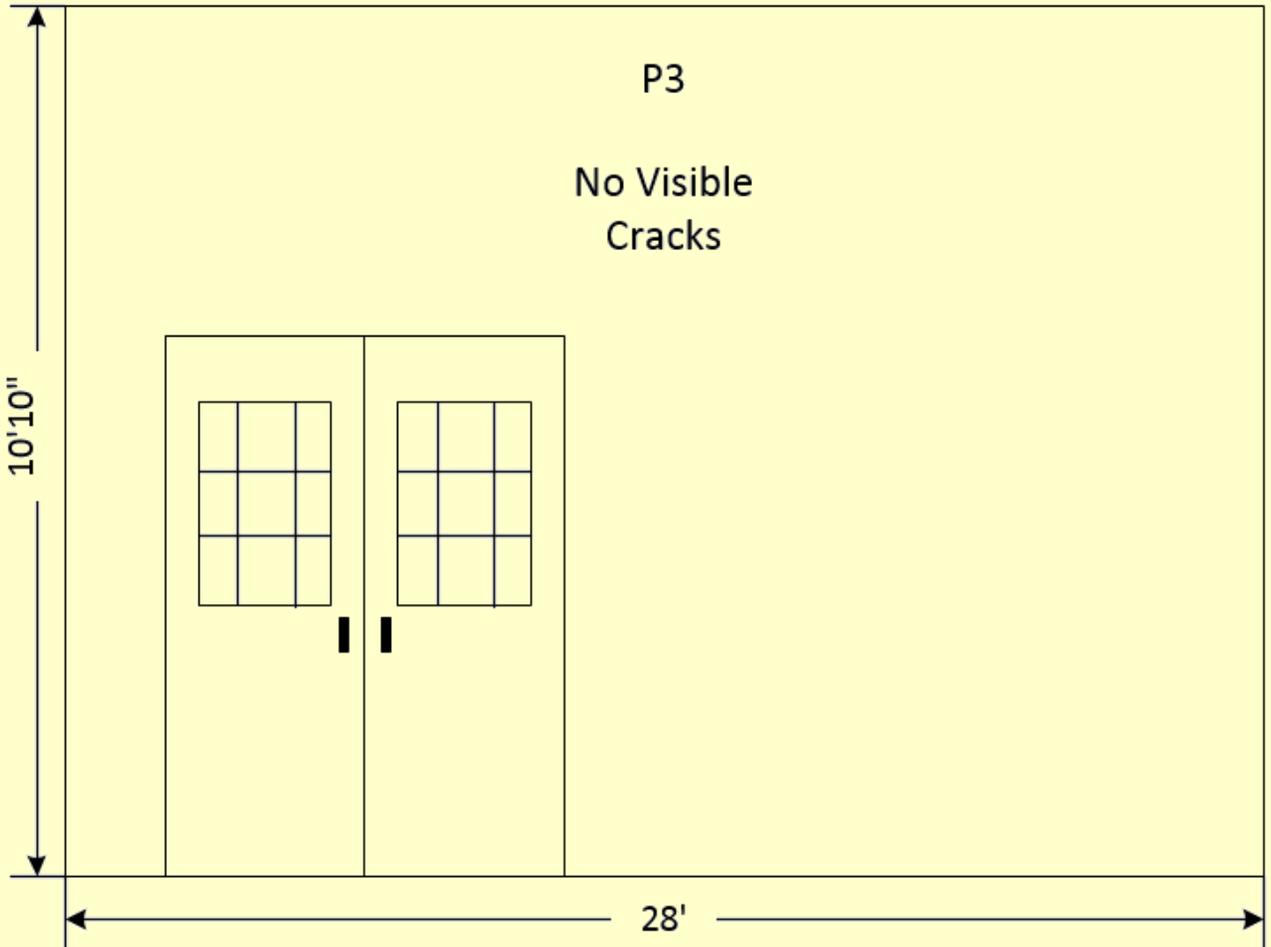
Area in SF	LF Cracks	Cracks PSF
303.14	0	0

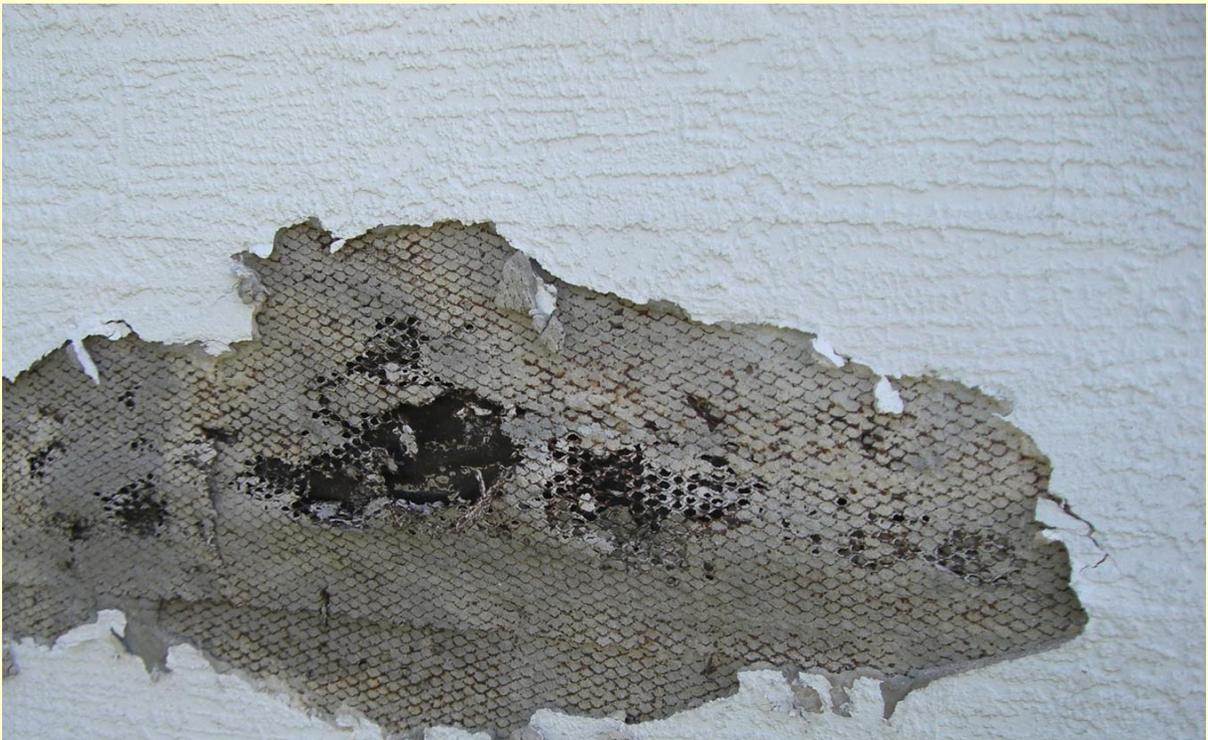
- A back section originally painted with an airless sprayer cracked circa 2005 - 2007 just like panel P1 and P2.
- This section however was not repaired, but left alone until 2010. The result was rusting of the lath so severe that the section had to be cut out and re-lathed and stuccoed. It was then properly re-coated and remains in tact today (2016)

- This damage manifested itself between 2007 and 2010, or in 3 years the wall **section** (not the entire wall) moved from repairable to non-repairable.

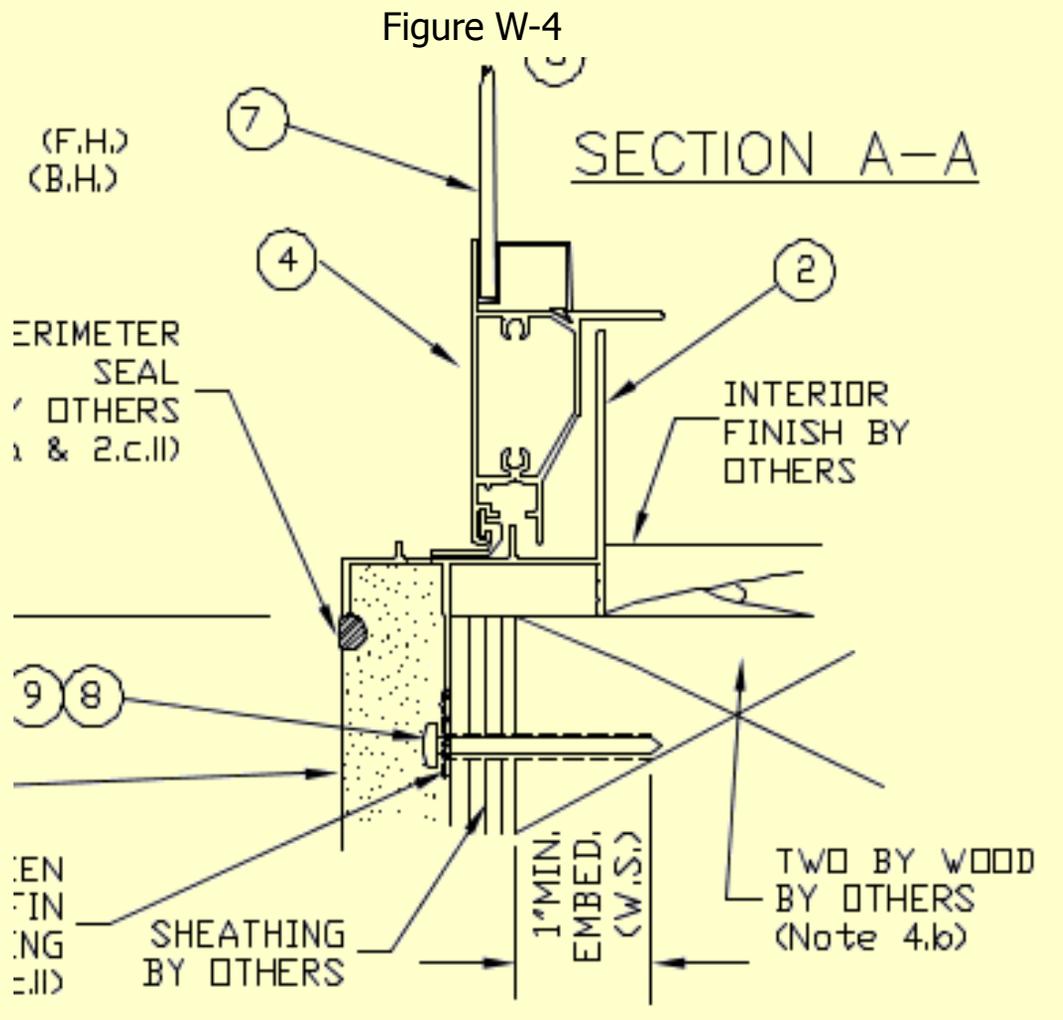
- Refer to Figure W-4 below. This is a section view of a window with a casing stop as part of its extrusion that has Florida Product Approval. It's mounting fins are flashed to the Weather Resistant Barrier. It has an integral receiver that can be used as a stucco casing stop. Interpreted literally, if you follow ASTM C-926 and separate with a casing, you violate the manufacturer's instructions – which violates code requirements. Catch 22. But, the code is not meant to be applied literally for each provision, it is supposed to be applied logically by those who know – not those that assume...

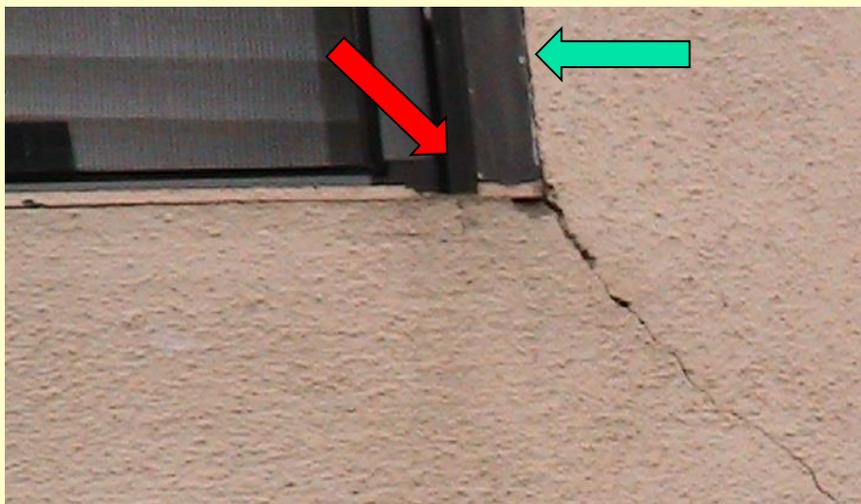
Photo W-3 – Close up at built-out window band

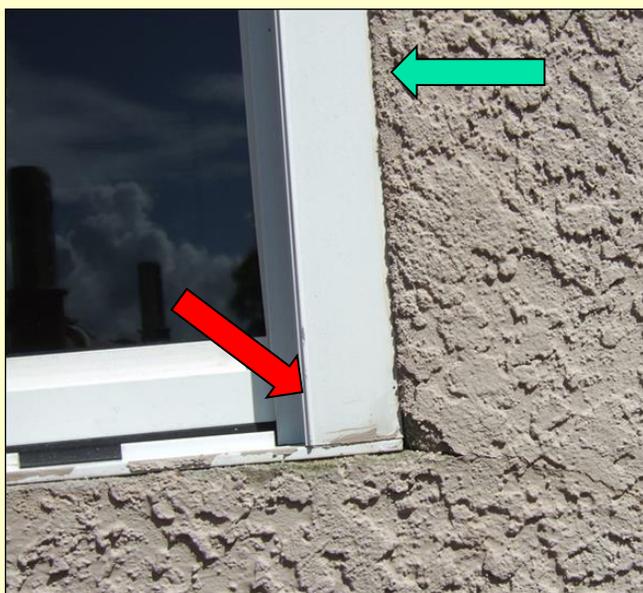
Photo W-4 – Close up of window with flush wall stucco

It should be noted that I would simply require the window be remediated around its perimeter (satisfying the inspector and consultants concerns) and remediate the jamb/sill junction at the same time. This protocol will fix any condition present and can be performed for a minor cost amount. But, it will not serve the “tear-off all” mentality of the percentage based litigation.

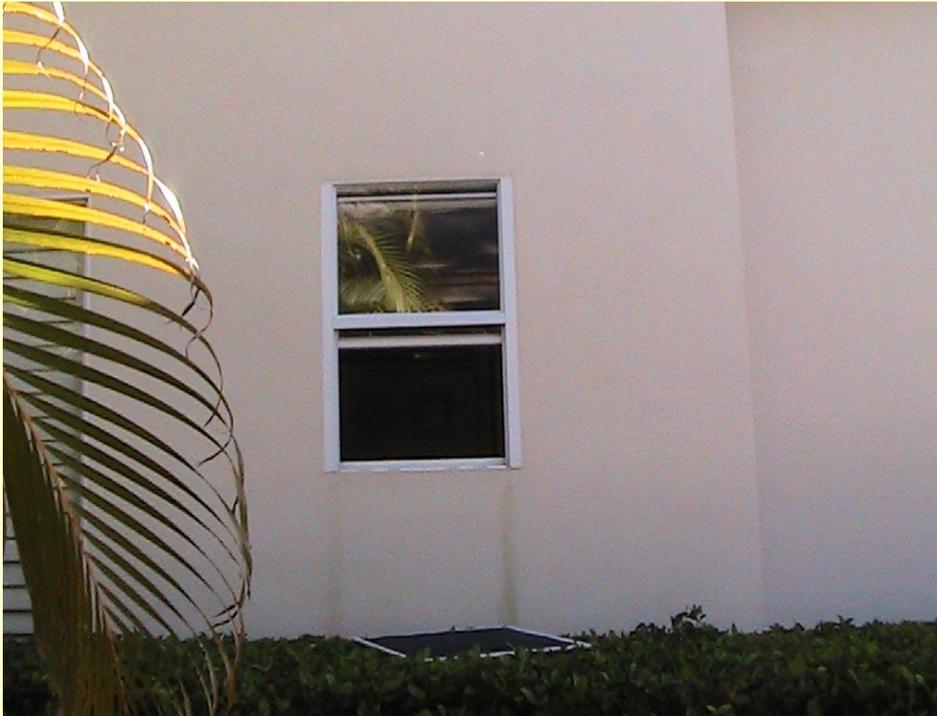
Photo W-5 – Flush window installation – No casing separation

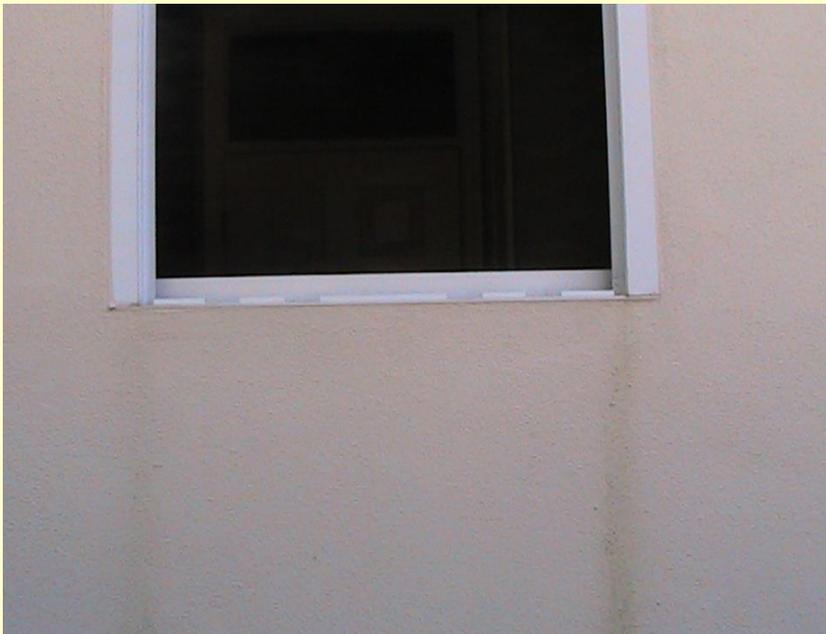
Photo W-6 – Flush window installation – No casing separation

Look Familiar – Interstitial Infiltration has created minor mold on interior

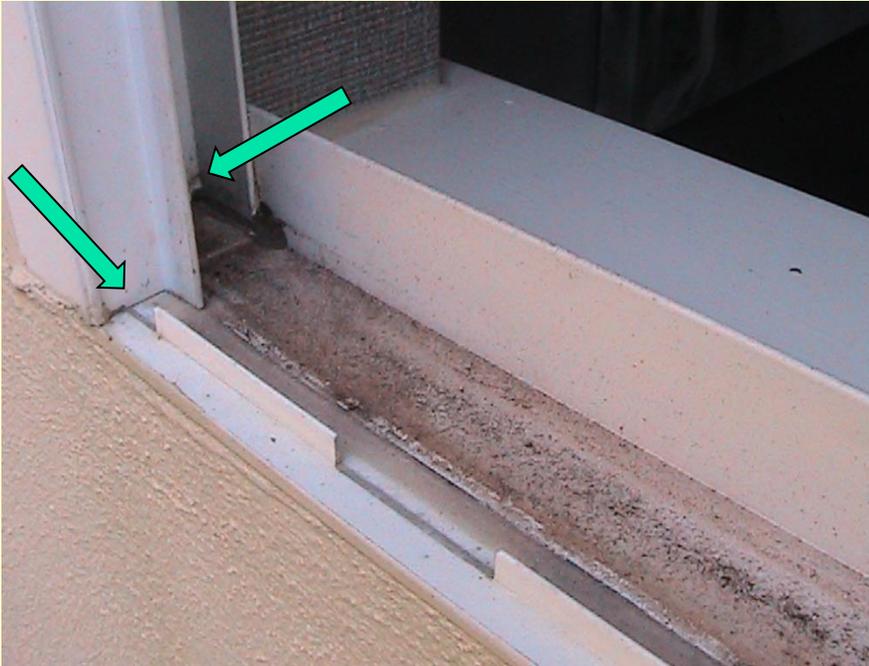
Photo W-7 – Close up – Arrows point to water intrusion points by testing

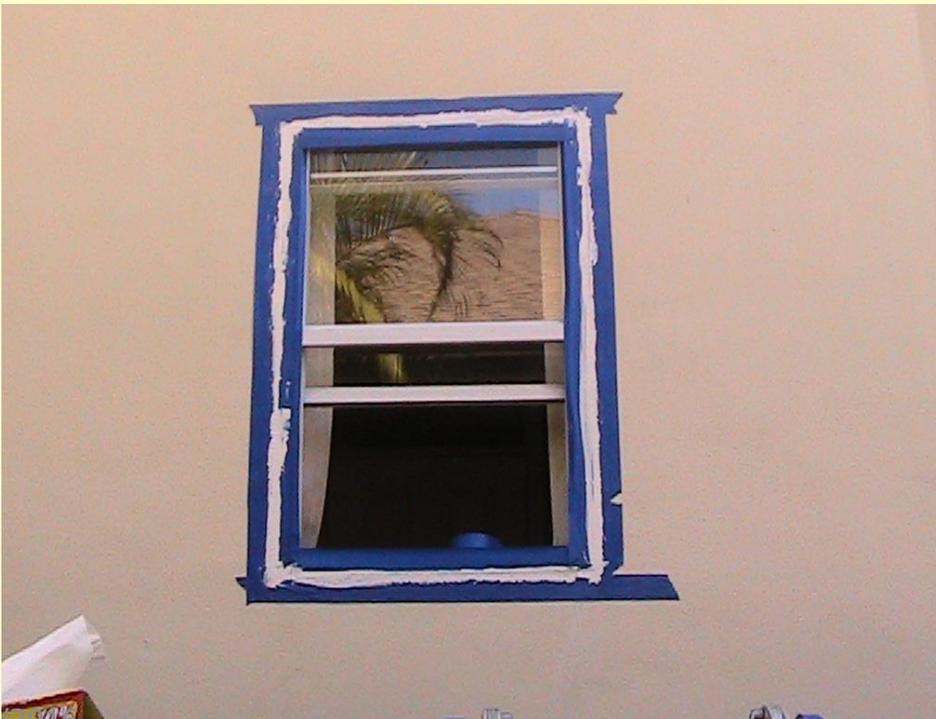
Photo W-8 – Close up – Repair protocol in progress

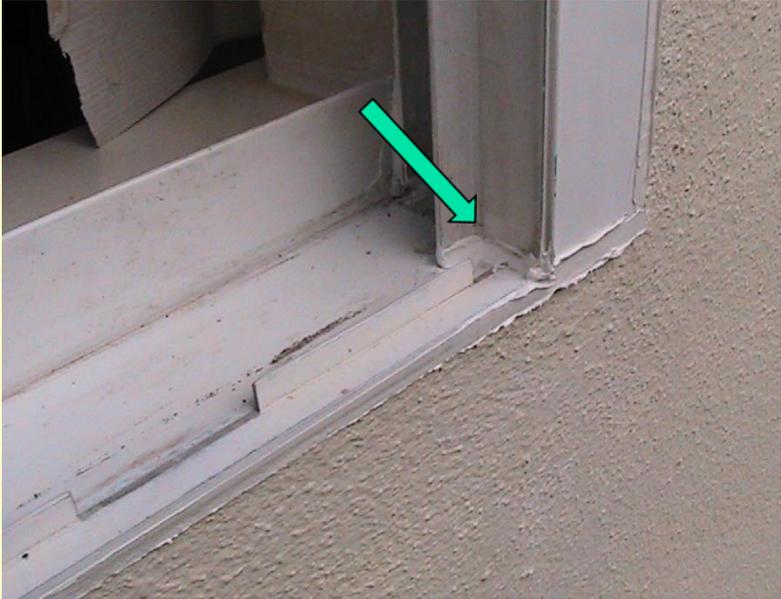
Photo W-9 – Close up – Corner repair seal complete

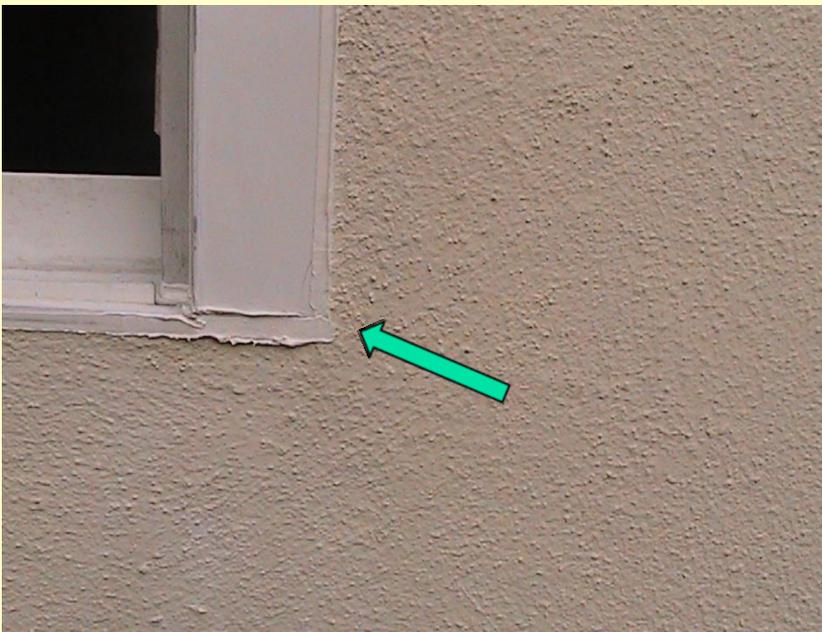
Photo W-9 – Close up – Perimeter separation repair complete

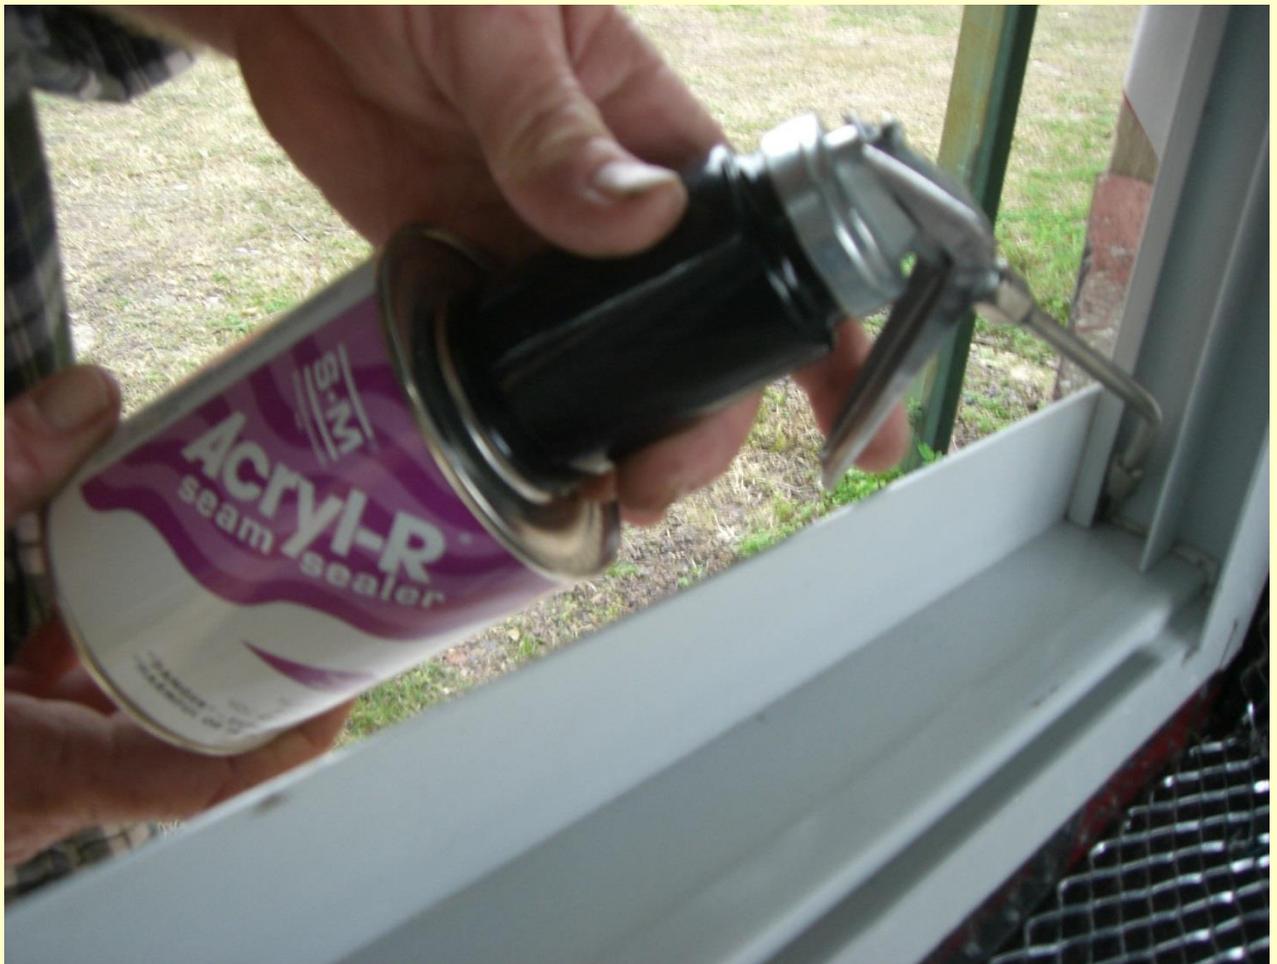
Applicator being used. Material tooled in-place with small sealant spatula

Photo W-9 Application in progress (different window from previous photos)

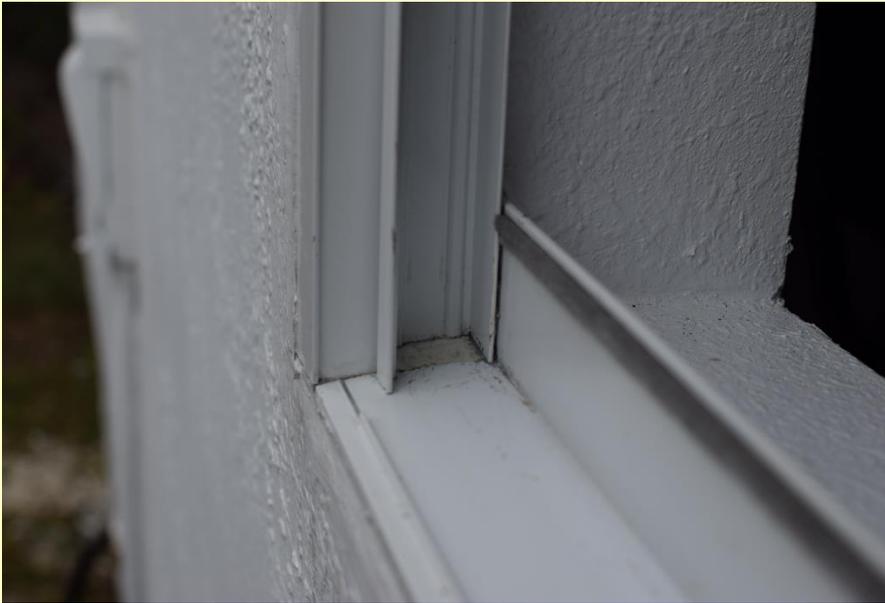
Photo W-10 – Example window jamb/sill joint leak

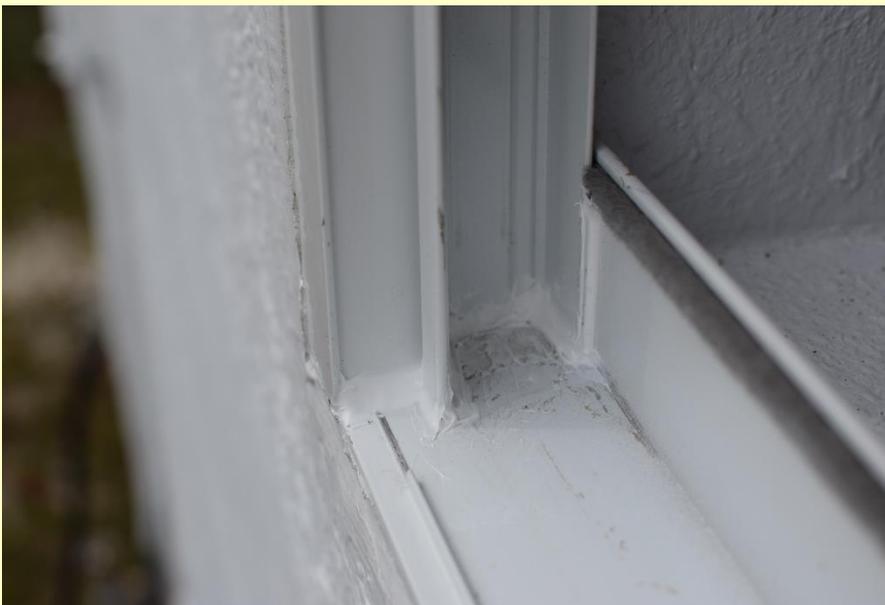
Photo W-11 – Example window jamb/sill joint repair

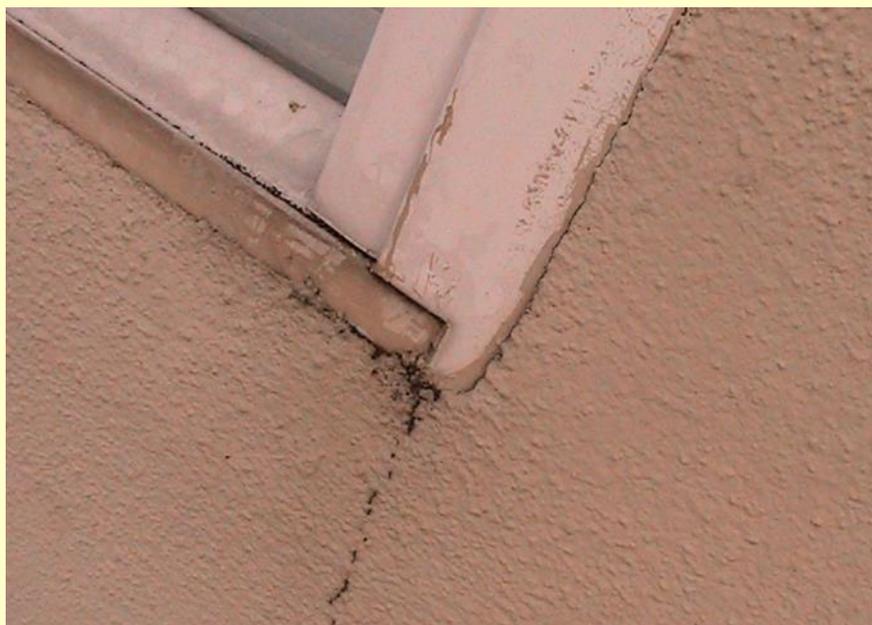
Photo W-14 – Close up – Window jamb/sill leak.
Although as previously stated, the remediation
protocol will seal the perimeter frame also.
