CONTRACTORS INSTITUTE

The Truth about Florida Stucco and Stucco Litigation
The Role of the Designer, Builder, Inspector and Owner

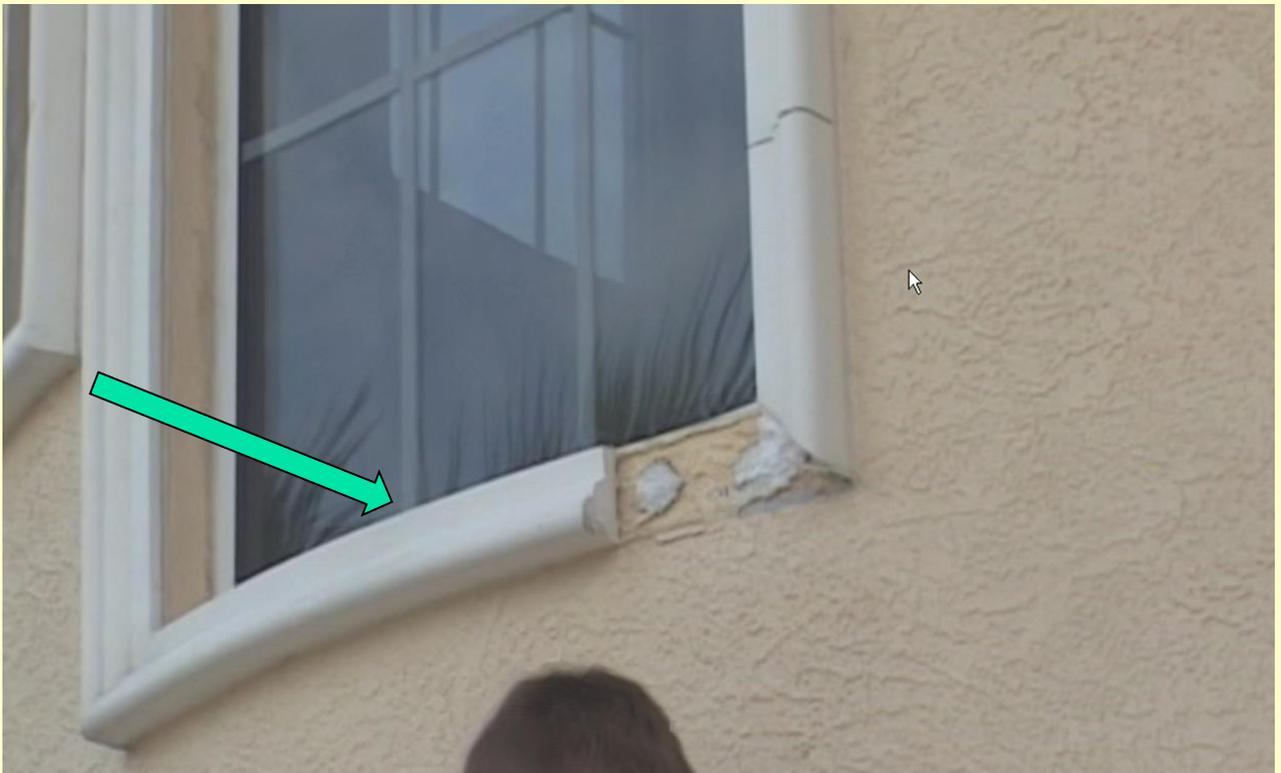
Photo B-1 – This banding has been correctly installed. It was being removed due to a misdiagnosis indicating it had been installed incorrectly and was the source of water intrusion. The water intrusion was finally determined to be from the fenestration – not the stucco band.

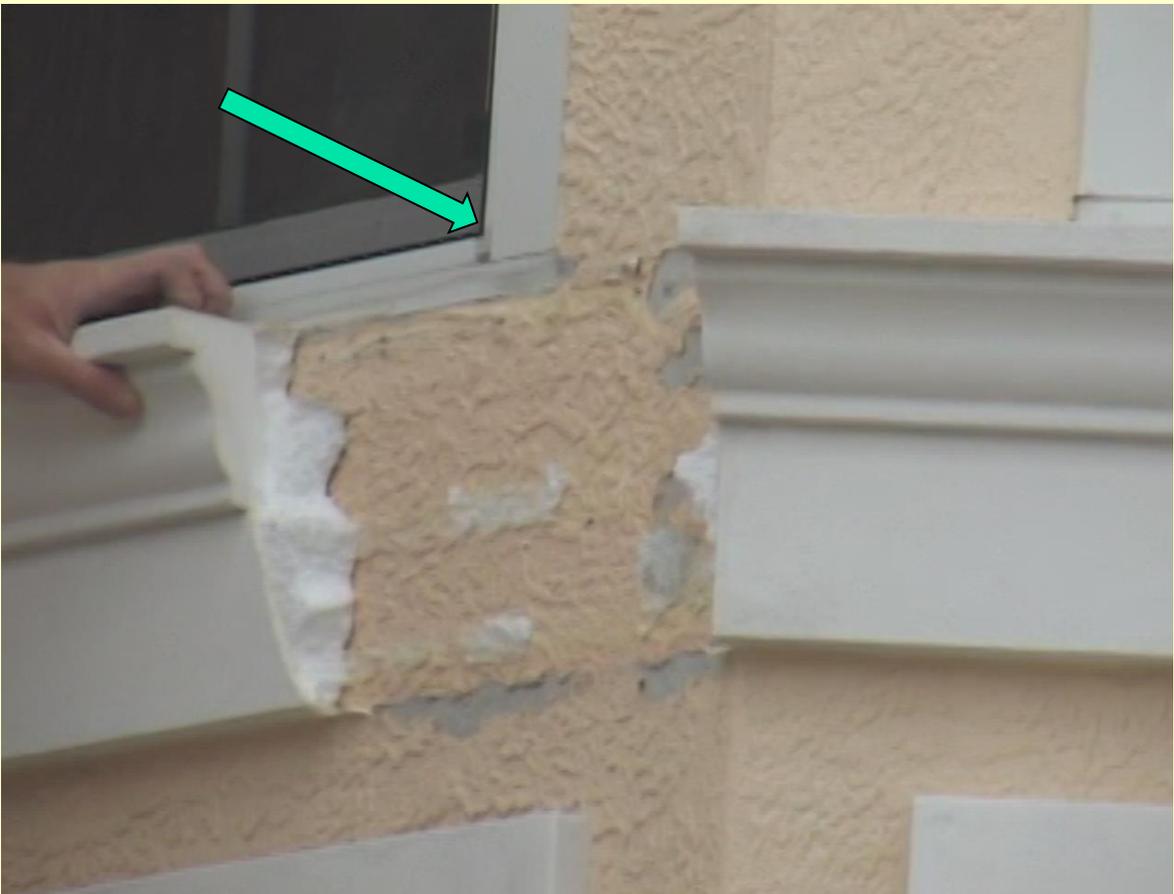
Photo B-2 – This banding has been correctly installed. It was being removed due to a misdiagnosis indicating it had been installed incorrectly and was the source of water intrusion. Water intrusion was from the jamb/sill junction – not the stucco band.

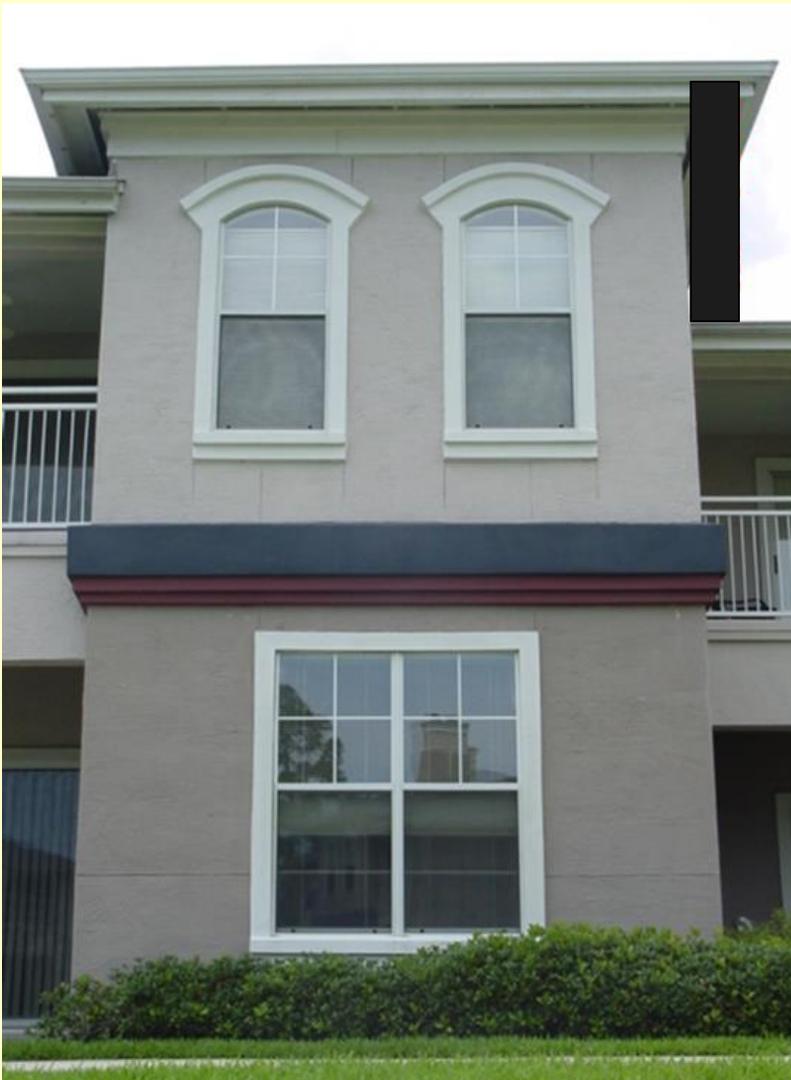
Photo B-3 – This banding has NOT been correctly installed. It needed to be completely removed due to improper installation. The foam was attached to the metal lath and stuccoed contemporaneous with wall. Alternatively, opposing casing stops wider than the wall stucco are attached directly to the lath and filled with stucco at the same time as the wall stucco (see Photo B-6, *infra*). These methodologies are, and always will be, fatal to the envelope integrity without elaborate, integrated head flashing in the wall above and over the band work. Even this is rarely done correctly – almost impossible to integrate with any drain plane or face barrier system.

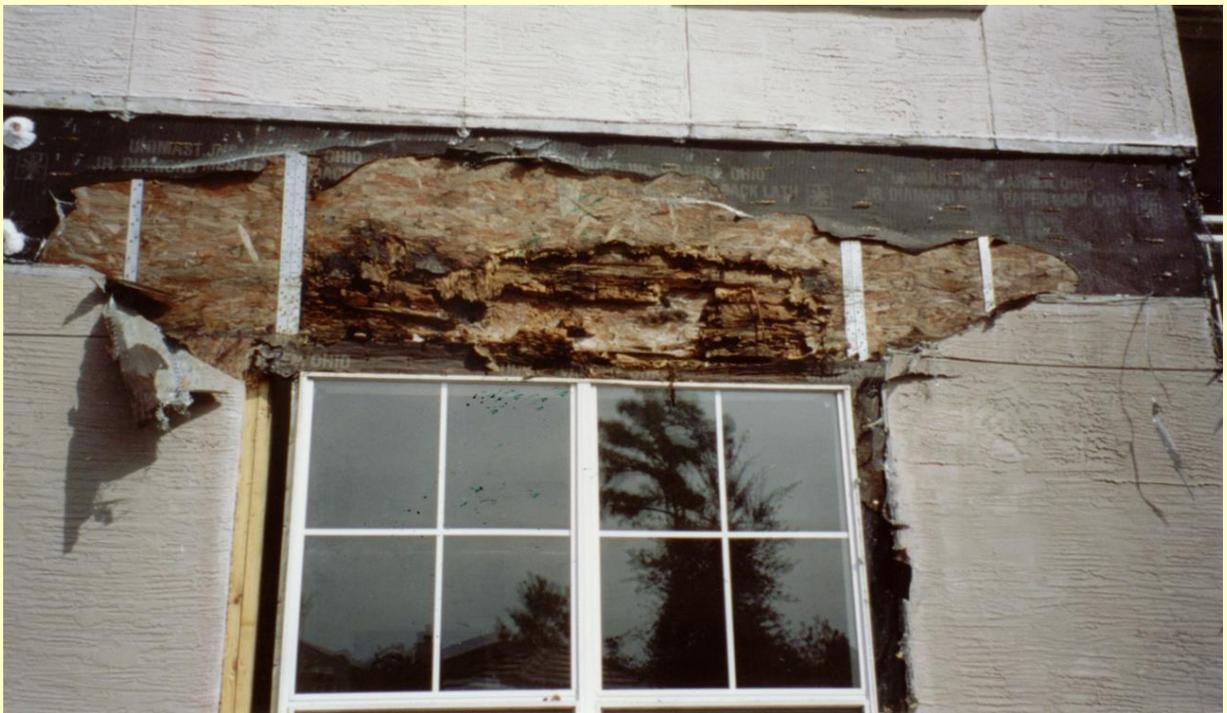
Photo B-4 – Banding removed from photo B-3. Note the damage over the lower window header from the upper banding placement. Adjacent walls were not as severely damaged due to water and vapor being able to be dispersed within and behind the stucco mass below.

Over the windows however, not only is there water intrusion, but there is a more radical temperature change providing for the activity of water vapor (Aw) to elevate and colonize fungal growth. Additionally the water/vapor had no other place readily to disperse – therefore increasing the time for the elevated moisture exposure. These conditions are disastrous. Period. But they are regionally repairable and do not normally require wholesale de-skinning.

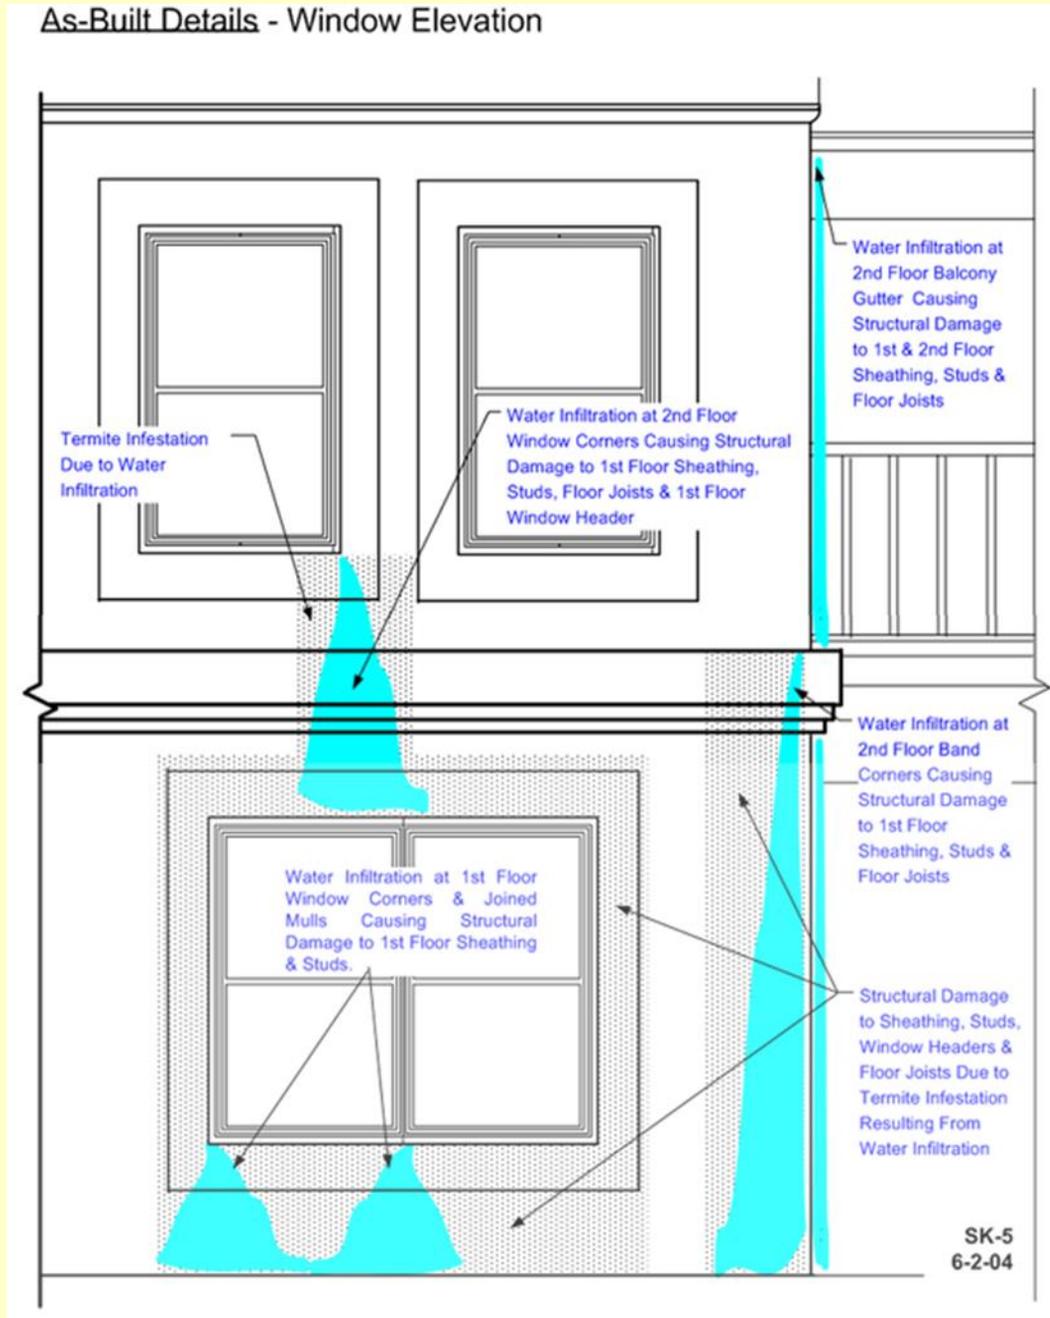
Drawing B-4 – Infra-red on a similar configuration of banding. Waterways pathed out window corners, window bands, horizontal banding and plastic corner beads all source of intrusion. Good news, we know where they all are and can now (and did) develop the repair protocols.

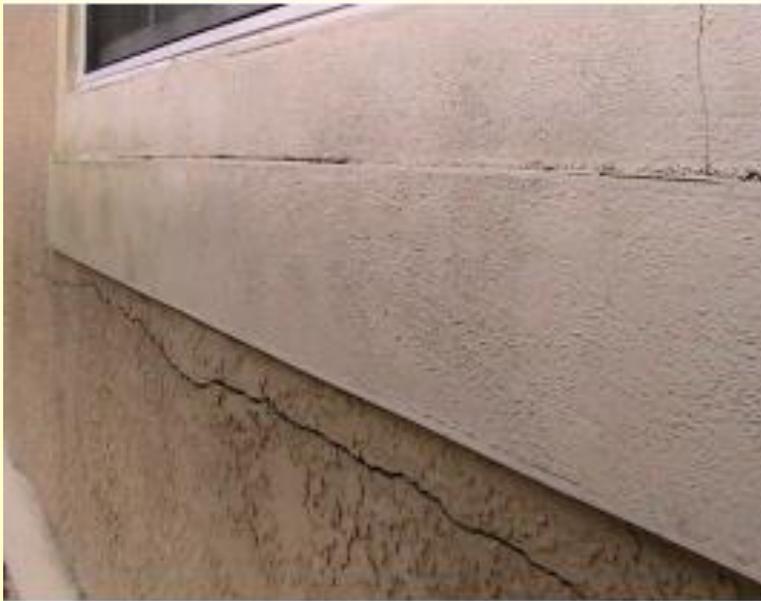
Photo B-5 – This should be self explanatory by now. This condition is so obvious you can see it before you get there!

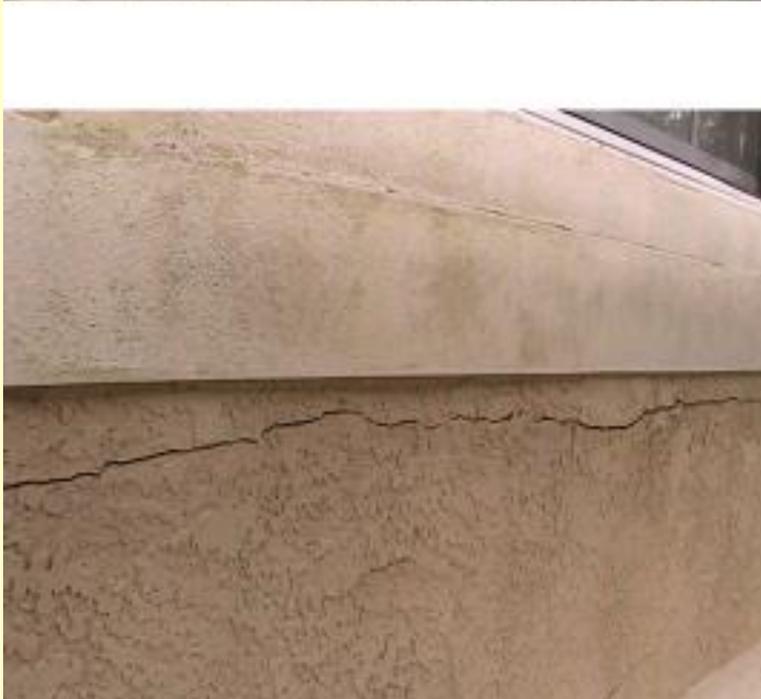
This is a band over a band. Both are attached directly to the lath and stuccoed at the same time as the wall.

Anyone trained can see this won't work. Where is the common sense...

This is a fairly inexpensive repair protocol.

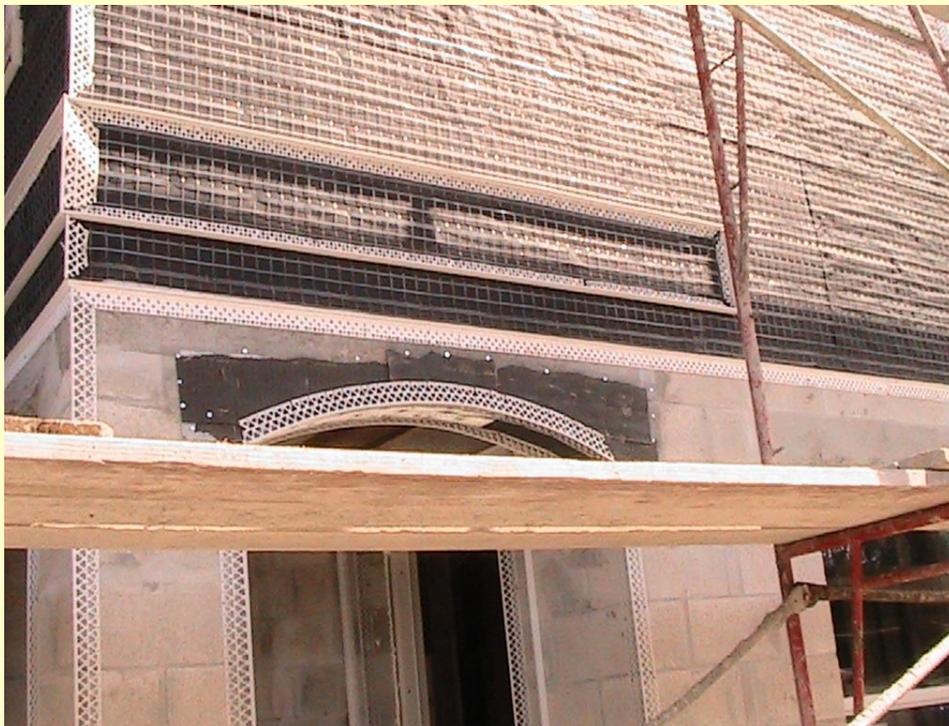
Photo B-6 – This banding has NOT been correctly installed. The banding is formed by wider casings installed directly on the metal lath. These practices are problematic for several reasons; 1. They place great thickness changes that are directly incorporated into the wall plaster with cold joint breaks on the banding. The ASTM standard is critical of paper over metal lath because the additional 1/8" change of thickness may trigger horizontal wall cracks since the source goes all of the way back to the metal lath directly – well this change is 1 inch!!! Are you crazy or what?

2. The horizontal expansion and contraction rates will be different than the wall. Granted, you have it separated with a casing stop, but what type of backer rod and sealant have you detailed to accommodate for that movement? 3. If you are using a drainage plane system, these interfere with the sub-stucco drainage due to fasteners, mass and configuration or placement of the mid-wall weep mechanism. If you are attempting a face barrier system, good luck – the laws of probability are against you with such inherent wall movement and casing stops that lead directly to the lath surface. Use all the peel-and-stick you want, success is rare with such configurations.

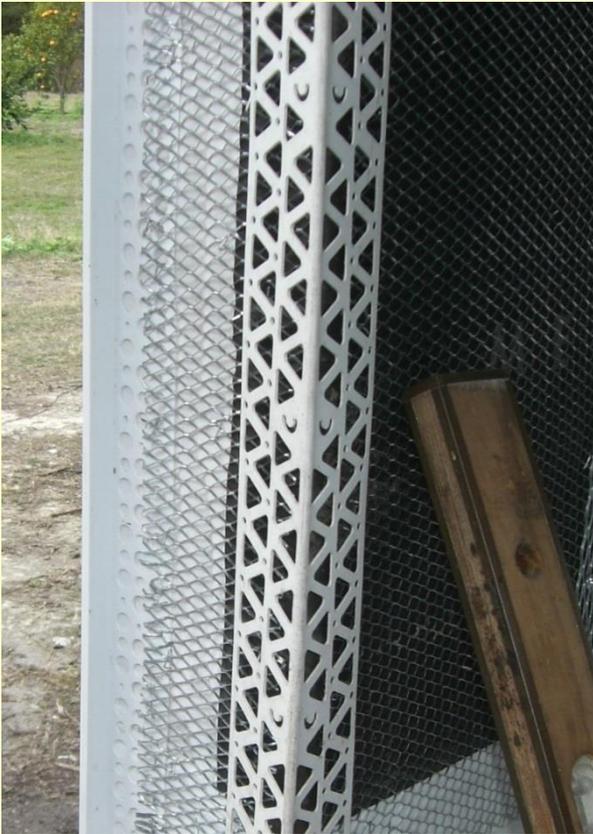
Photo C-2 – Plastic corner bead

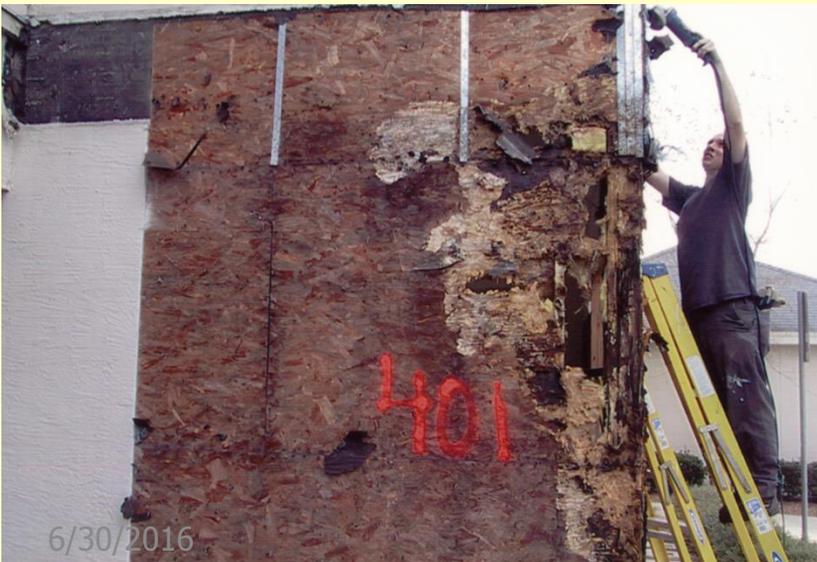
Photo C-3 – Where the Plastic corner bead was improperly installed, sealed and prepped for stucco.

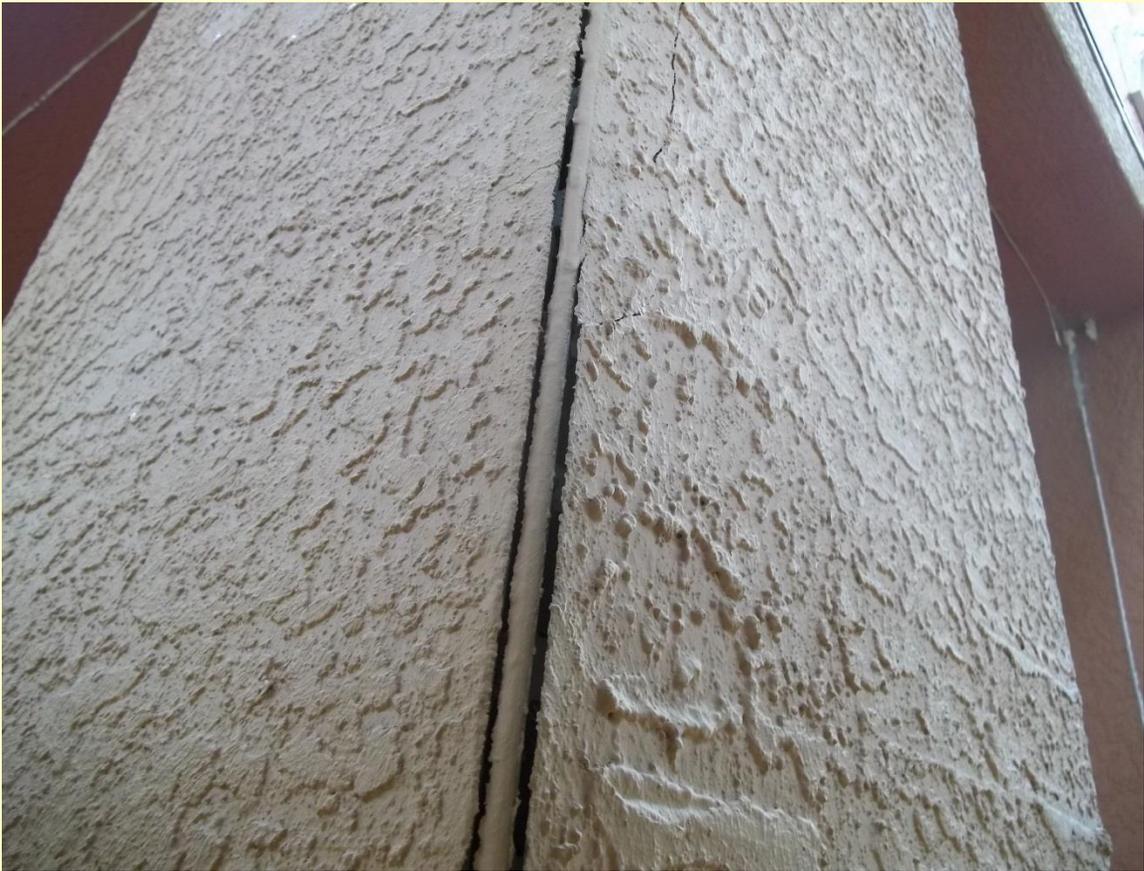
Photo C-4 - When you see this, you have trouble. Severe consequences are around the corner if you wait to repair

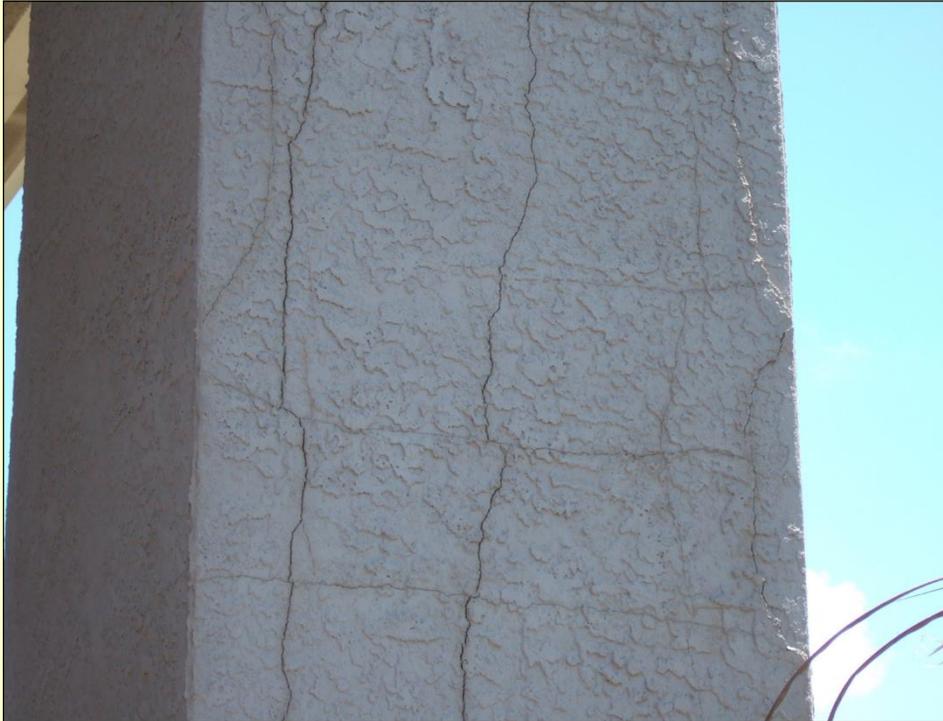
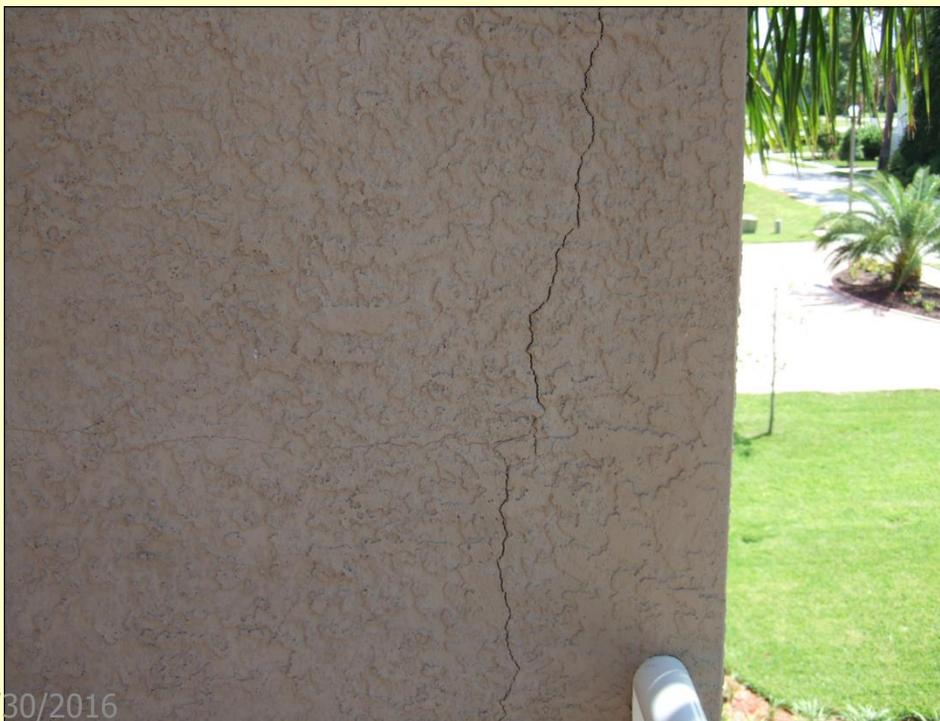
See, I told you not to wait. Photos C-5 and C-6. 12 – 24 months can mean a lot when staving off damage extents

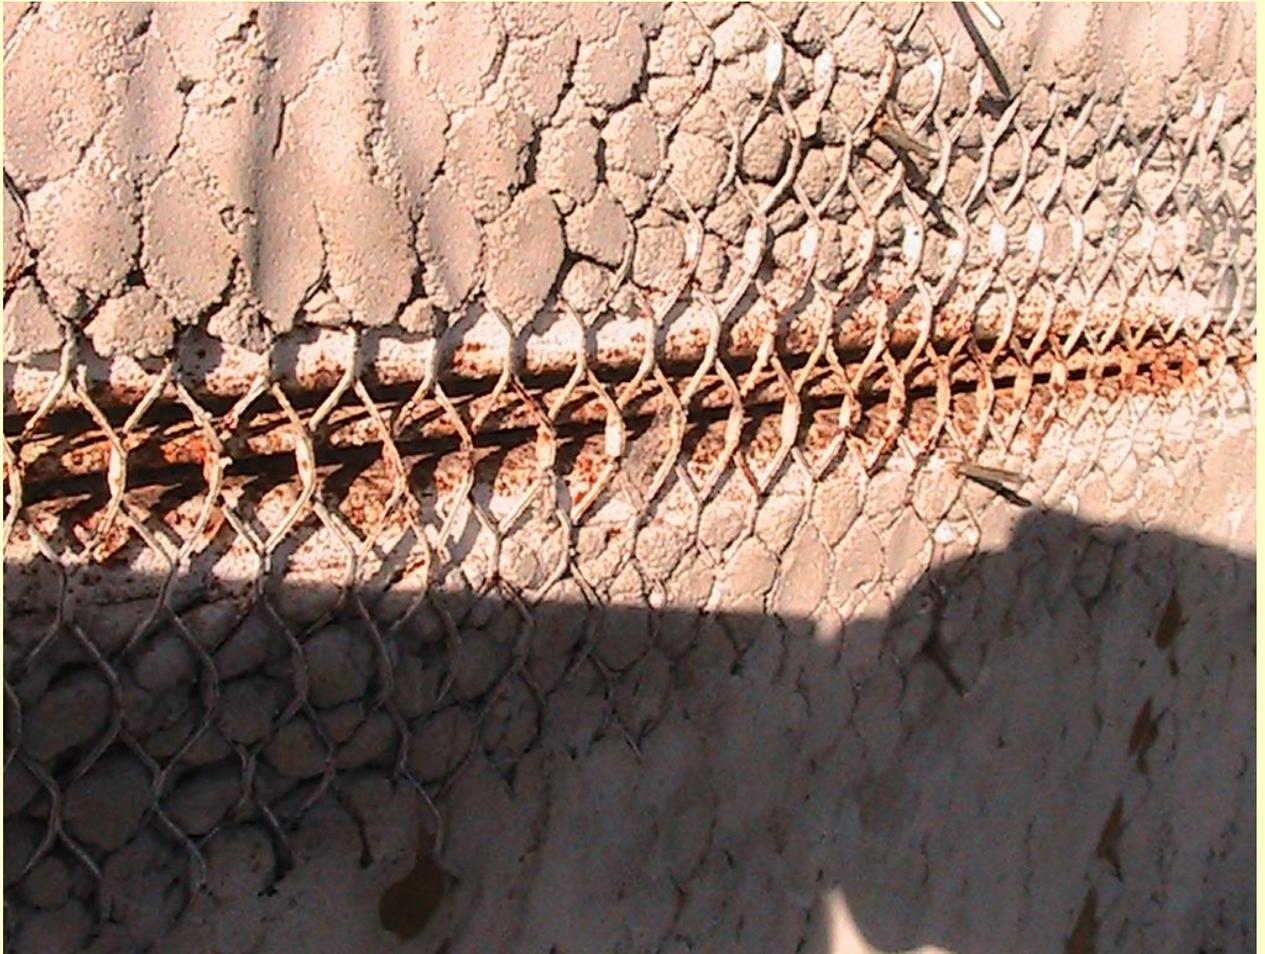
Paper over flange provides a direct water route to substrate

Salt air corrosion from free air circulation behind stucco at drain plane. Photo is the back side of a control joint where air circulates effortlessly at these locations. Also shows continuous lath behind joint. Unless otherwise specified, ASTM C-926 and 1063 recommends the lath be cut. This is a controversial requirement. The lath exhibits no signs of stress from expansion or contraction, just rusting from atmospheric conditions.

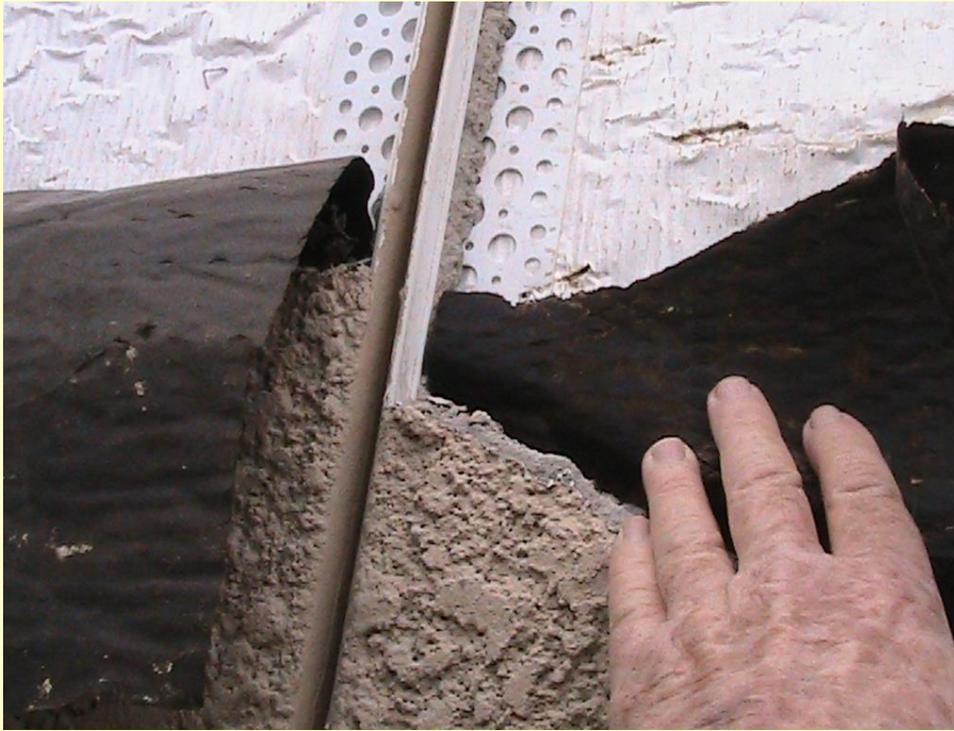
Incorrect Application – Accessory Flange not “Fully Embedded” in the cement plaster

Paper over flange provides a direct water route to substrate

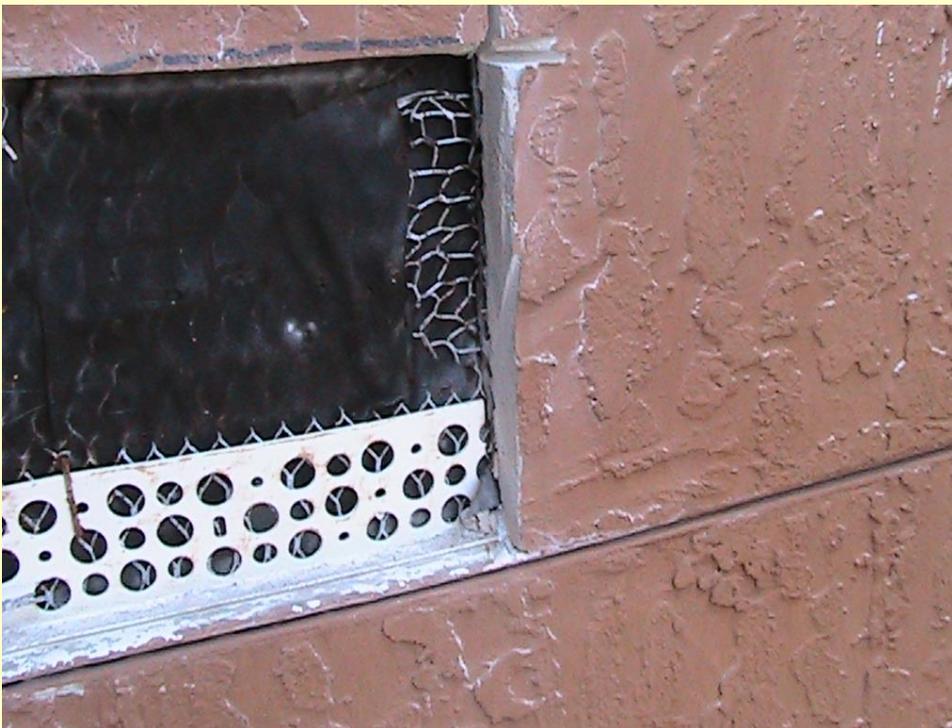
Paper over flange provides a direct water route to substrate

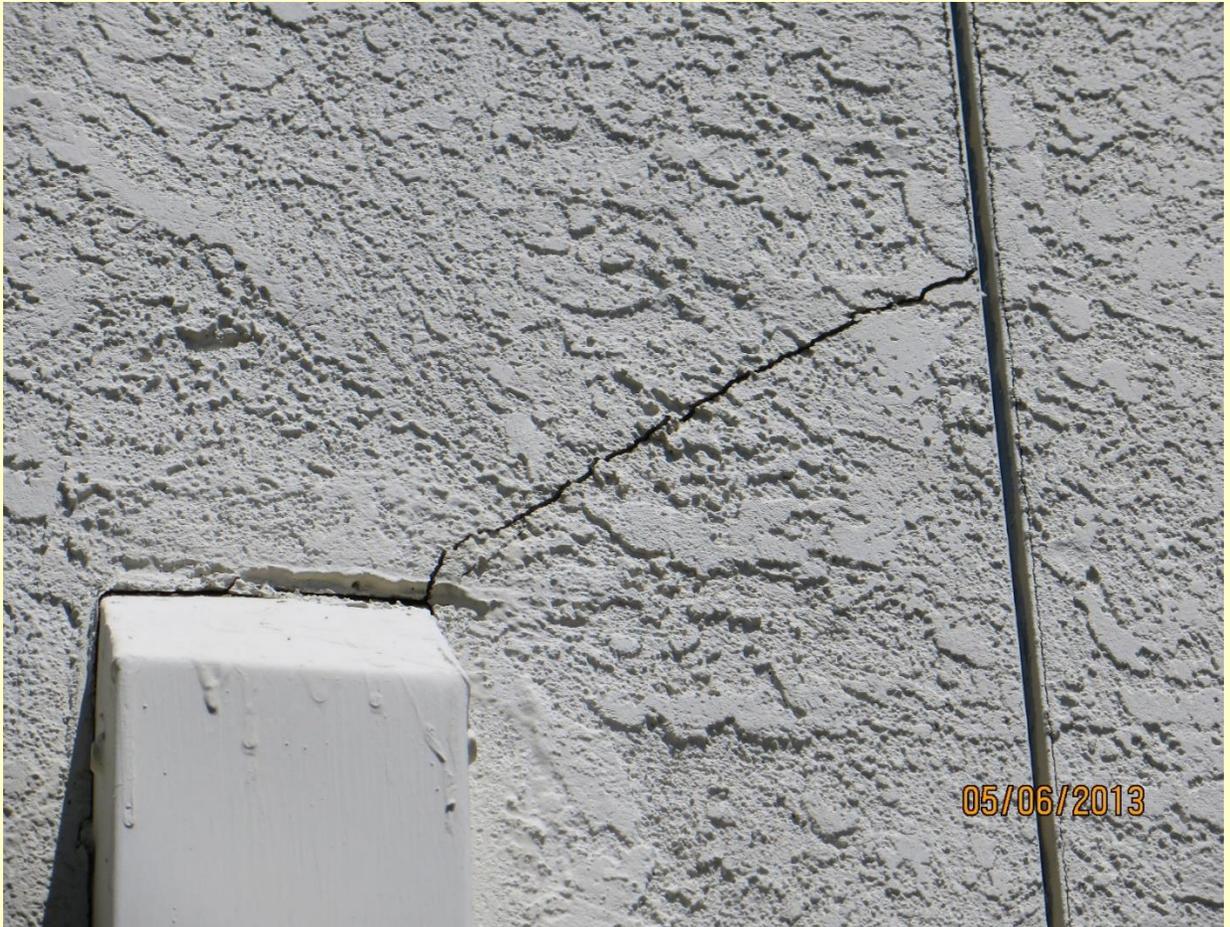
Cracks do not “align” vertically at a control joints – the wall cracks in the same manner with or without control joints.

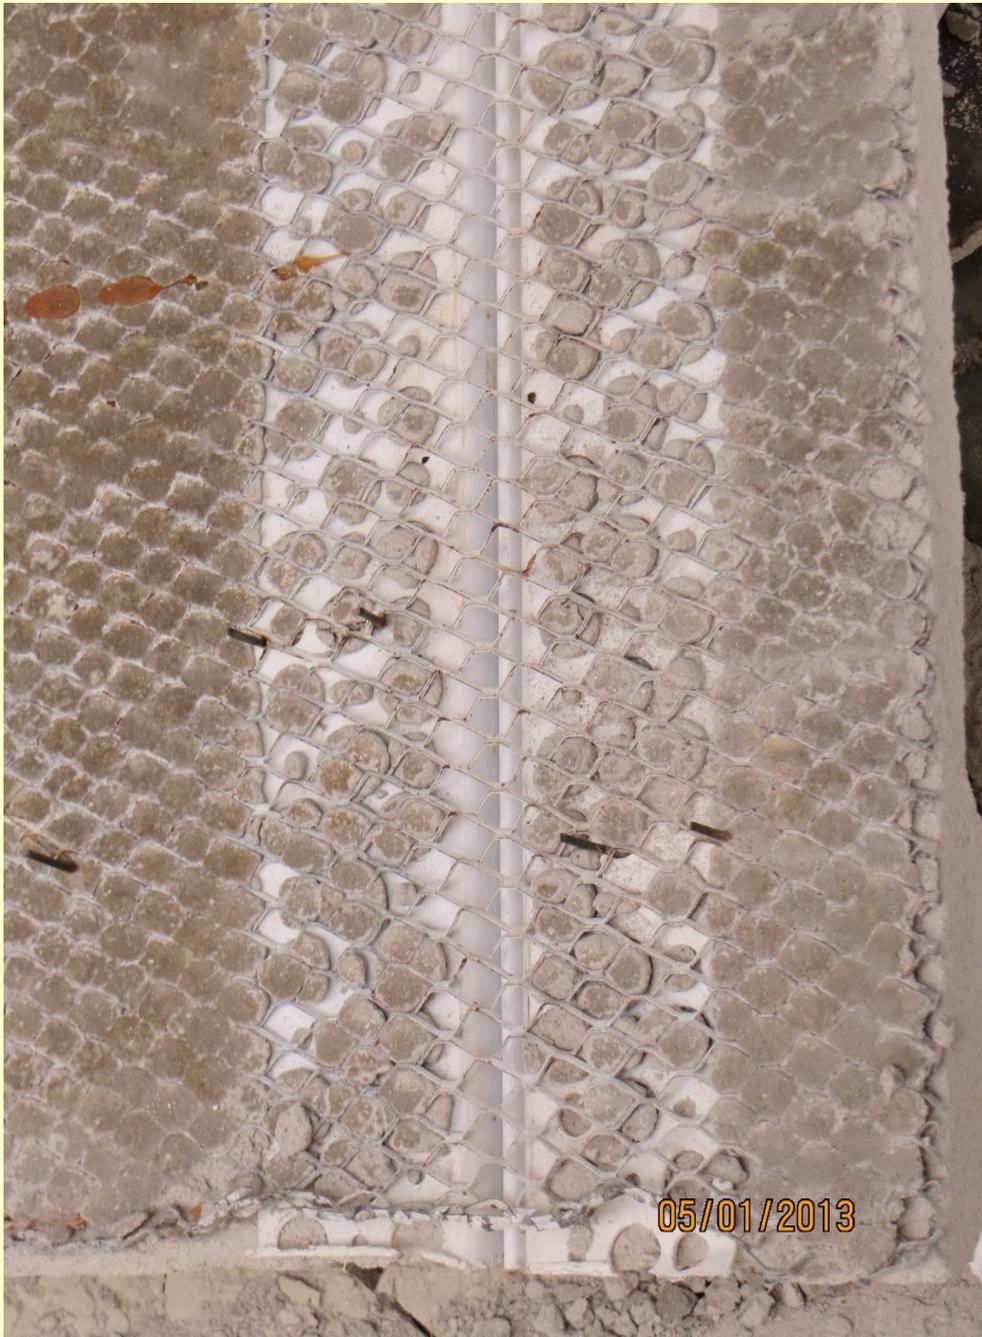
Even though paper had NOT blocked the accessory's flange – still incorrect application – Accessory Flange not “Fully Embedded” in the cement plaster

These types of accessory flanges are difficult to apply correctly and achieve full embedment

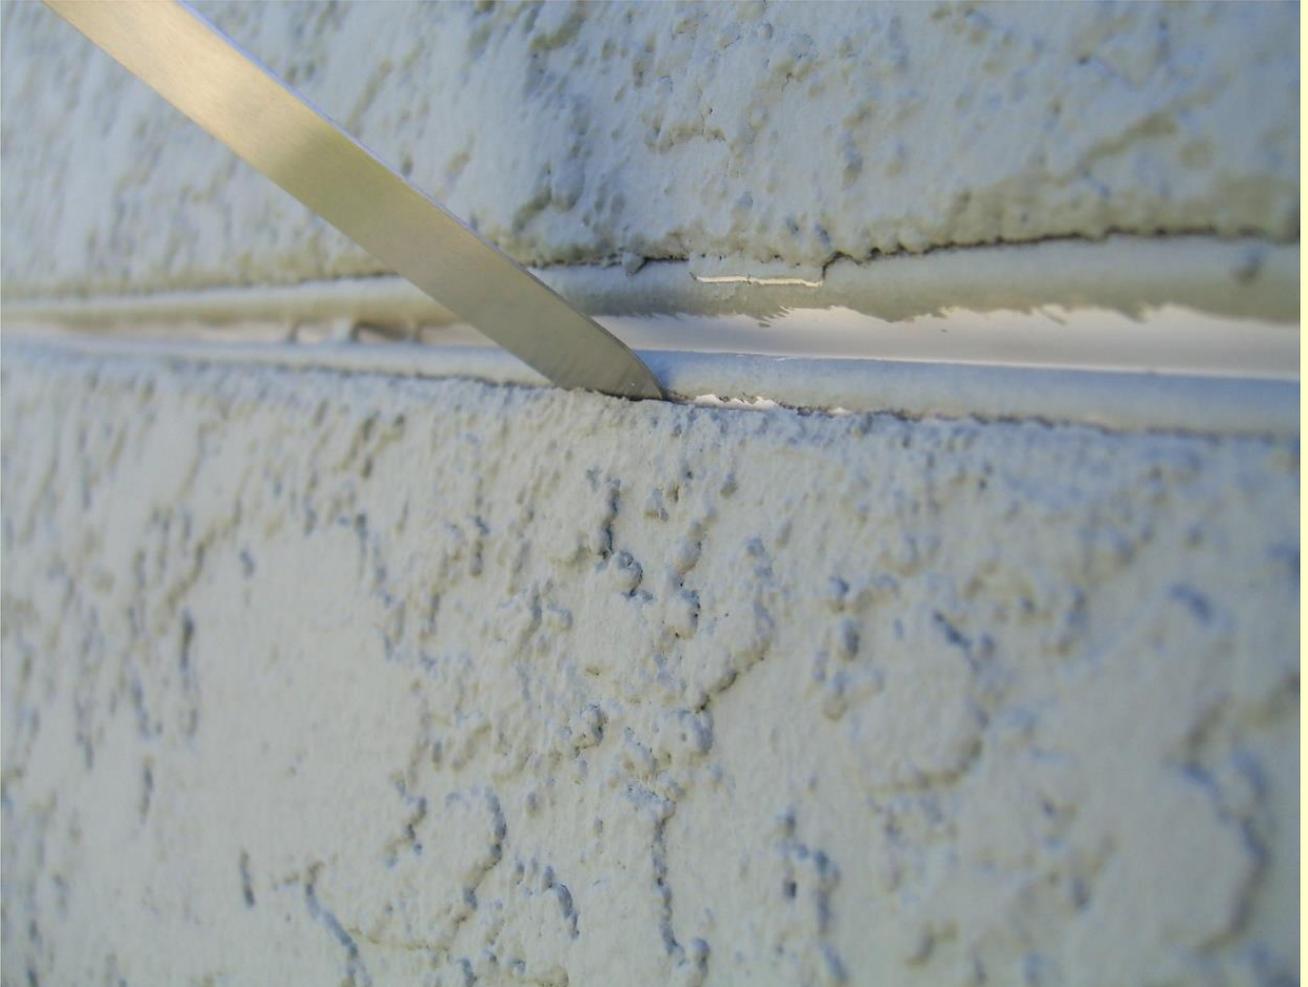
Trouble. Stucco contractor should have provided a key way for sealant – painter should have put one there if one was not. Builder should have caught the error. Instead – all did nothing but leave a leaking wall assembly.

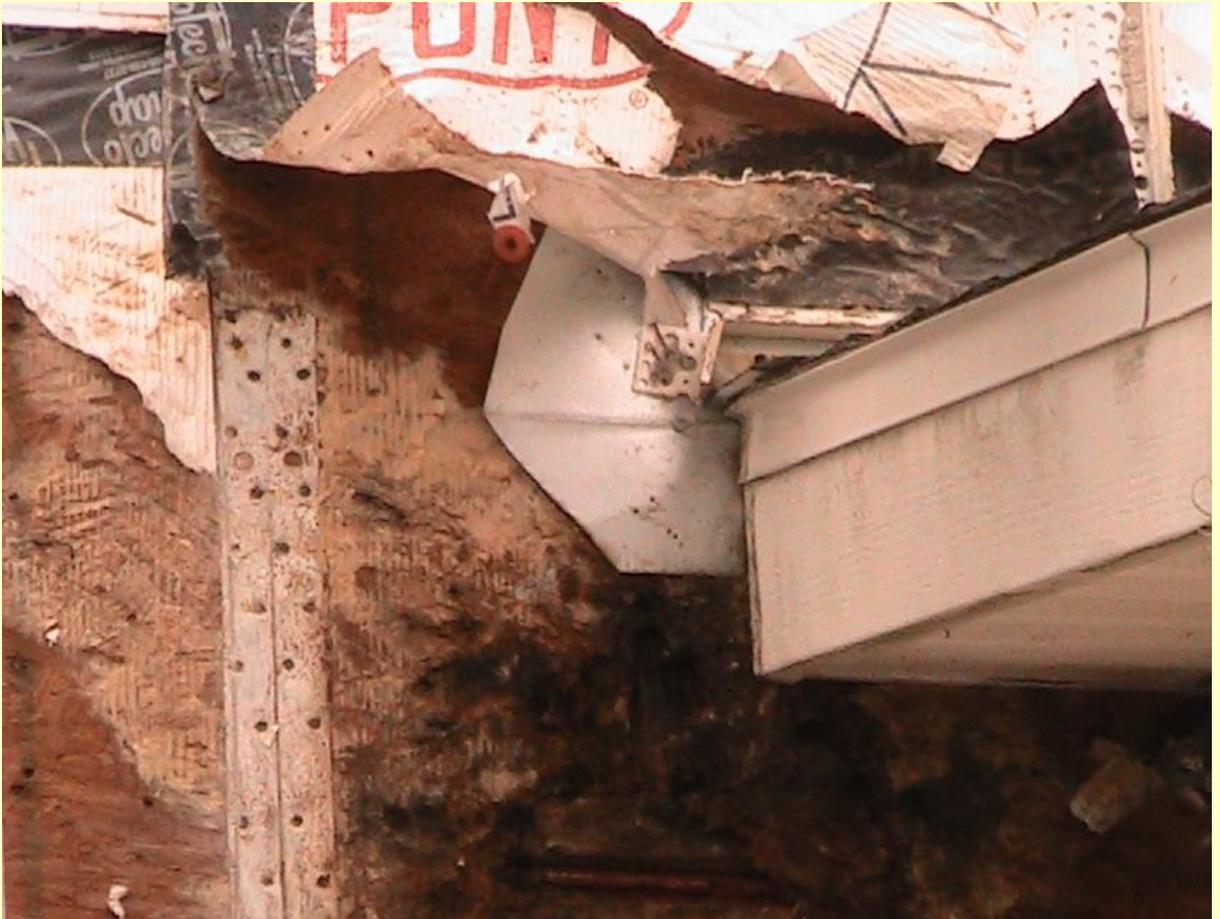
- Water path directly to the substrate

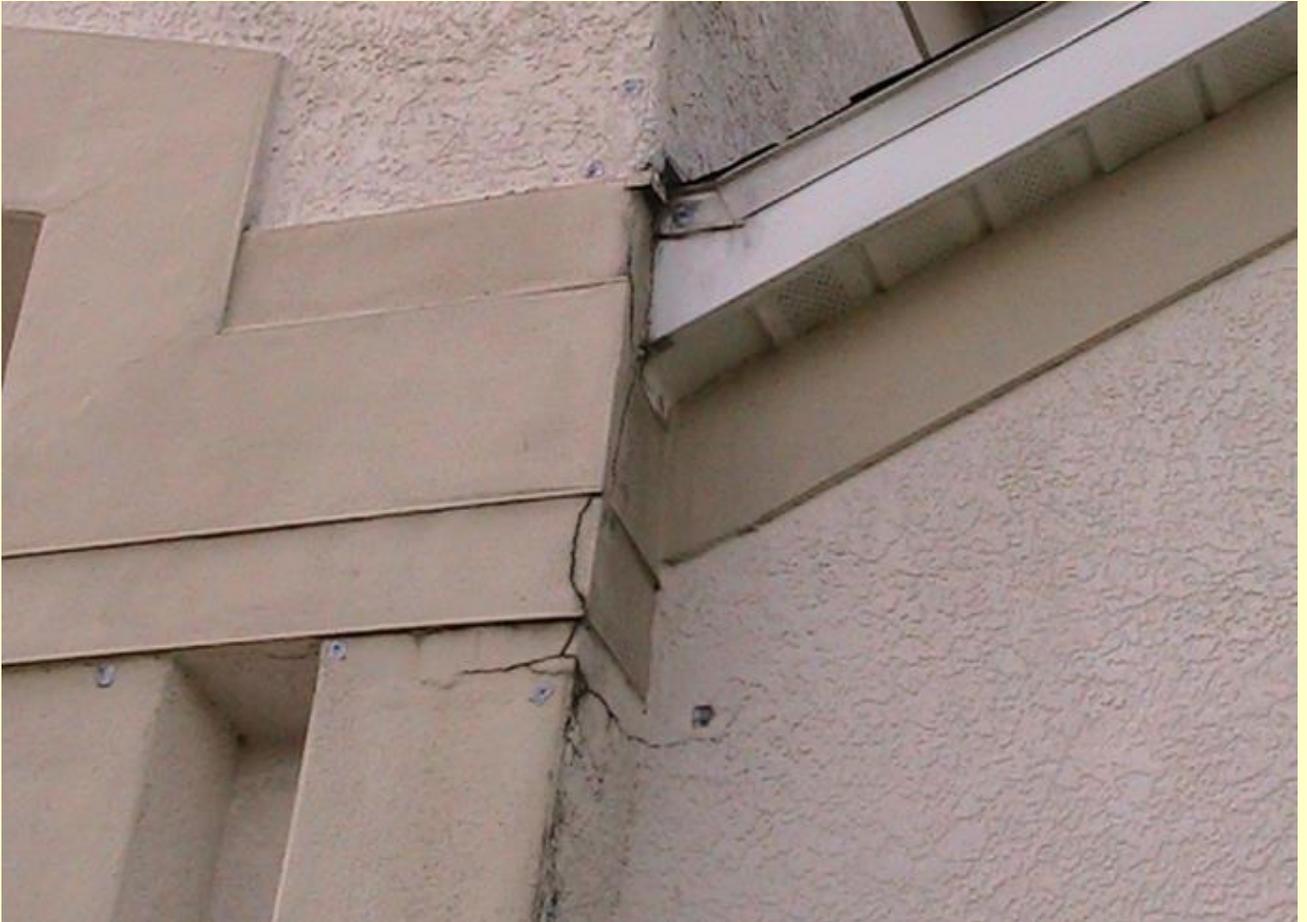
Section 18 - Water Intrusion at Roof Flashing behind Stucco Bands. This is a mess. Bad design, bad band installation, bad roofing flashing, bad fascia installation, bad wall accessories, bad painting, bad sealant (non-existent)

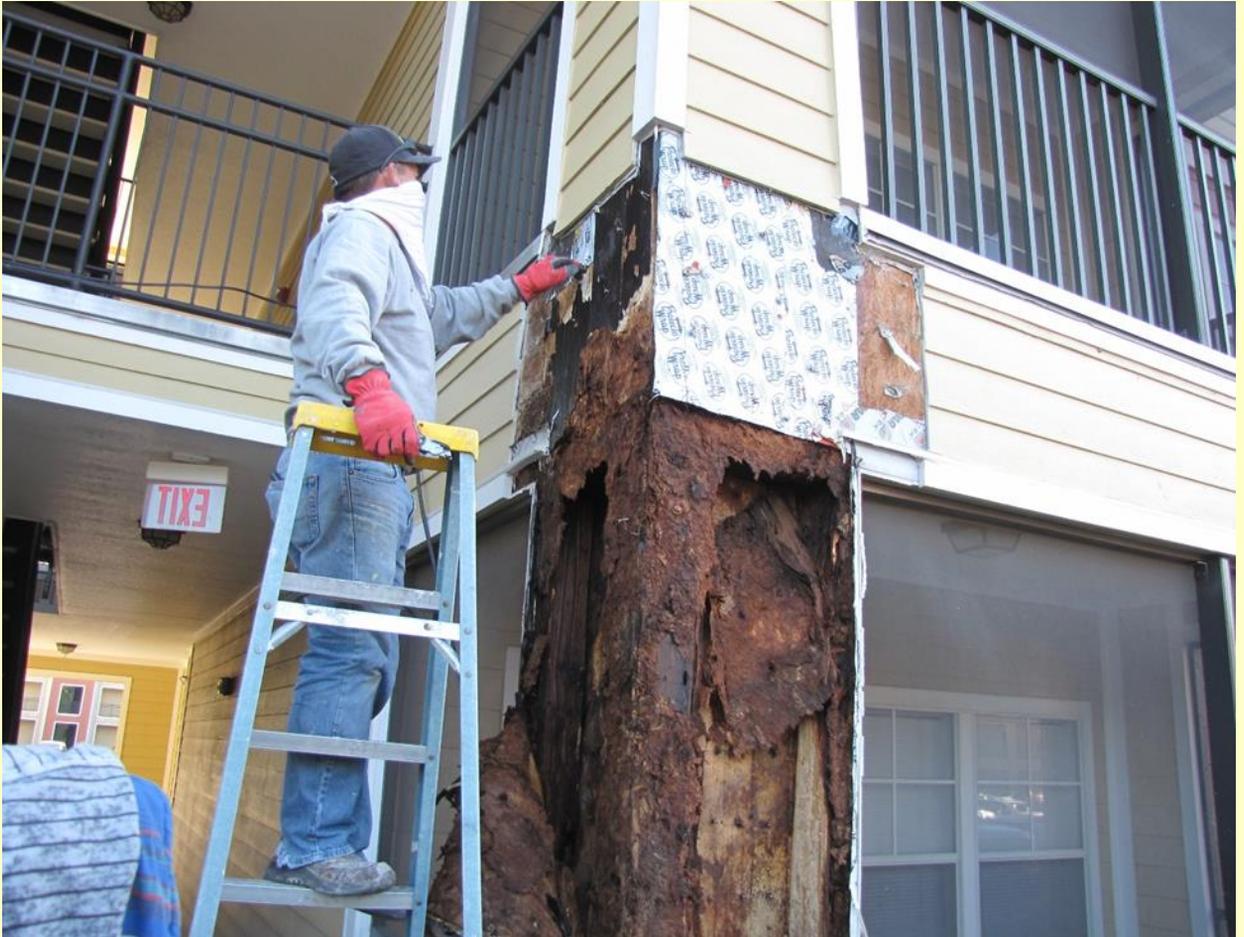
Section 20 - Deterioration behind peel-n-stick.
Bad Lap Siding? How did the water get there?

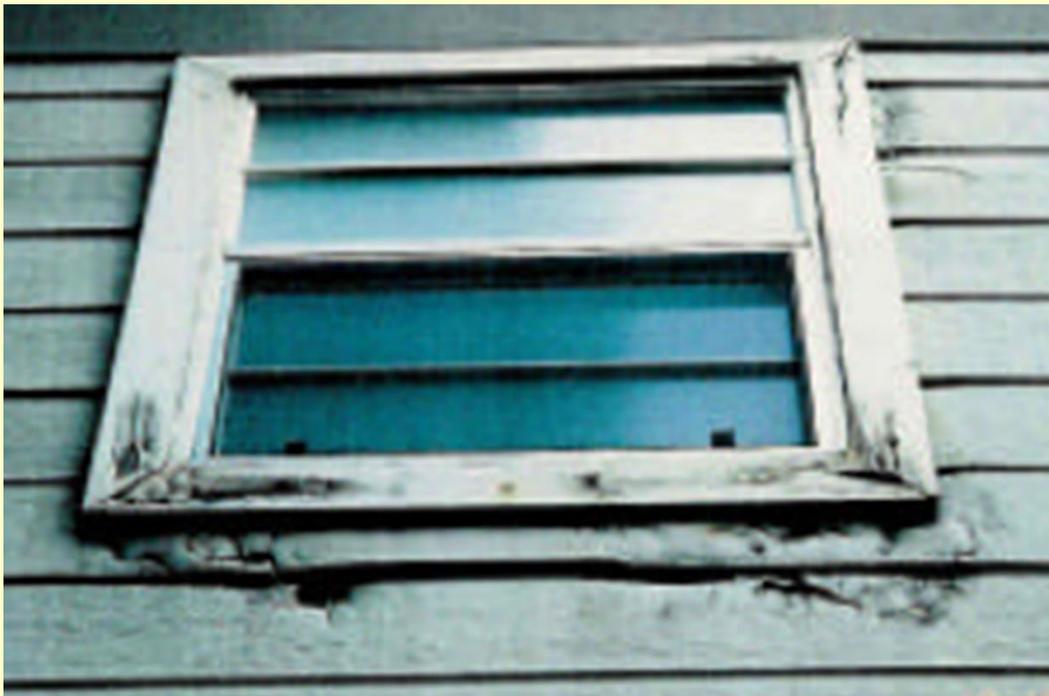
Section 20 - Window Trim Seal or Window corners themselves
