# A summary of Moisture Effects Behind Florida Stucco Systems

Developed by The Stucco Institute  
Contact: Robert Koning - Director  
8301 Joliet Street  
Hudson, Florida 34667  
727-863-5147  
[robertk@koning.com](mailto:robertk@koning.com)

## What is REALLY Happening in our Stucco Applications

# How Moisture Gets Behind the Stucco Assembly

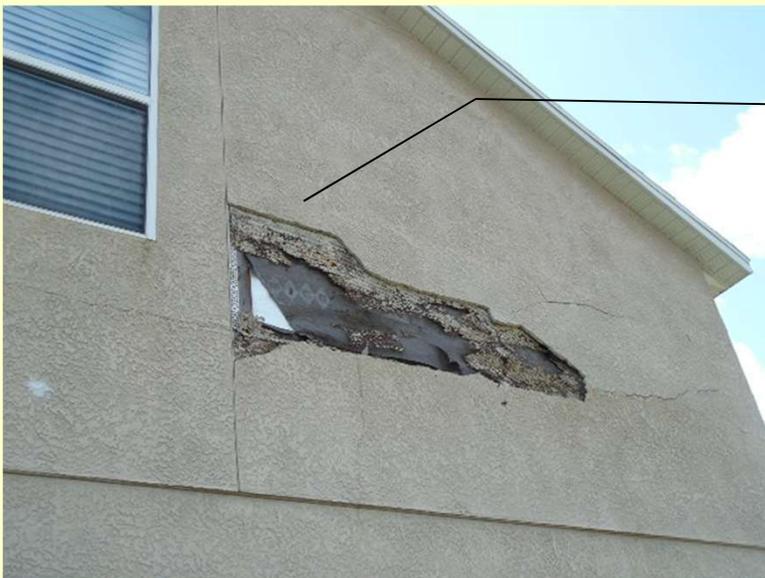
Rusting metal lath caused by bulk water entry at incorrectly installed control joint and insufficient coating and sealants. All leading to high R/H behind stucco system

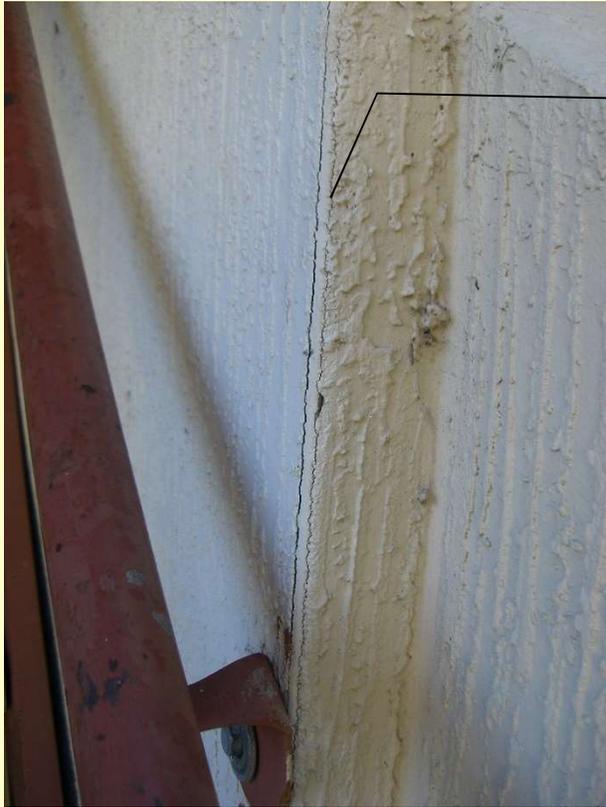
Corner Bead cracking and allowing bulk water infiltration. Coating so thin it is immeasurable. Sealants needed. All leading to high R/H behind stucco system

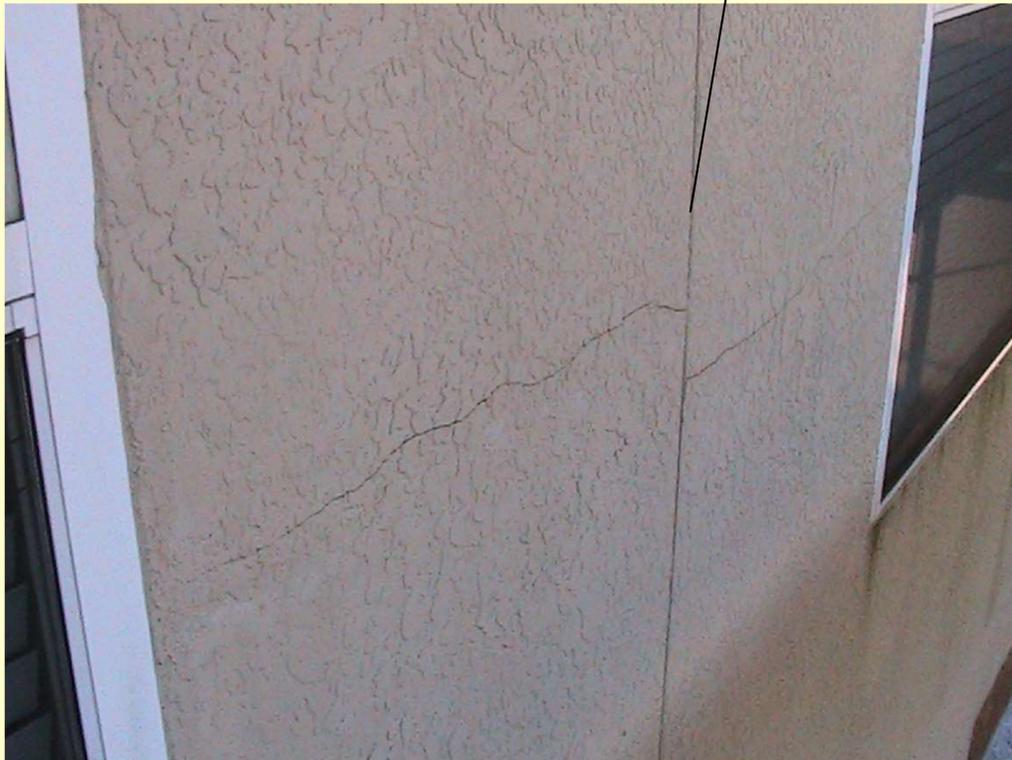
Control joint admitting bulk water entry. Insufficient coating thickness. (3 mils) Sealants needed. All leading to high R/H behind stucco system

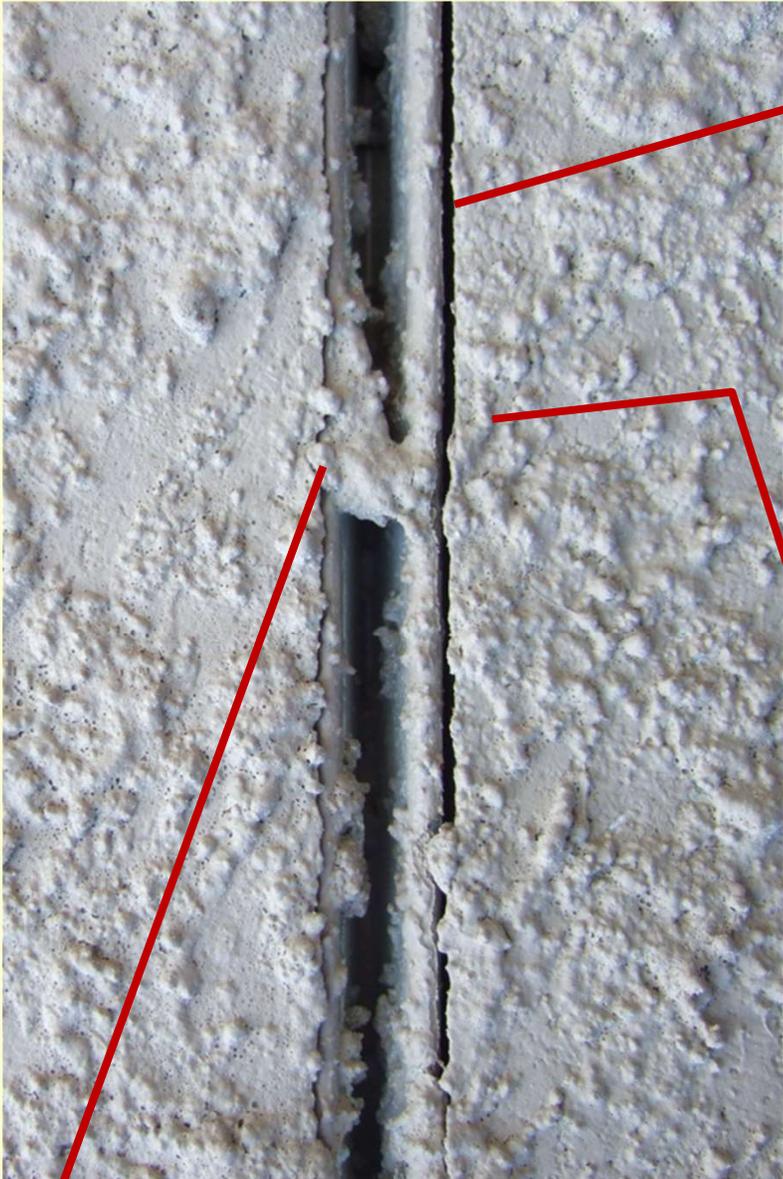
Close-up of corner  
Bead cracking and  
allowing bulk water  
infiltration.  
Coating so thin it is  
practically  
immeasurable.  
Sealants needed.  
All leading to high  
R/H behind stucco  
system

Coating is supposed to be 12  
mills.

How thick does this appear to  
be? Paper thin, too thin to  
obtain useable measurement.

Proper millage would bridge this  
gap and prevent water entry.

No self respecting plasterer would  
ever leave a joint like this.  
It would have been cleaned, edges  
brushed, and a small "V" groove on  
each side for the painter to seal.

The old way was to cut a "V"  
groove on each side of the  
control joint interface and seal.

The sequence was; prime wall,  
install sealant, apply finish  
coats.

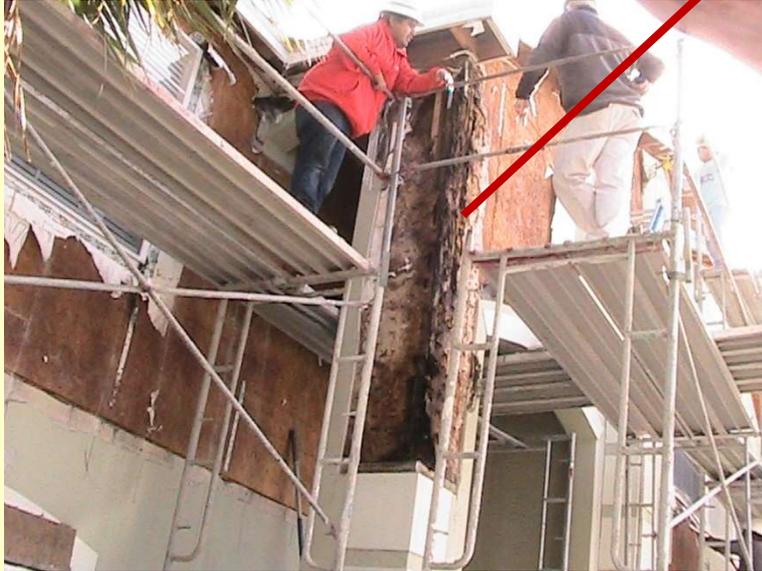
Corner bead flanges not fully embedded within the plaster body admitting water.  
Coating too thin; 2.5 to 4 mils.  
All leading to high R/H behind stucco system.

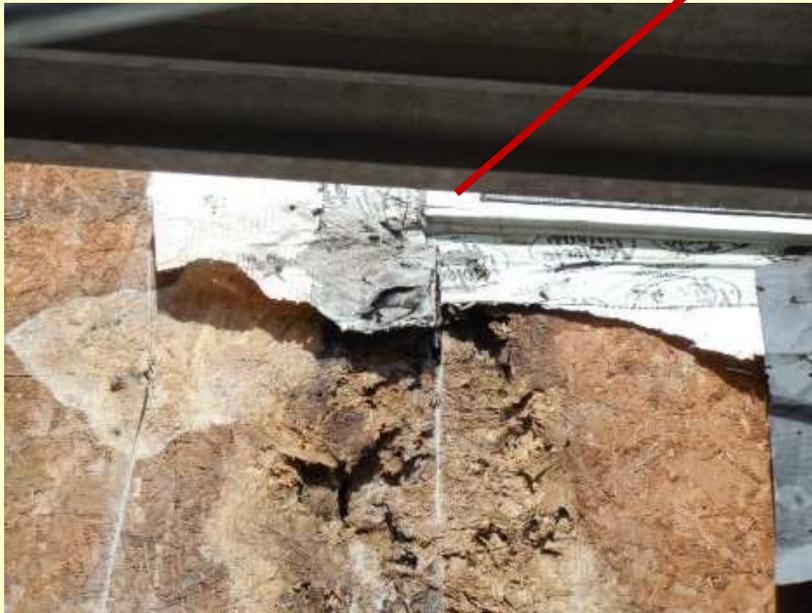
Mechanical Joint at bottom window sill intersection.  
Behind system condensation. Note decay starts behind flashing tape.  
Coating so thin it is immeasurable.  
Sealants needed.  
All leading to high R/H behind stucco system.

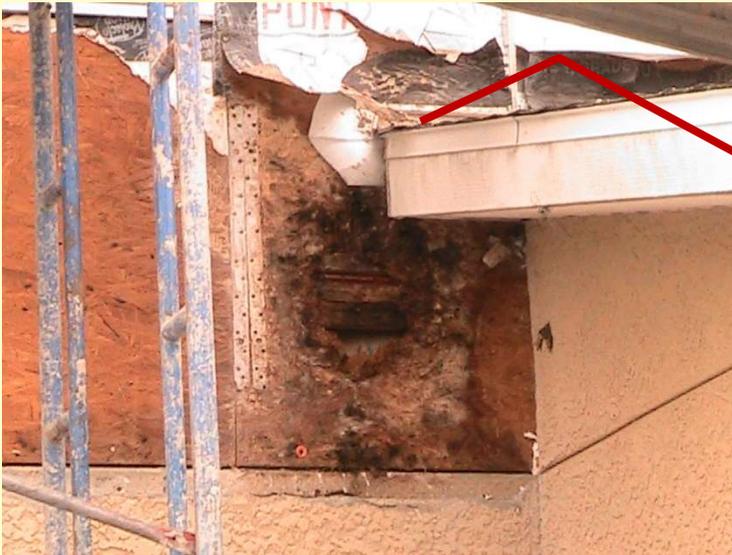
Roof flashing incorrectly installed.  
Improper interface (flashing not "kicked-out").  
All leading to bulk water and high R/H behind stucco system.

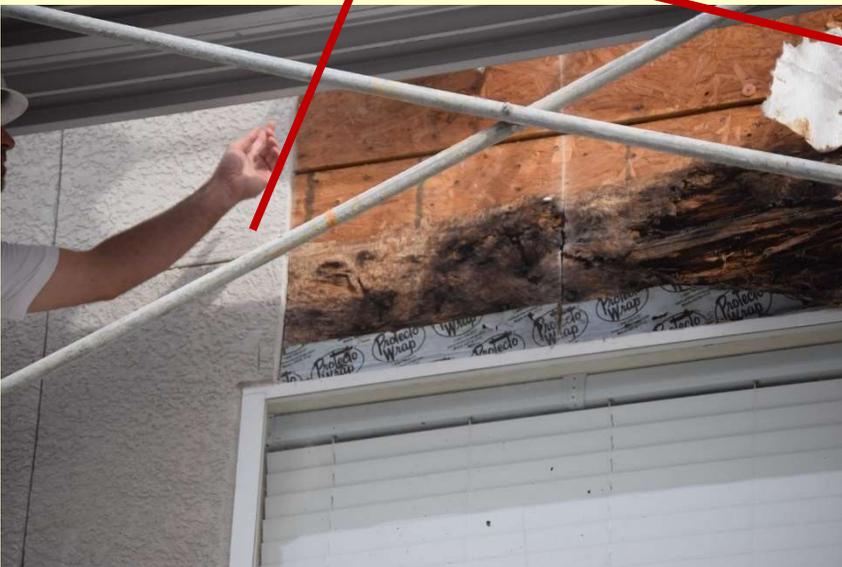
Horizontal Control Joint allowing bulk water infiltration.  
Coating too thin (2-3 mils).  
Sealants needed.  
All leading to high R/H behind stucco system.

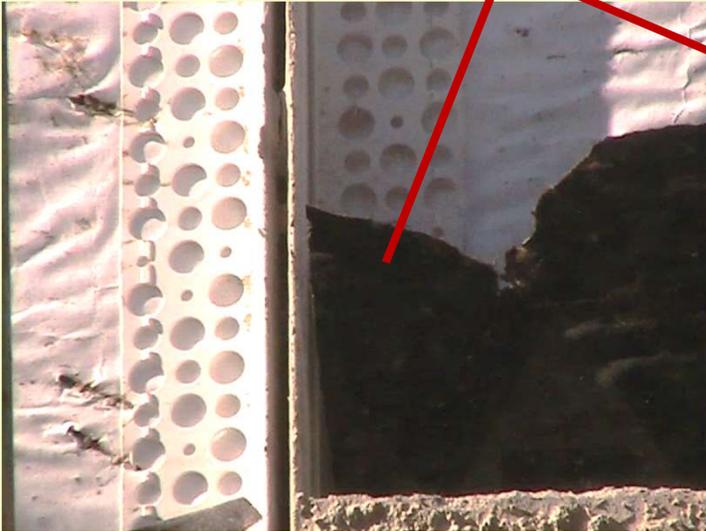
Vertical Control Joint installed with paper over flange preventing flange embedment – source of bulk water entry. Sealants needed. All leading to high R/H behind stucco system.

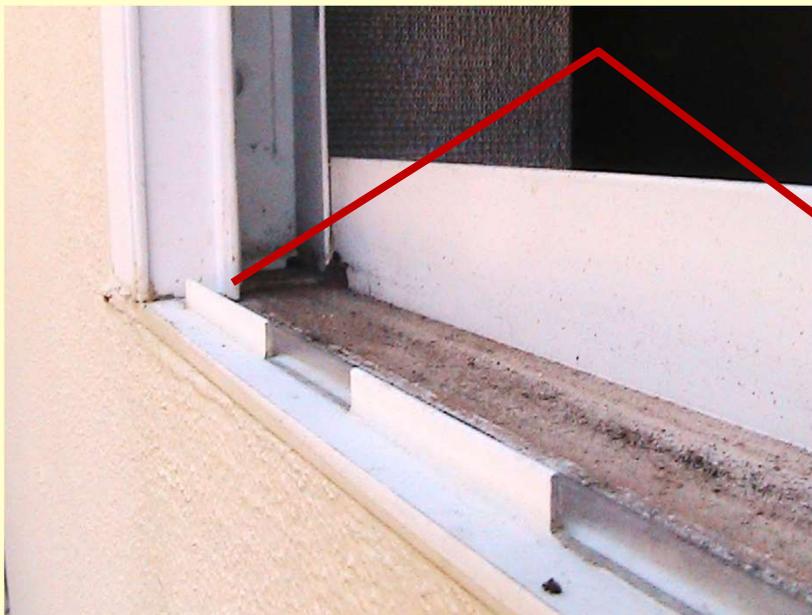
Mechanical joint only watertight to 10% of design pressure. Stressed by wall movement and high wind conditions, corners must be re-sealed when building is repainted. Sealants needed. All leading to high R/H behind stucco system.

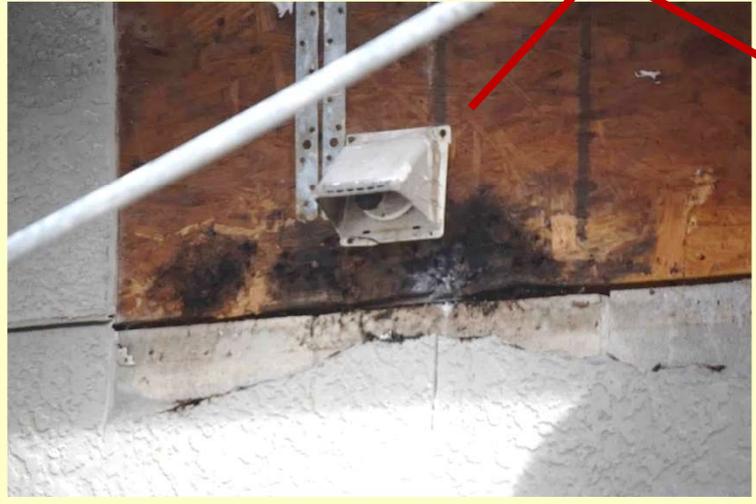
Flush mount dryer exhaust mounted to wall instead of on top of the finished stucco. Localized intrusion. Can lead to high R/H behind stucco system.

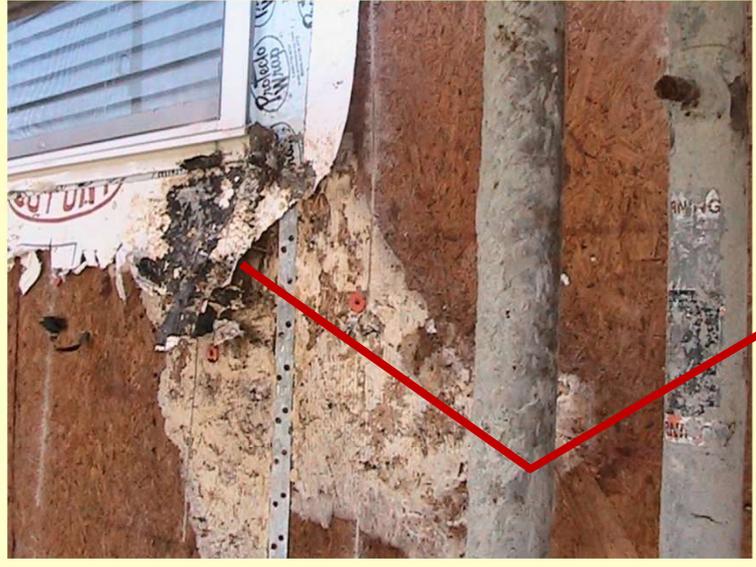
Window mechanical corner joint failure. Moisture source behind flashing. Aluminum window jambs/sills are first condensing surface at dew point. Sealants needed. All leading to high R/H behind stucco system.

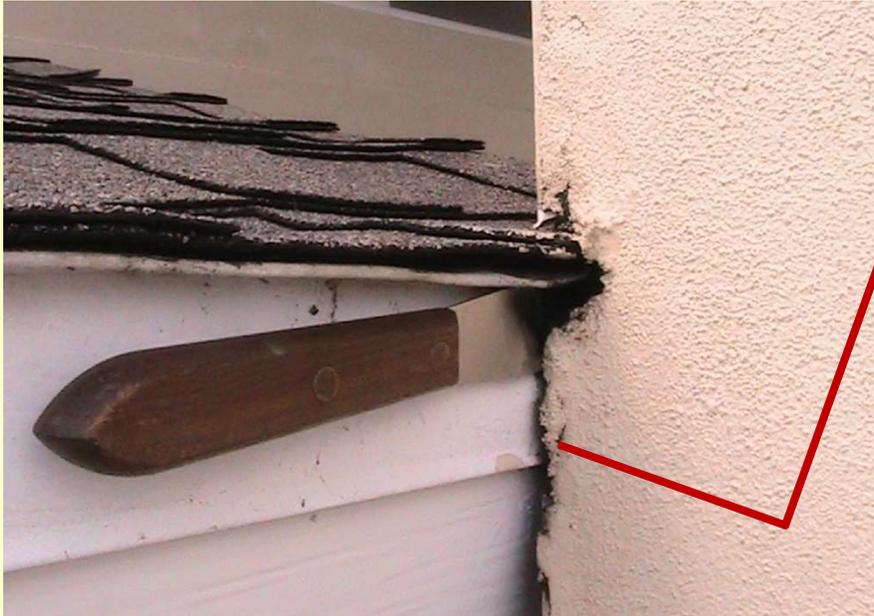
Metal eave drip behind stucco. Incorrect sequencing of work. No sealant. System not separated with "V" groove and sealed. Bulk water entry. R/H behind stucco system. This was entirely preventable.

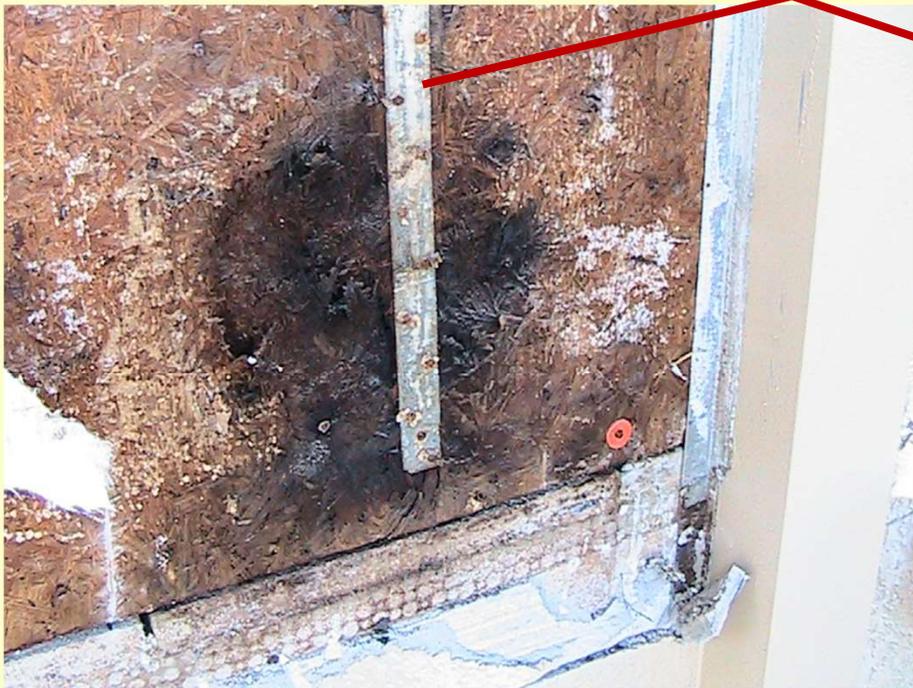
Condensation on fasteners and strap

Stucco must be applied tight to the wall with great hand pressure or sprayed with a machine

Hey, what is this, stucco being simply "laid-up" with a slicker? Hey, that won't work. But, most all have all been done that way. The industry is now moving to stop this practice. Look at the picture – 3 men "mudding" up the walls – no trowels. This makes for a "fluffy" application that vapor can pass through a lot easier than a densely packed application. Proper face barrier however will prevent that passage.

Slickers noted by arrows

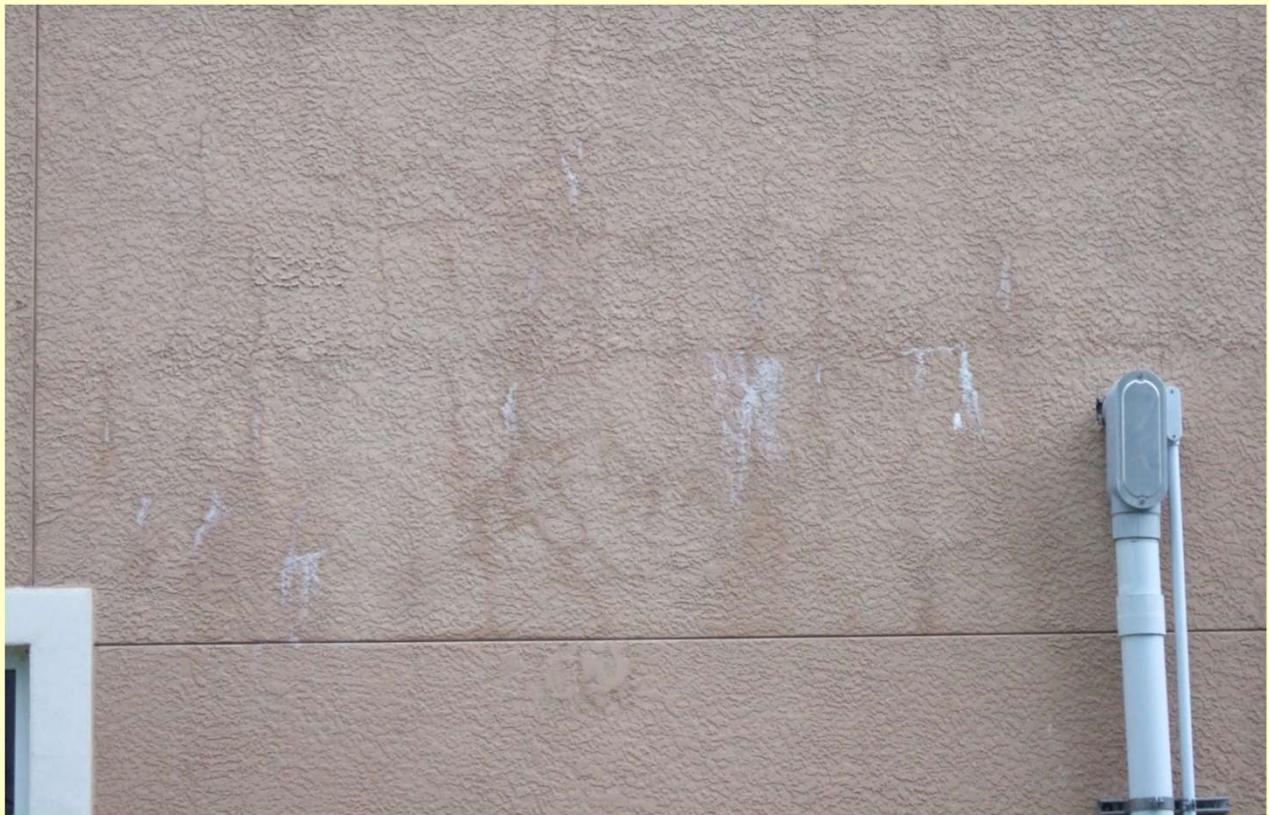
How much vapor do you think is passing through this wall? Paint so thin, measurable samples cannot be practically taken. Microscopic examination shows 0.75 – 1 mill.

Assume you had thickness of 3 mills and you needed 9 mills;  $\frac{2}{3}$  of your product would be missing. Now, think of a standard roofing shingle, if you could cut off  $\frac{2}{3}$  of its thickness with a laser and placed the remaining  $\frac{1}{3}$  on the roof – how long would it last? Maybe 5 years?

Now think of all that passing vapor “trapped” behind the wall. When evening comes, temperature drops, dew point is attained, the vapor will condense on what? Maybe the back of the metal lath?, aluminum window frames?, metal straps?.... You get the point.

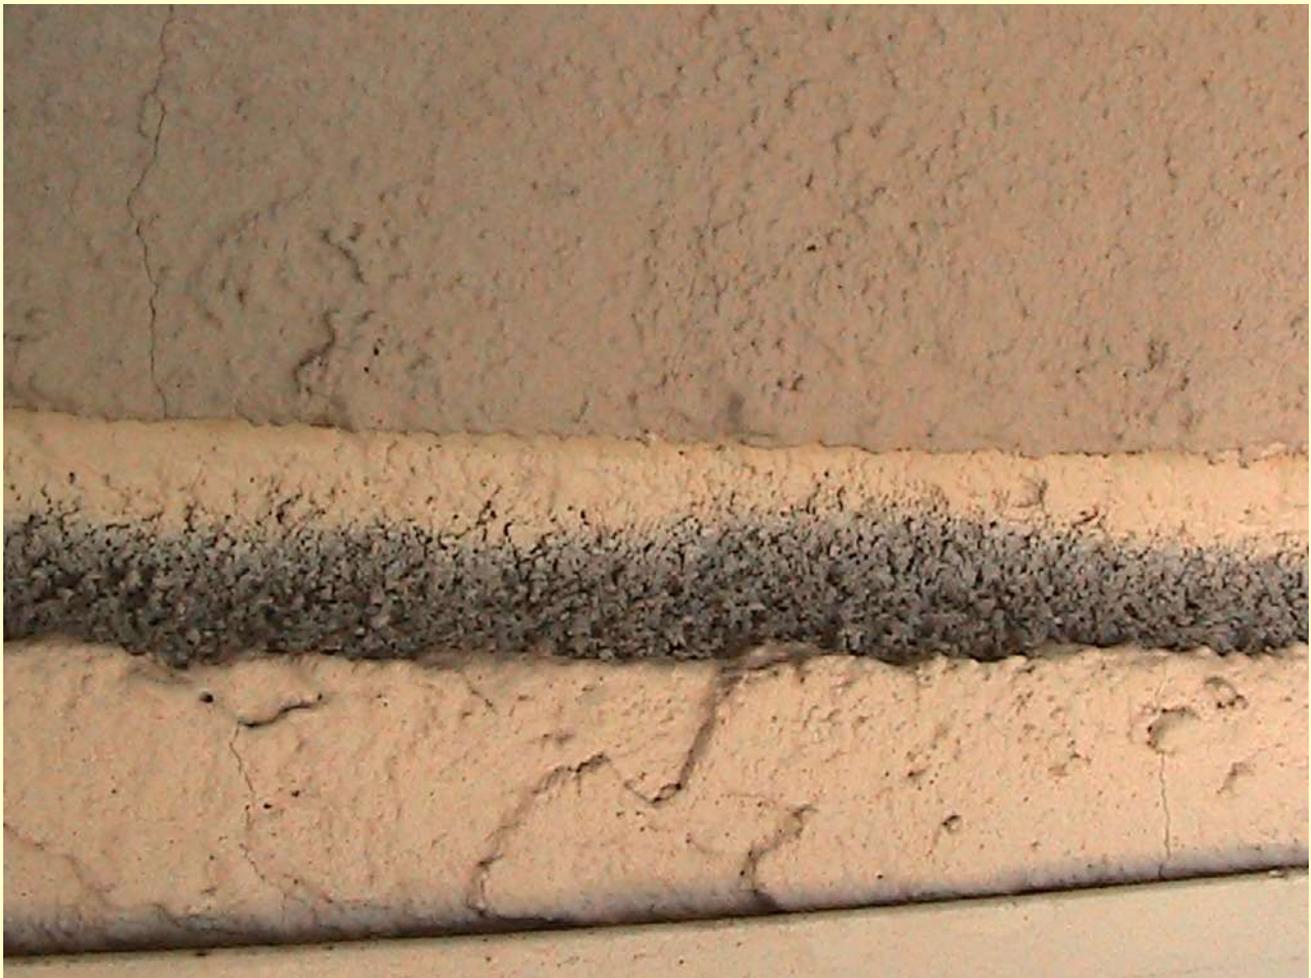
This is a close-up of a cut-in stucco reveal above a window on the 2<sup>nd</sup> story of a newly built, newly painted, occupied home. The paint specifications SHOULD call for 12 mil thickness – but, as usual, they say nothing. In case you're missing it, the gray is bare stucco. Since a spray rig was used to paint (instead of brush and roller) the upward spray caught the upper side (the one you see from the ground) of the reveal, but left the bottom (that will catch water) completely bare. Thickness on face of wall was less than 4 mils. Gee, I don't know why where're having these stucco problems!!!!

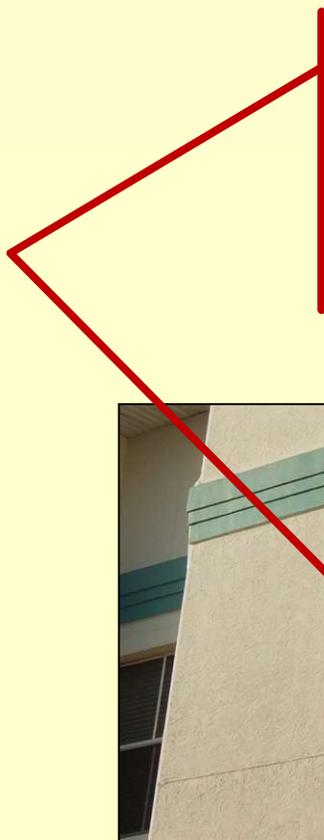
Wall coating too thin, moisture condensing behind panels.  
Building needs re-coating and new sealants  
All leading to high R/H behind stucco system.  
Action is needed now – not later, all is salvageable now with no further damage.

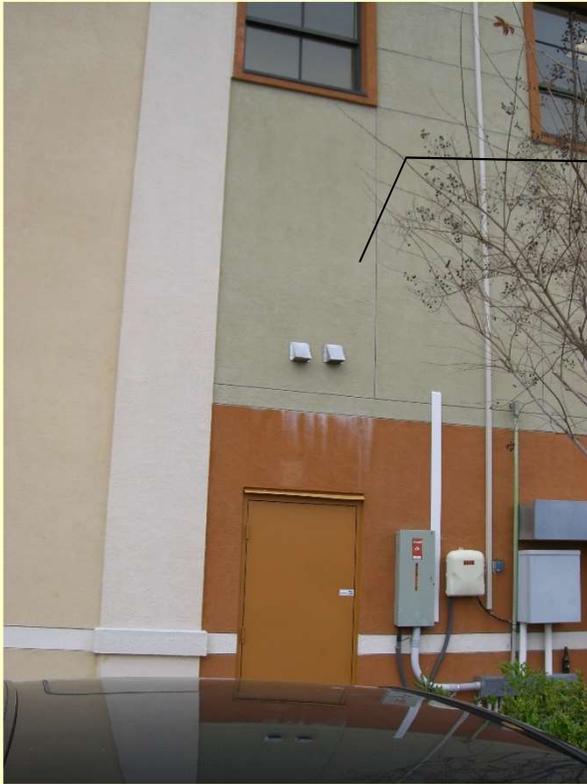
Coating too thin 2.5 to 4 mils.  
All leading to high R/H behind stucco system.  
Aluminum dryer vent provide a perfect subsurface cavity condensing surface.

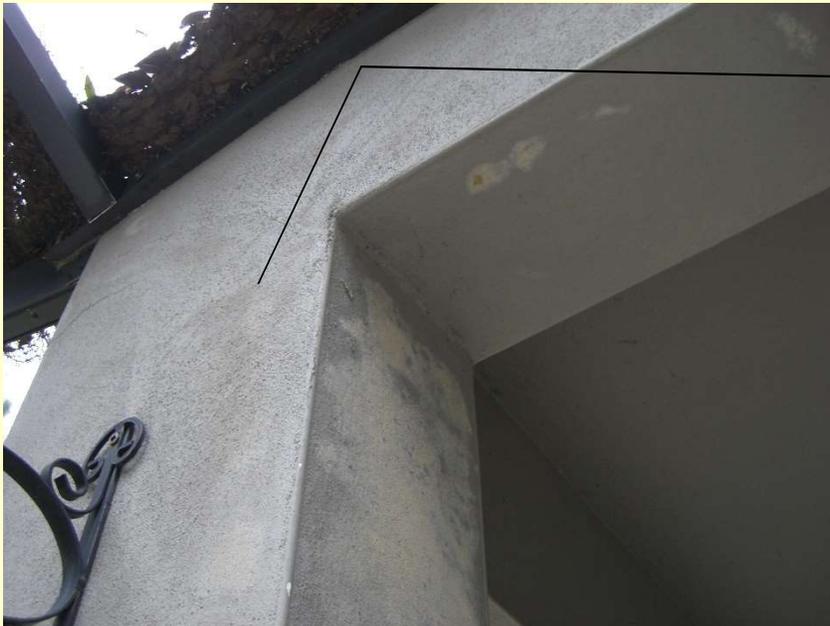
Corner Bead cracking, allowing bulk water infiltration.  
Coating so thin it is immeasurable.  
Sealants needed.  
All leading to high R/H behind stucco system.

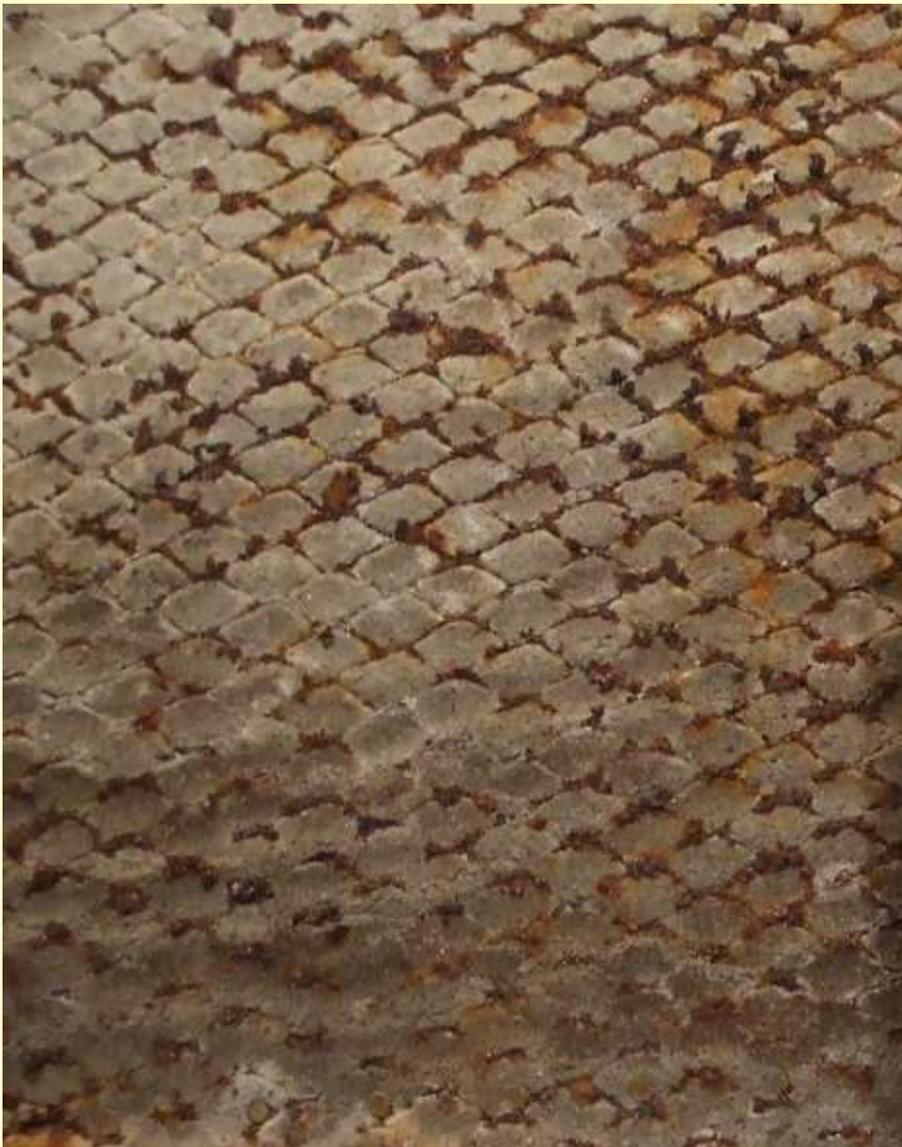
Effects of condensation on metal lath at the back plane of the stucco assembly. Water vapor depositing moisture and salts. I was taught how to prevent this from happening by plasterers over 40 years ago. They knew this would happen if you did not install a stucco system for Florida's environment. More later on... Multiple layers of backing paper some of ASTM's international requirements make this problem WORSE!

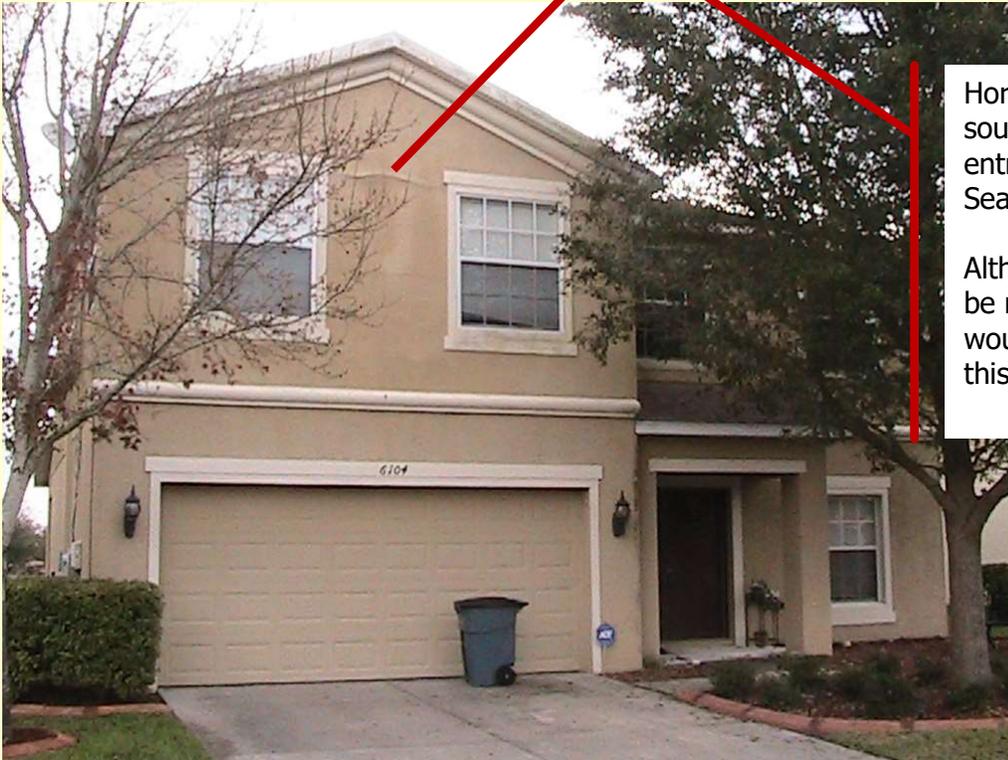
Horizontal control joint is source of bulk water entry. Sealants were needed.

Although the wall could be repaired, economics would dictate removal of this wall only.

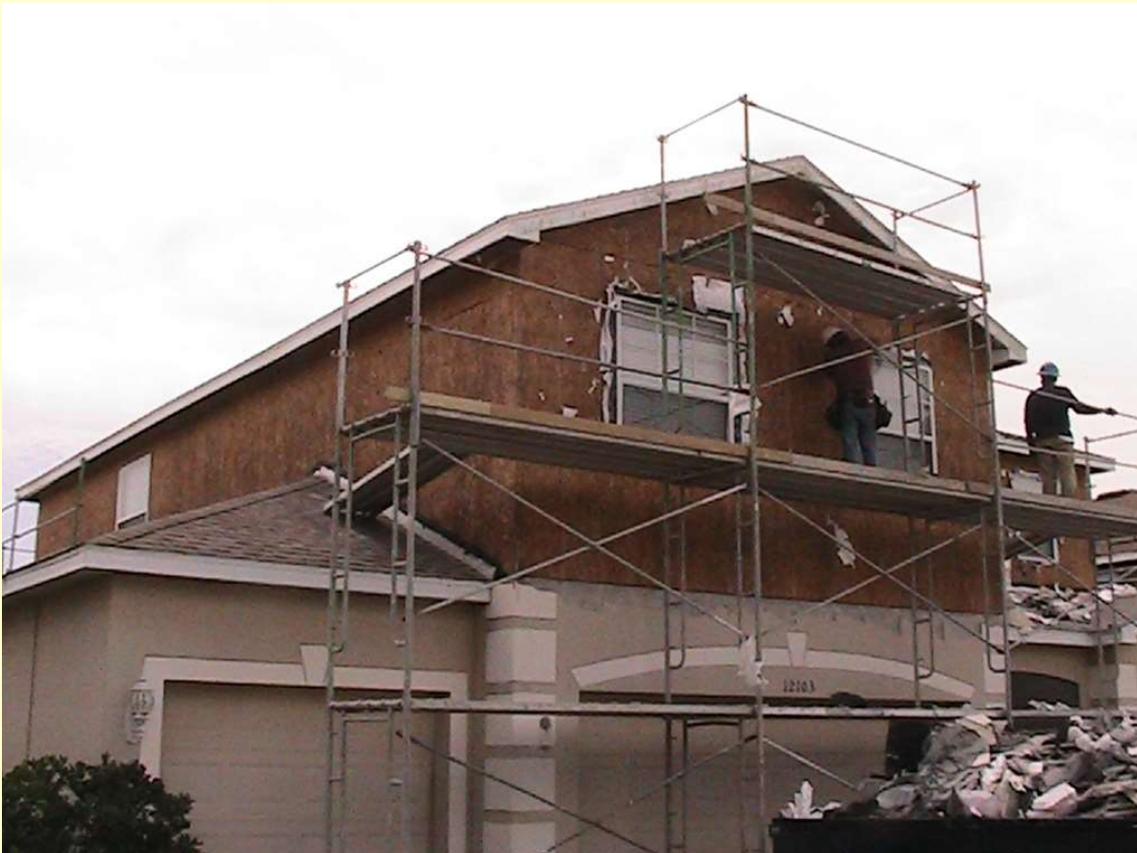
These buildings are being de-skinned by the advice of a "con-sultant" masquerading as a stucco expert. Their reason for de-skinning; there were no drain planes or weep screeds so the system was deemed "non-code compliant". Otherwise, the jobs were perfect and around 8 years old. Note, there is no damage, no water migrating to be let out of a "weep" screed. The houses had face barrier systems that were working perfectly. These new code compliant replacement systems are now showing signs of failure as soon as 3 years.

The ASTM standard referenced by the code has an important provision within its text that reads: "unless otherwise specified". The consultant should have determined if the contractor had in fact, "specified otherwise" before claiming code violations and ordering un-necessary de-skinning.

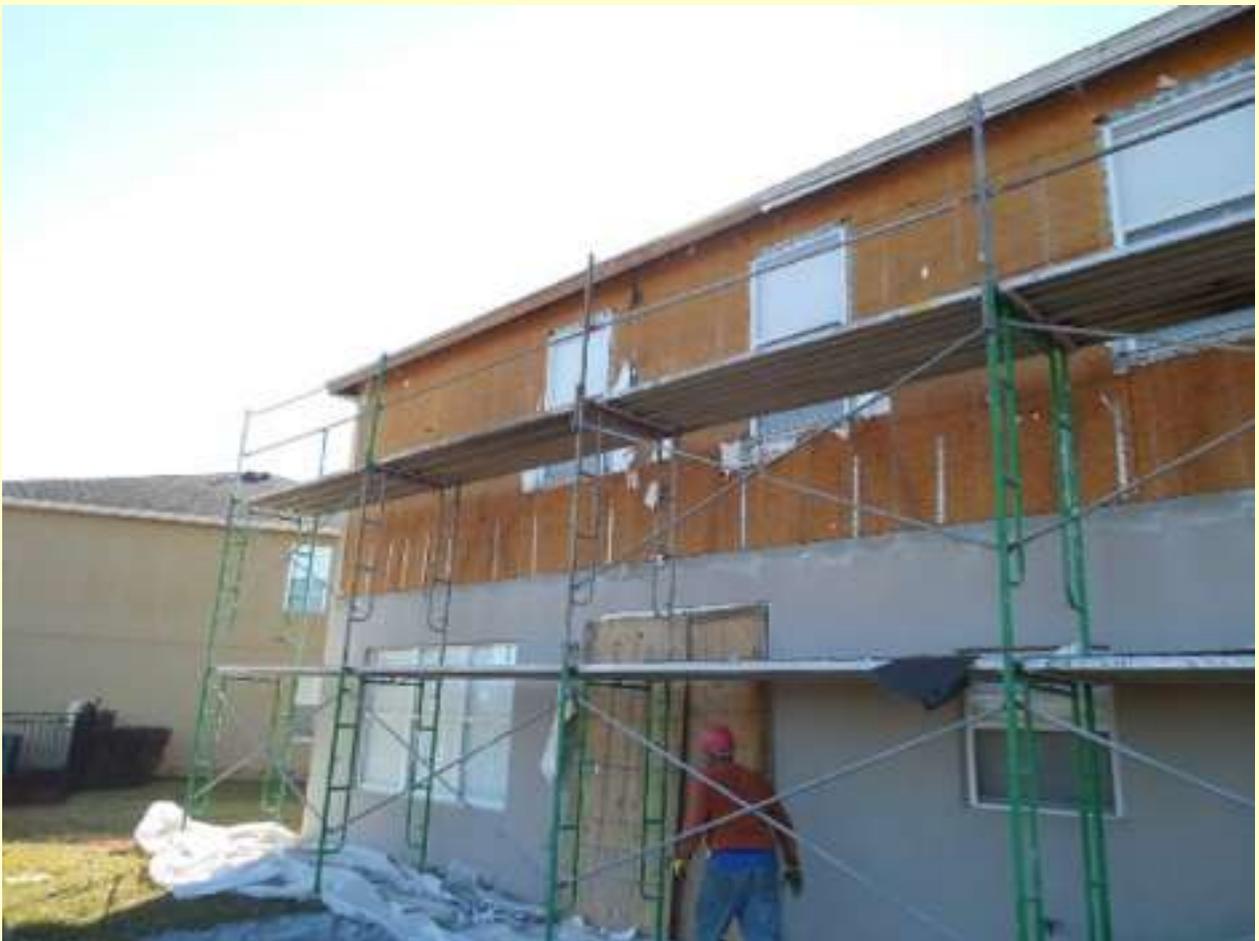
No weep screed, no drain plane, perfect performance – yet, the order to deskin was given by the “professional”. Anyone see any damage?, any water dammed at the bottom? Face barrier system performing perfectly. Un-knowledgeable, un-professional consultants..... This is what is ruining our profession. We can fix the job problems – we cannot seem to fix the professional incompetence.

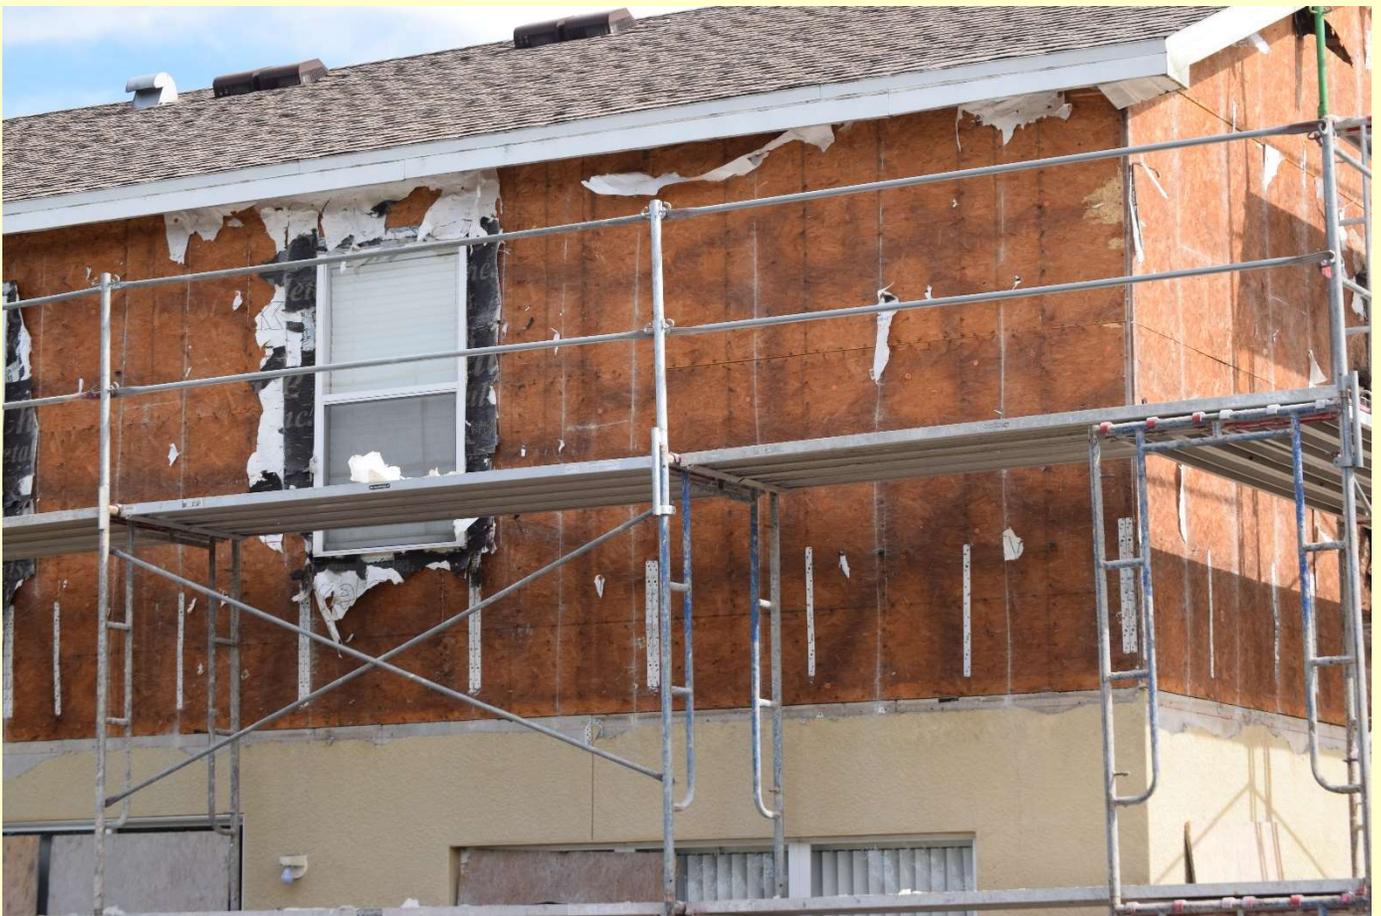
Again, a complete waste of money, time and effort – and the new so called “code compliant” systems being re-installed (although they really are not compliant) are now on their way to failure. Boy is this going to be a mess 10 years from now..

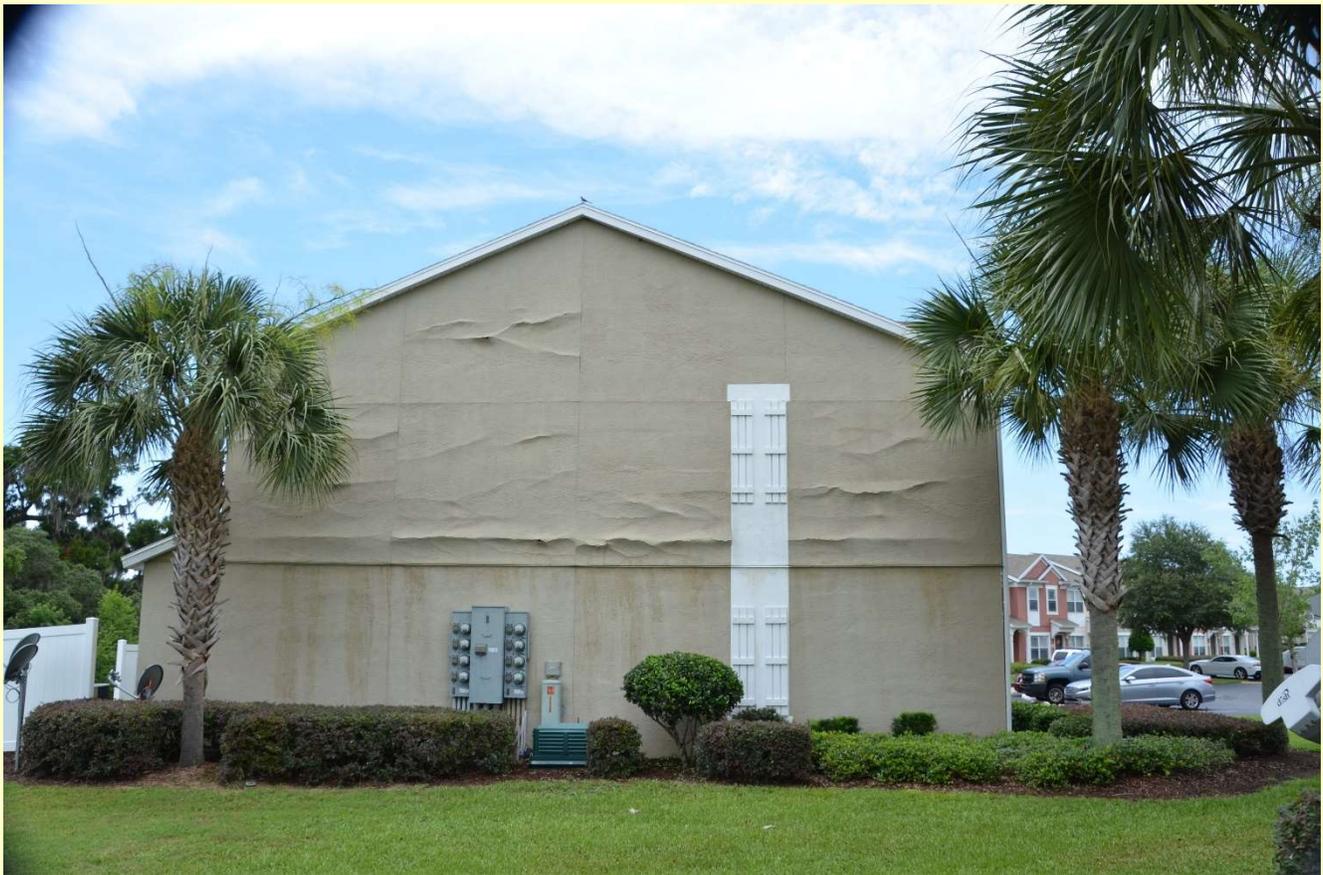
Group, in this case, classic control joint defects is initiator. We have traced them on many jobs. Paper over control joint flange. Water enters, travels down until a paper lap, or void, turns and migrates it horizontally. Air is elevated behind the assembly, OSB swells (in its thickness stressing the brittle stucco coat), cracking (minute at first) is then further initiated, leading to the introduction of ambient R/H (vapor). Vapor cools at night, condenses on the first available condensing surface (back side of the lath) causing rusting, which expands....etc....

Exacerbating factors; drain plane allows vapor to accumulate and circulate behind the stucco assembly, slickers used to lay on first coat, insufficient mil thickness allow the whole wall to become permeable.

Small amounts of vapor should be able to pass through (when we used wood or plywood) the sheathing, but OSB is virtually a vapor barrier unto itself. So the vapor is blocked or severely impeded at this plane. Again, small amounts still would not be a problem by and of itself. However the amount grows exponentially and after a few years it can become catastrophic when coupled together with other exacerbators such as; base coat by slicker, air circulating drain plane allowing the free entrance of moisture laden air, insufficient mil thickness allowing the passage of vapor and allowing the stucco to become wet after each rain, stucco control joints installed incorrectly allowing bulk water

and vapor admission behind the wall that that is seriously restricting the vapor migration (discharge) through to the conditioned side of the wall. Dew point behind the stucco assembly occurs almost every night causing condensation on the first available condensing surface; the exposed metal lath, and, if we could make it worse, the depositing of migrating salts on the same metal surface, now factor the stress of thermal swings to the front and back of the assembly coupled with wet/dry areas...
