Full scale Stucco Model Testing  
Developed by Robert Koning – Director of  
Contractors Institute  
8301 Joliet Street  
Hudson, Florida 34667  
727-863-5147  
[robertk@koning.com](mailto:robertk@koning.com)  
All material Copyrighted 2015

# Full Scale Testing Model Constructed with a Sealed Stucco System

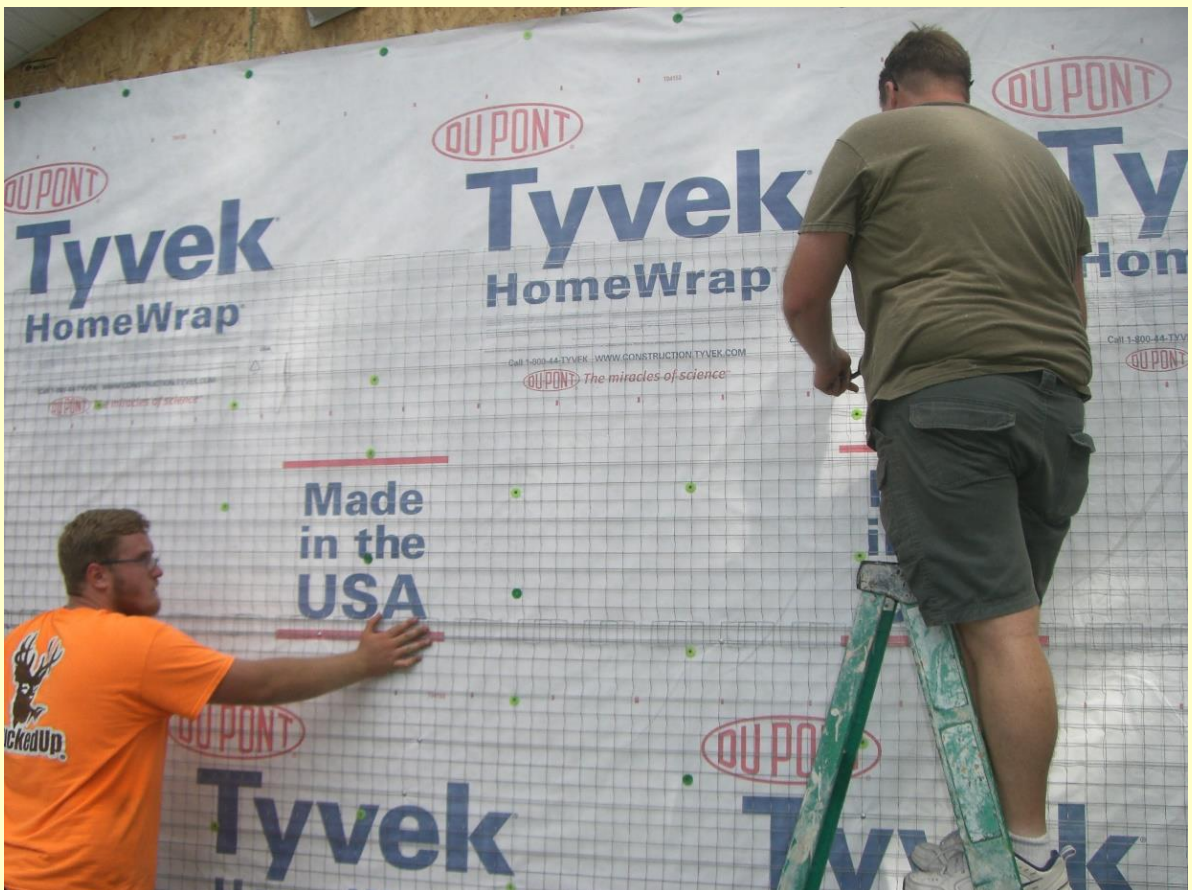
- West Wall lath installation
- Structalath installed directly over Tyvek Housewrap
- Installed July 10<sup>th</sup> 2015

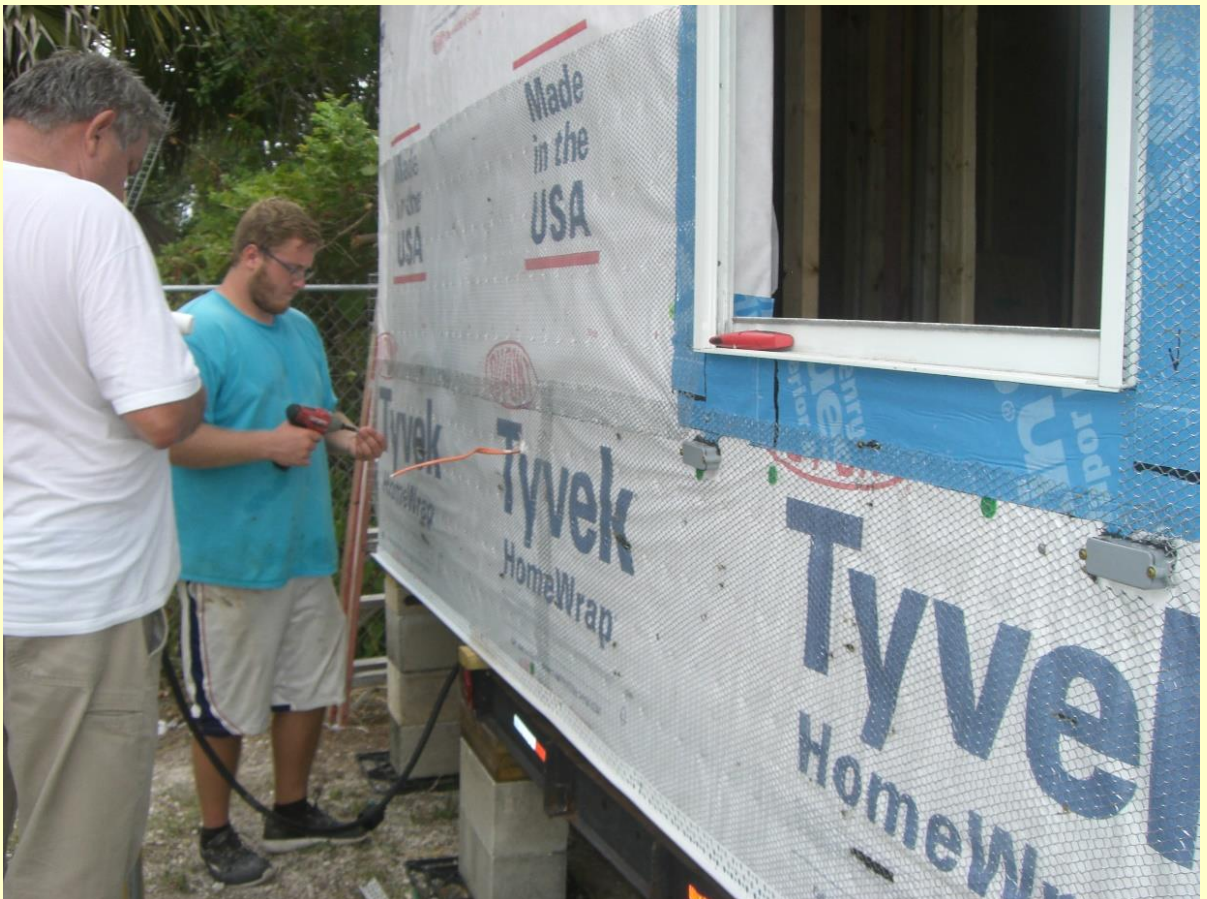
- East wall lath installation
- Amico Wire Lath installed directly over Tyvek Housewrap
- Installed July 11<sup>th</sup> 2015

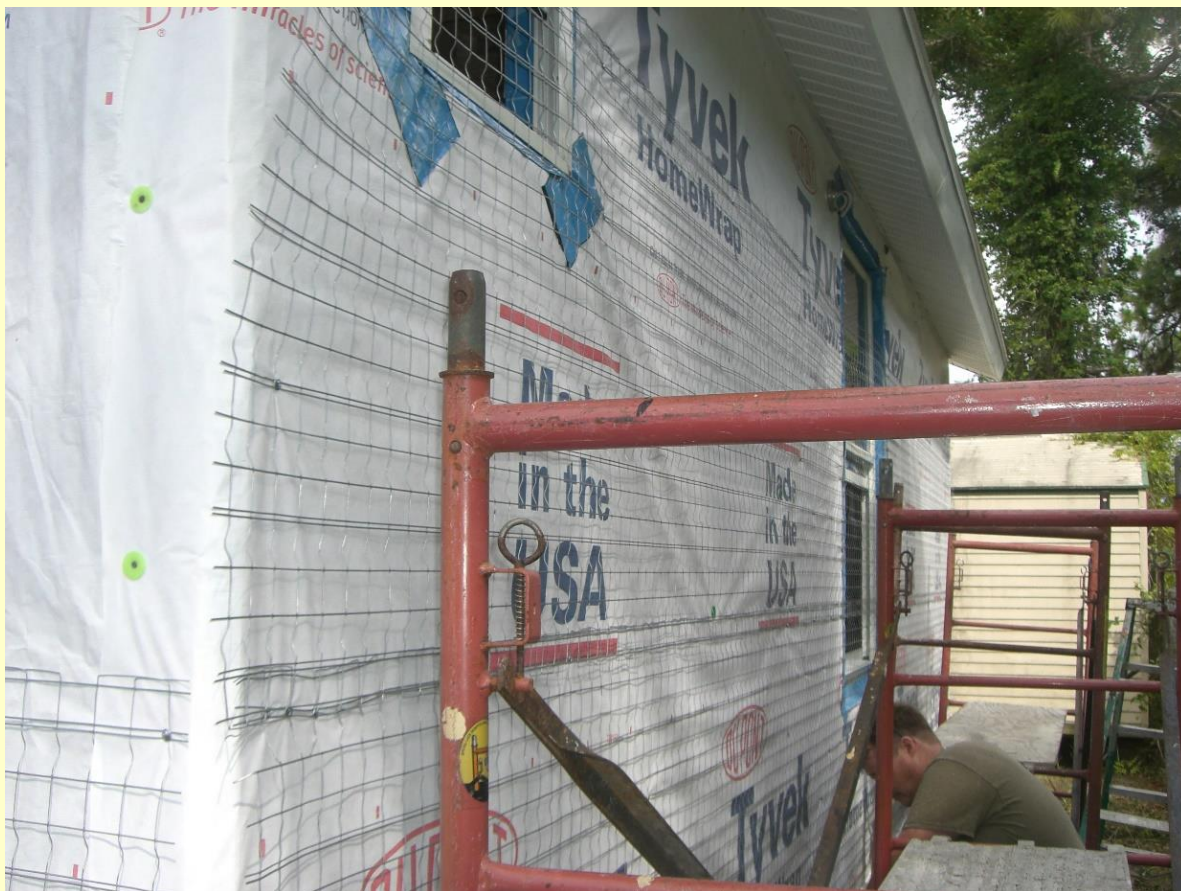
- South Wall lath installation
- Structalath installed directly over Tyvek Housewrap
- Installed July 10<sup>th</sup> 2015

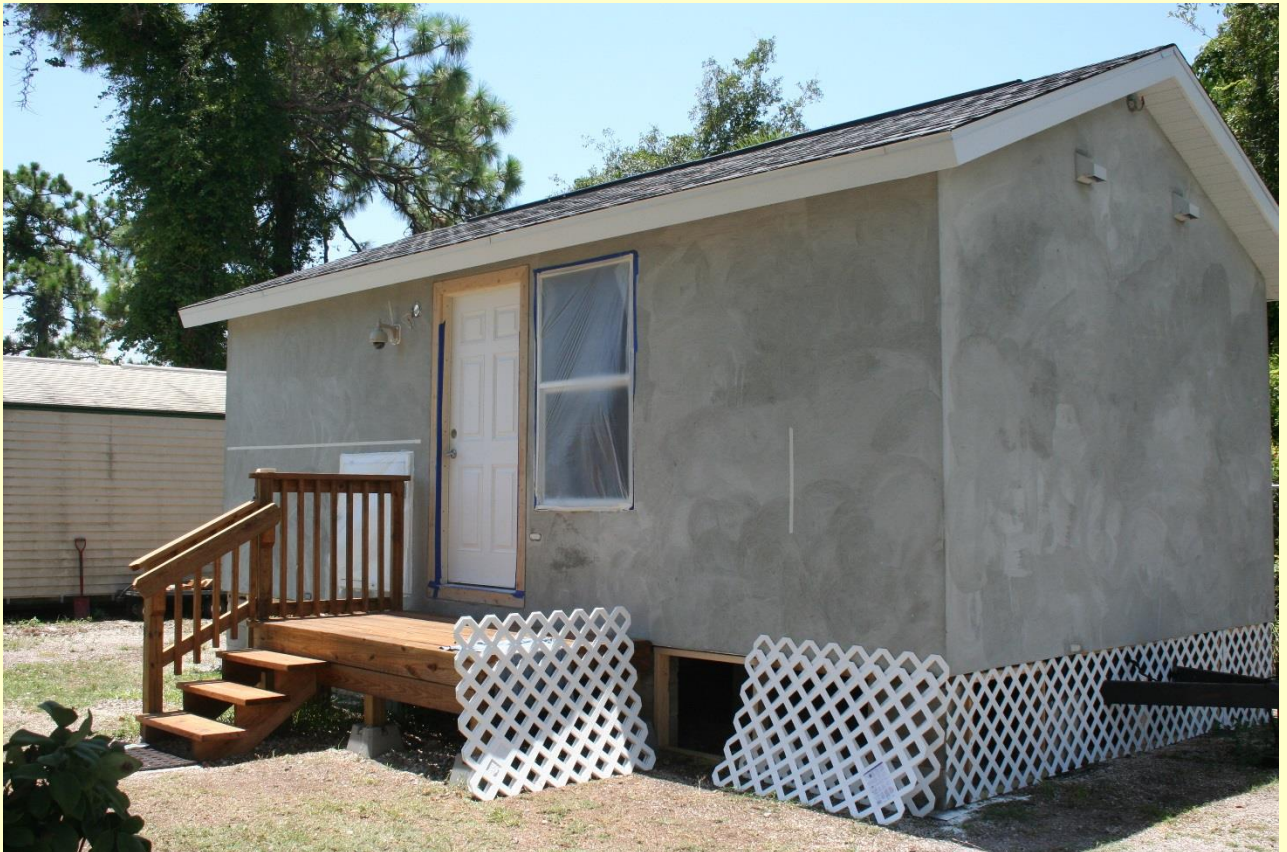
- North Wall
- Stucco Installed 6/24/2015
- Cured for 19 days before any crack documentation
- All walls densified except east wall

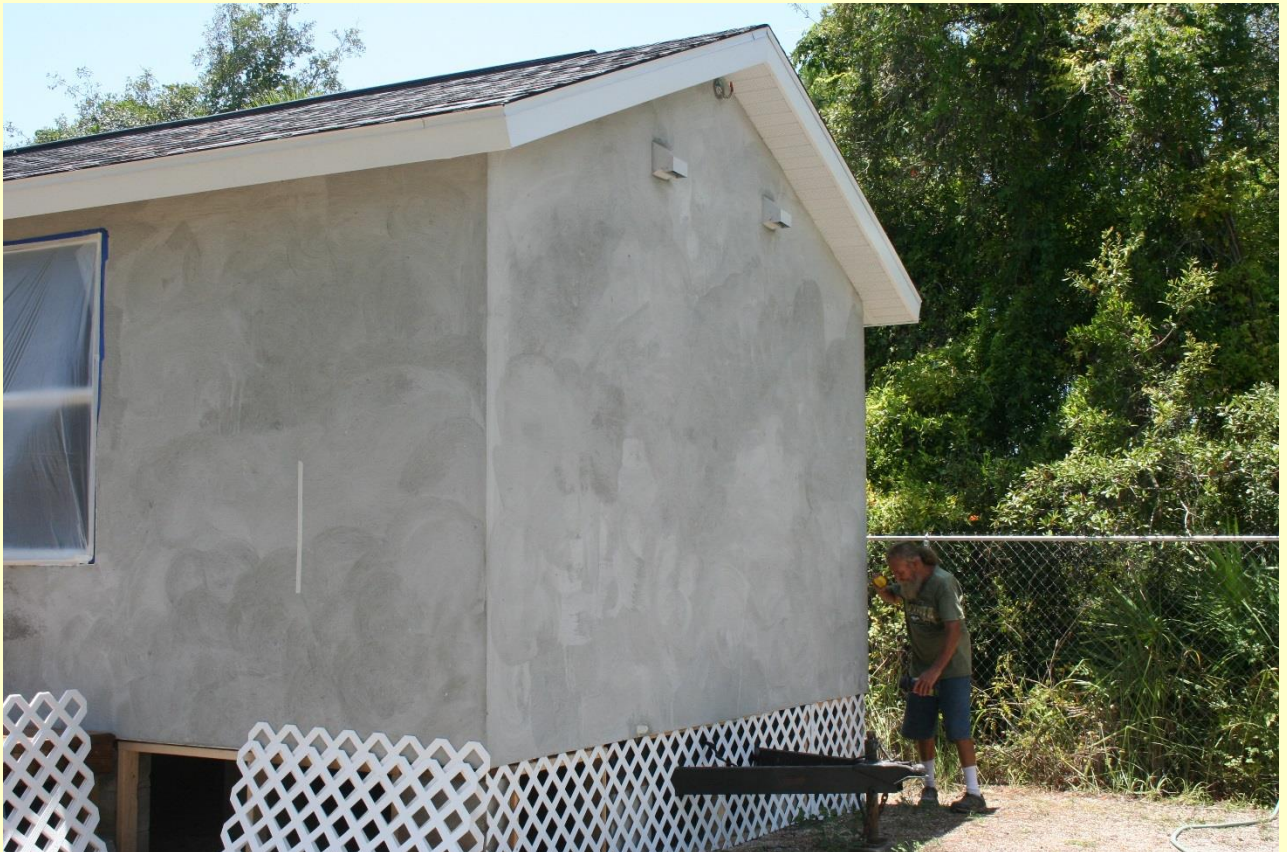
- West Wall
- Stucco Installed 6/24/2015
- Cured for 19 days before any crack documentation
- All walls densified except east wall

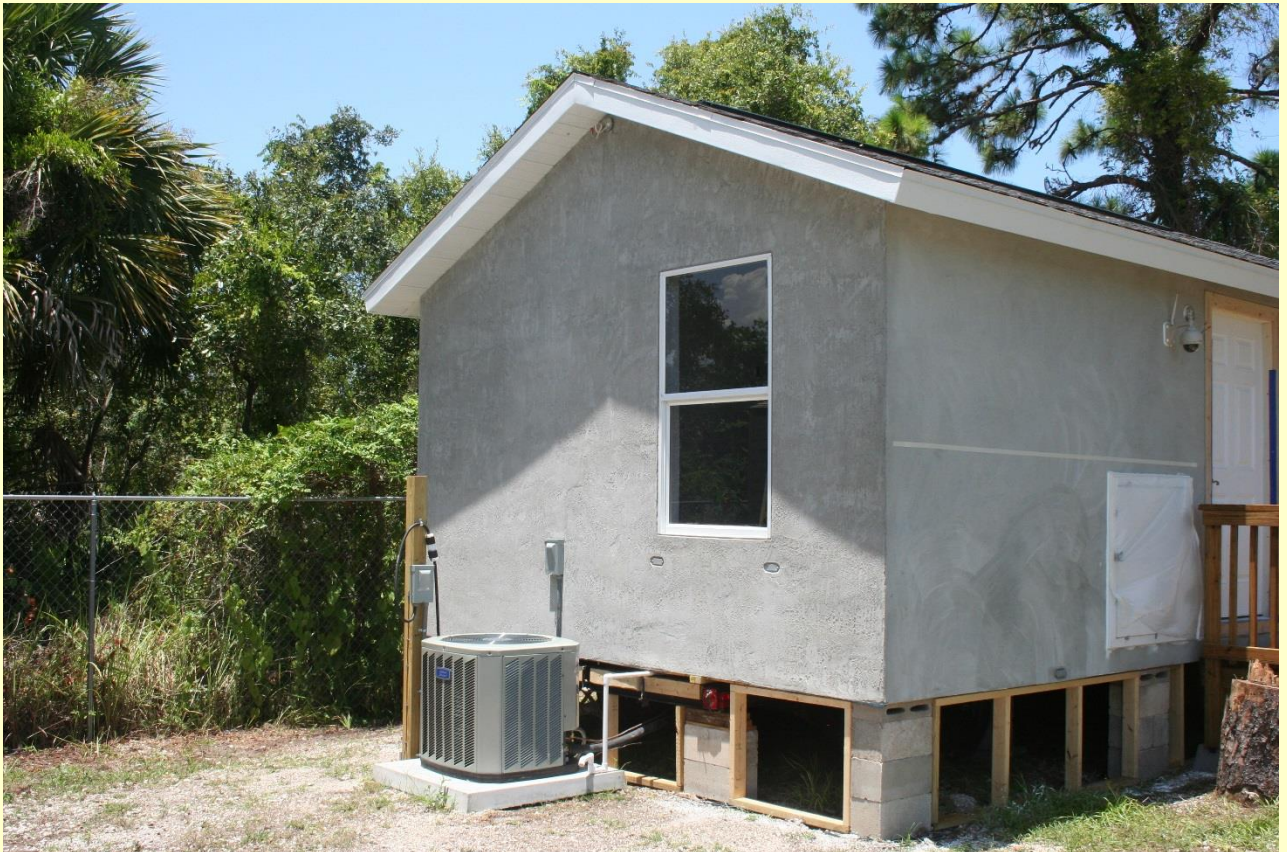
- East Wall
- Stucco Installed 6/24/2015
- Cured for 19 days before any crack documentation
- East wall not densified

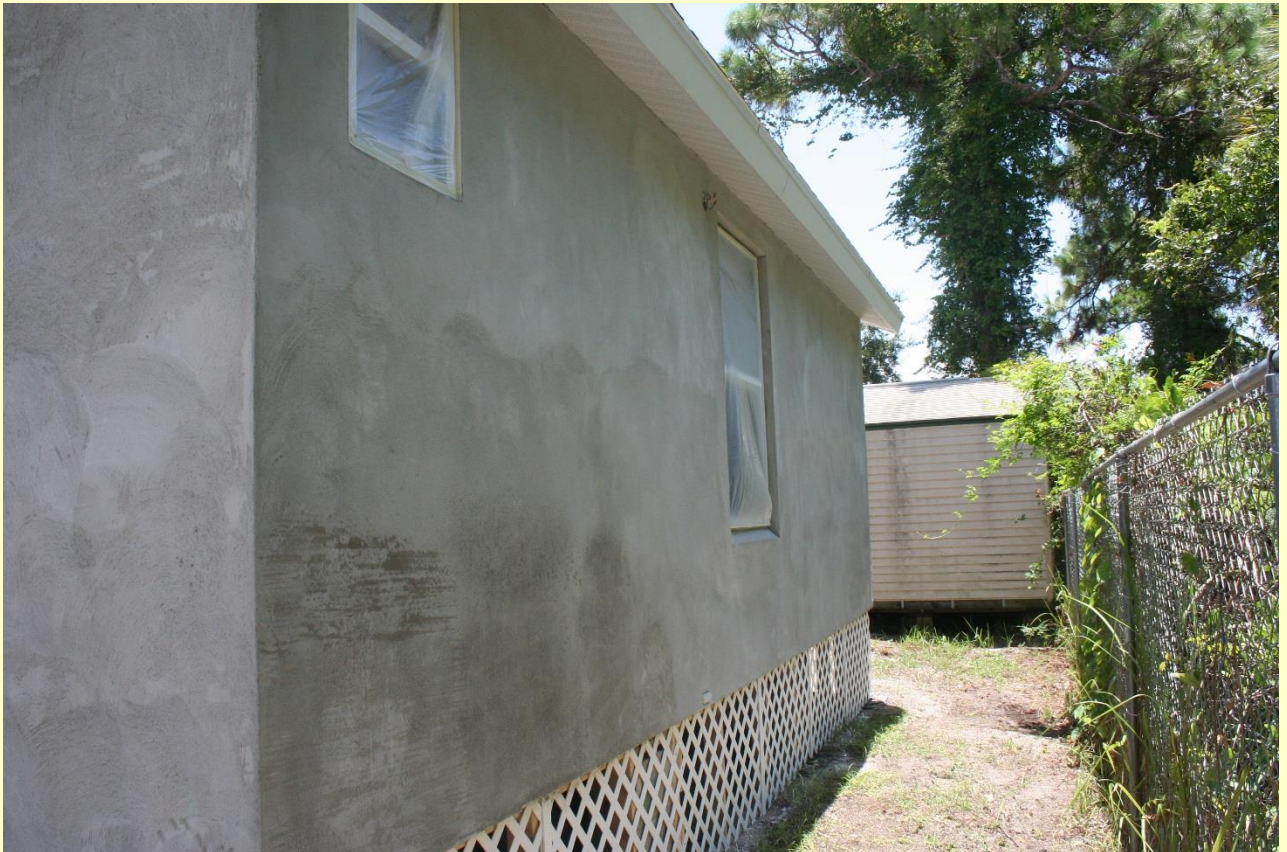
- South Wall
- Stucco Installed 6/24/2015
- Cured for 19 days before any crack documentation

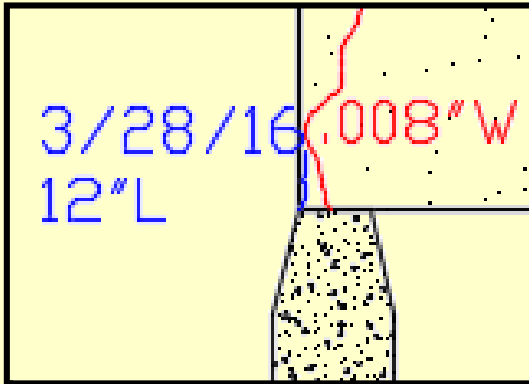
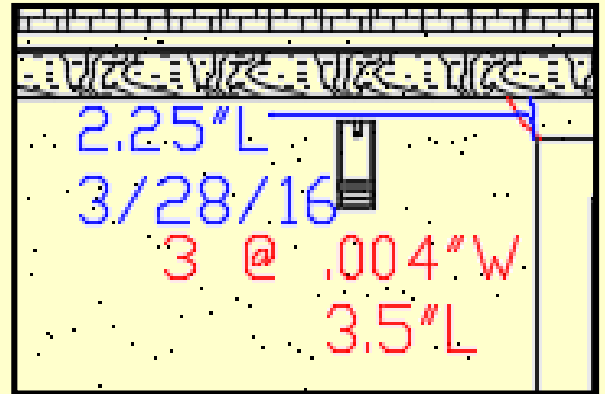
# Post Painting Fractures Developed March 28, 2016

Blue = New Crack (Post Coating)  
Red = Existing (During Curing)

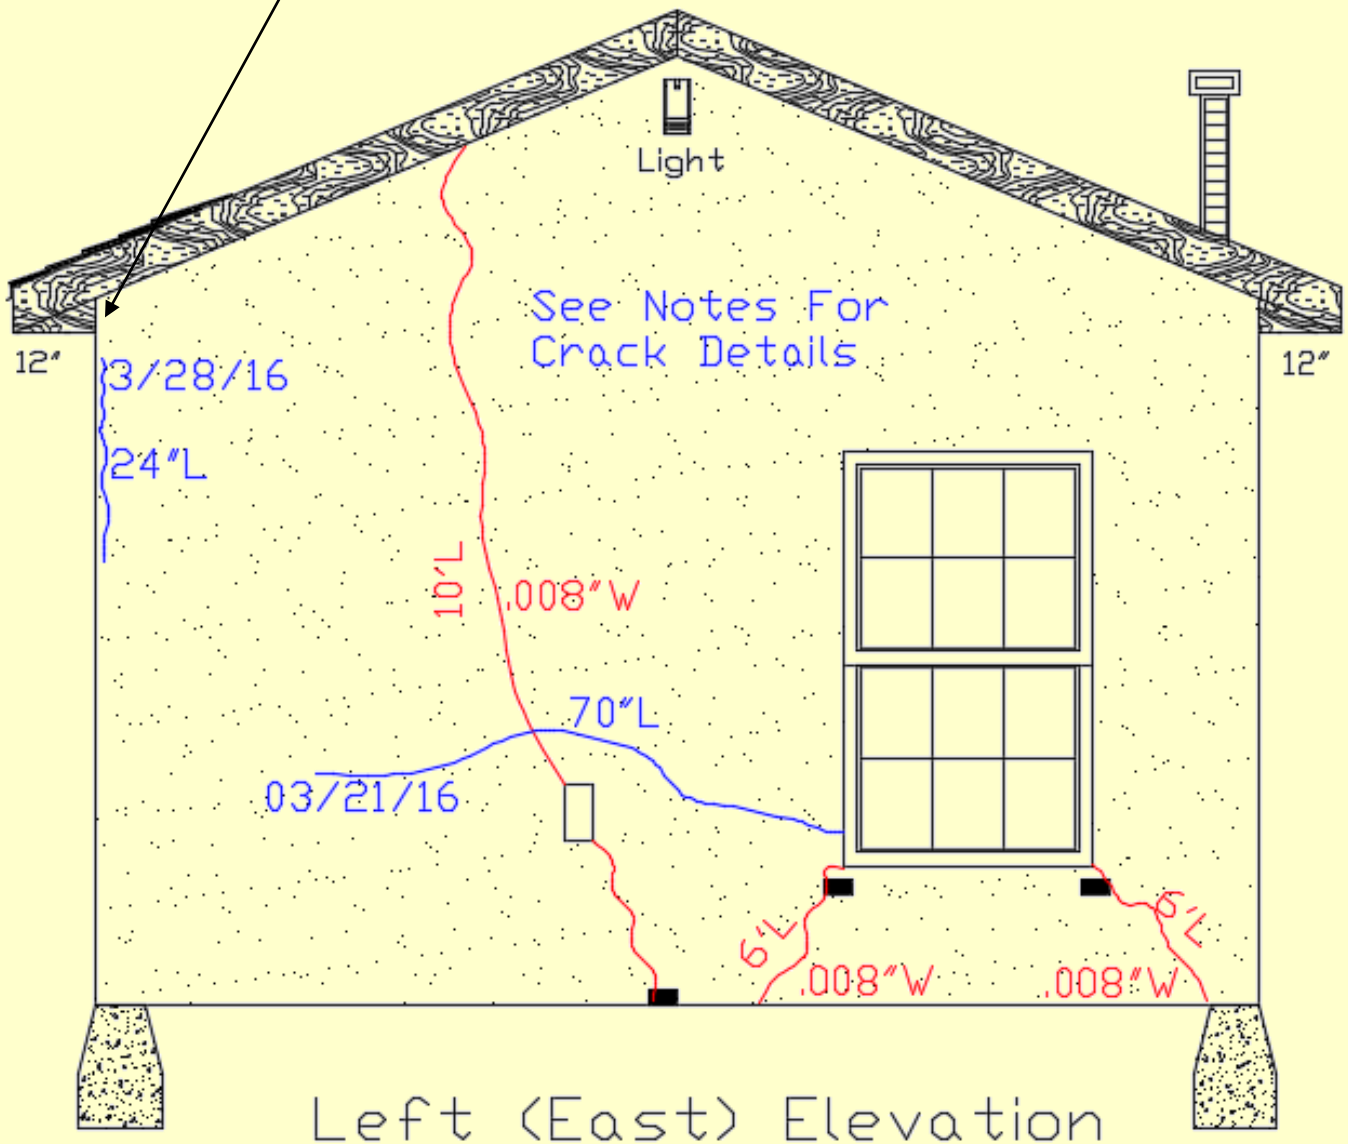
# Post Painting Fracture Updated March 28, 2016

Developed on March 28,  
2016
