Florida Stucco Application and Repair Newsletter

35 Year old Stucco Walls Performing
Flawlessly!
2nd Story Wood Sheathed Wall Over Block
1st Story.

Newsletter 19-01-1&2

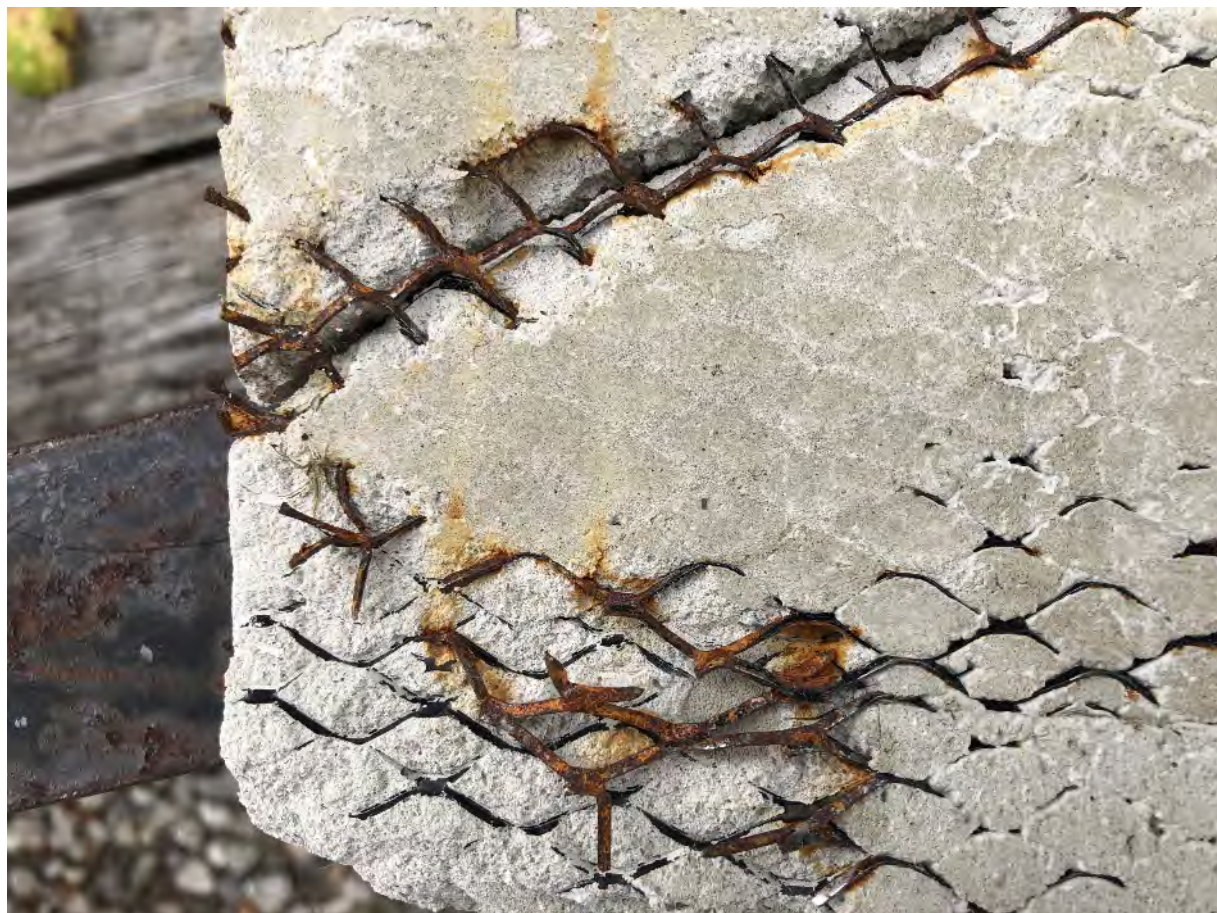
The installation shown herein would be written up by consultants serving the litigation industry with count after count after count as "code violations" in addition with violations of numerous ASTM or other provisions, including but not limited to; Stucco thickness violations, Weep screed violations, Mid wall transition violations, Corner bead Violations, Attachment placement violations, Attachment length violations, Drain plane violations, Housewrap violations, Control Joint violations, Panel size violations, Metal lath embedment violations, Paper lap violations, on and on. They would say the stucco system in its entirety would need to be completely removed and replaced, it won't last! That it surely is in danger of imminent failure! Danger Will Robinson!
