Newsletter NL 104.0

35 Year old Stucco Walls Performing
Flawlessly!
2nd Story Wood Sheathed Wall Over Block
1st Story.

01/12/2019

THE STUCCO INSTITUTE NEWS LETTER

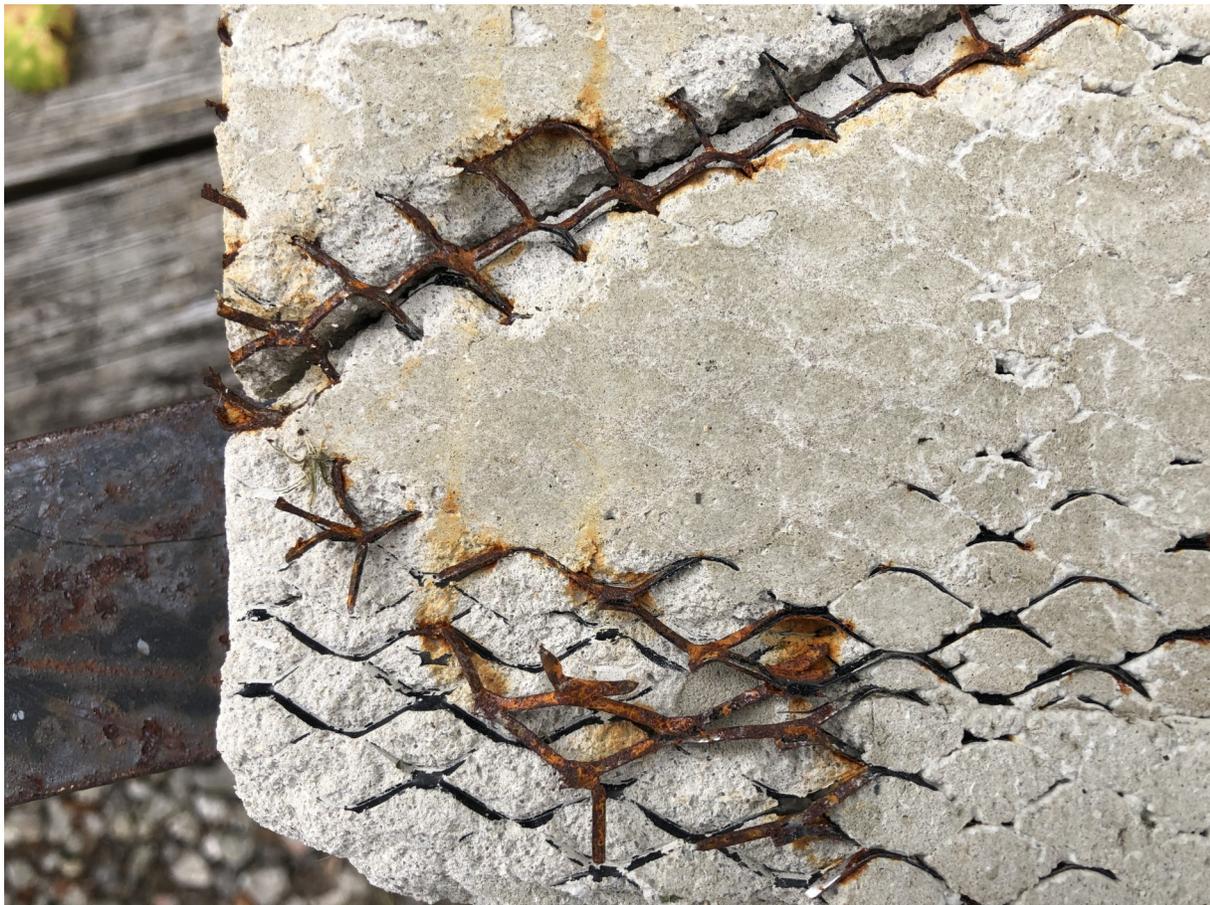
The installation shown herein would be written up by consultants serving the litigation industry with count after count after count as "code violations" in addition with violations of numerous ASTM or other provisions, including but not limited to; Stucco thickness violations, Weep screed violations, Mid wall transition violations, Corner bead Violations, Attachment placement violations, Attachment length violations, Drain plane violations, Housewrap violations, Control Joint violations, Panel size violations, Metal lath embedment violations, Paper lap violations, on and on. They would say the stucco system in its entirety would need to be completely removed and replaced, it won't last! That it surely is in danger of imminent failure! Danger Will Robinson!
